- i) to report on the recent logging activities in compartments 168 - 170 of Oakes State Forest within the context of the July, 1990 Standard Erosion Mitigation Conditions for Logging (SEMC's);
- ii) to compile recommendations necessary to rehabilitate any soil conservation problems identified in i) above; and
- iii) to prepare recommendations for the Forestry Commission to consider when it proposes to carry out logging in areas of a similar nature to Oakes State Forest.

OAKES STATE FOREST

Compartments 168 - 170.

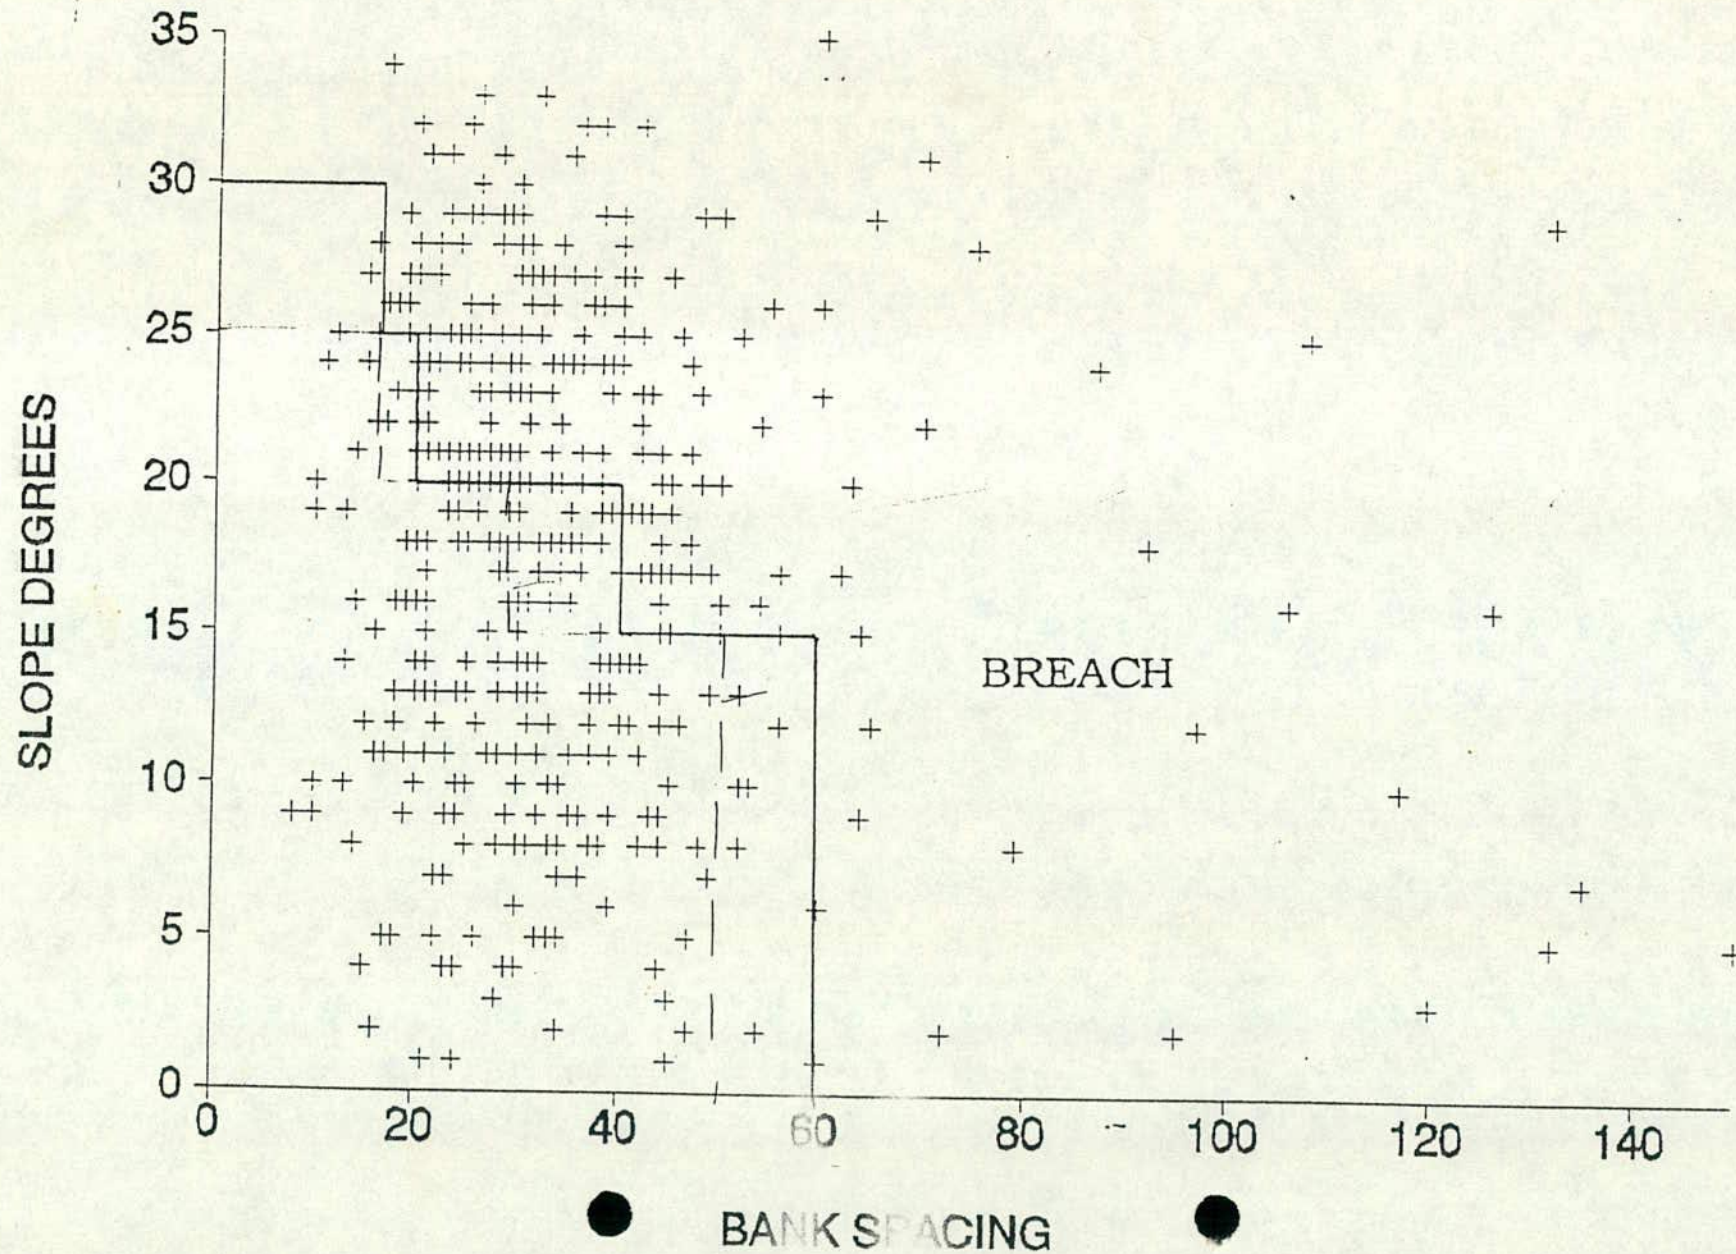
Figure 6 Snig Track Compliance with SEMC's

Measured bank spacing has been plotted against track slope in Figure 6 to illustrate the degree of compliance with the SEMC's. The stepped solid line represents the conservative bank spacings applicable if the erosion hazard were taken as "average". All points to the upper right of the line therefore represent breaches of the SEMC's (see Section 8.2.1 for details). Five points exceed the scale limits of the plot. Had the banks been constructed in accordance with the SEMC's the scatter plot would have shown a concentration of points along a diagonal line below the stepped solid line in the graph. In fact the points are randomly distributed with no correlation between slope angle and bank spacing ( $r^2 = 0.12$ ). In other words the bank spacings are completely random; there is no evidence of any relationship between the constructed bank spacings and the track slopes as would have been expected were Clause 2.4(ii) of the SEMC's implemented.

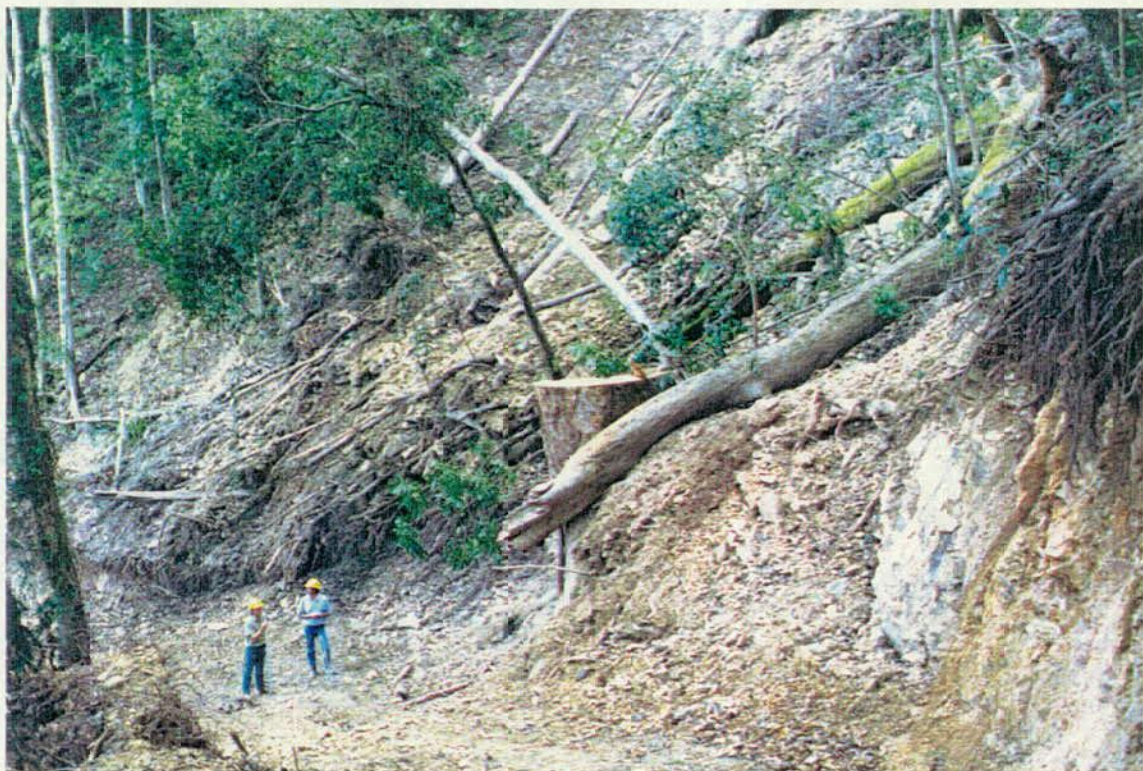
SLIP ON SNIG TRACK SU6 FROM DUMP 7  
DOWNSLOPE. NOTE WINDROW

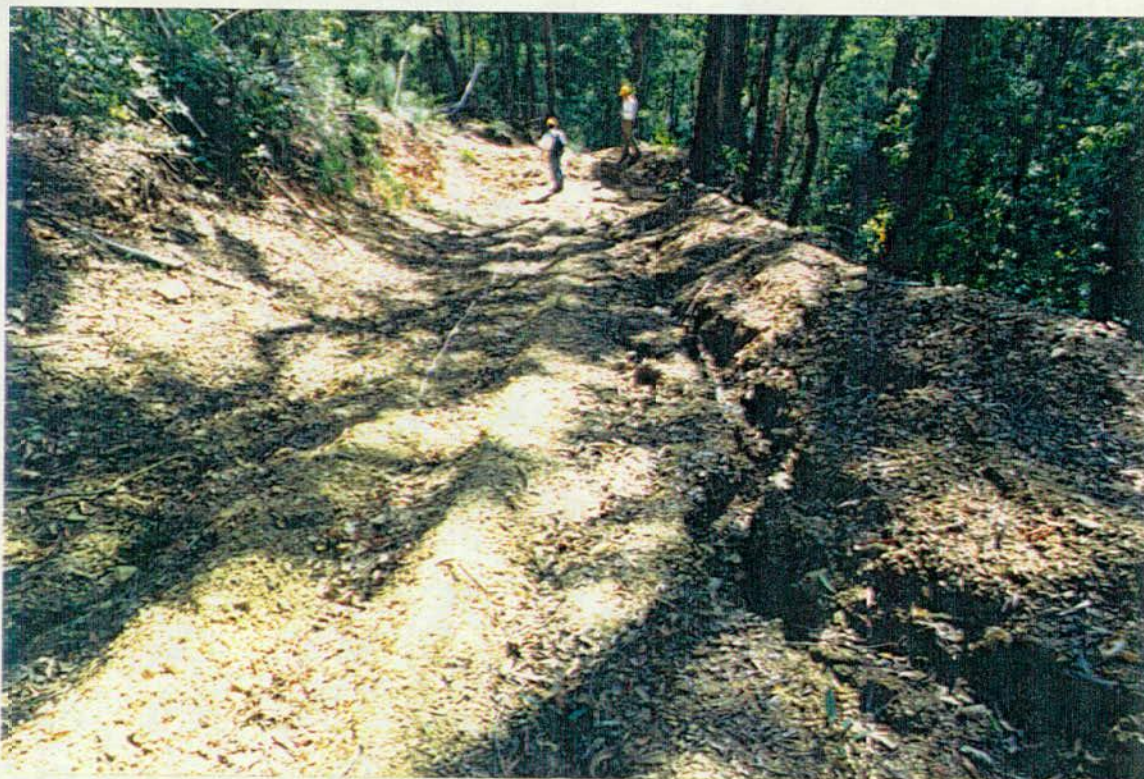
TALUS COVERED. SLOPE FROM CATBIRD ROAD TO  
SNIG TRACK SC6 FROM DUMP 4

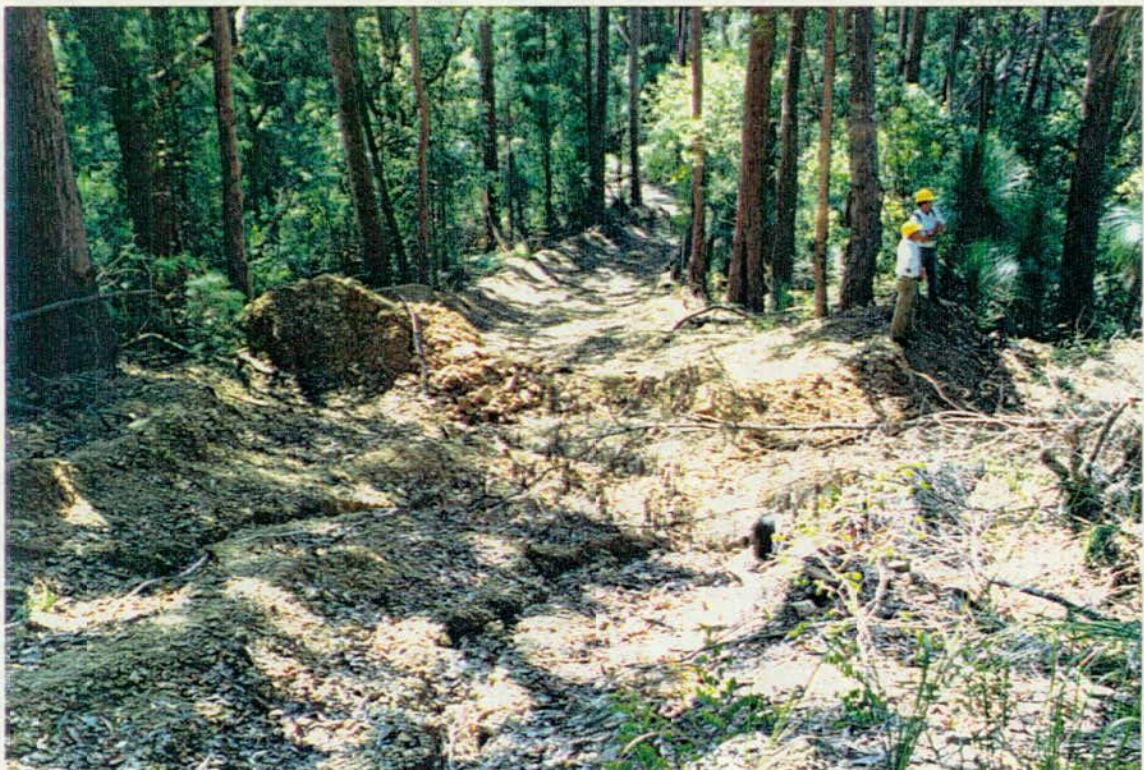
SIDECUT SNIGTRACK, UPSLOPE WITH HIGH WINDROW  
AND DEEP RILL

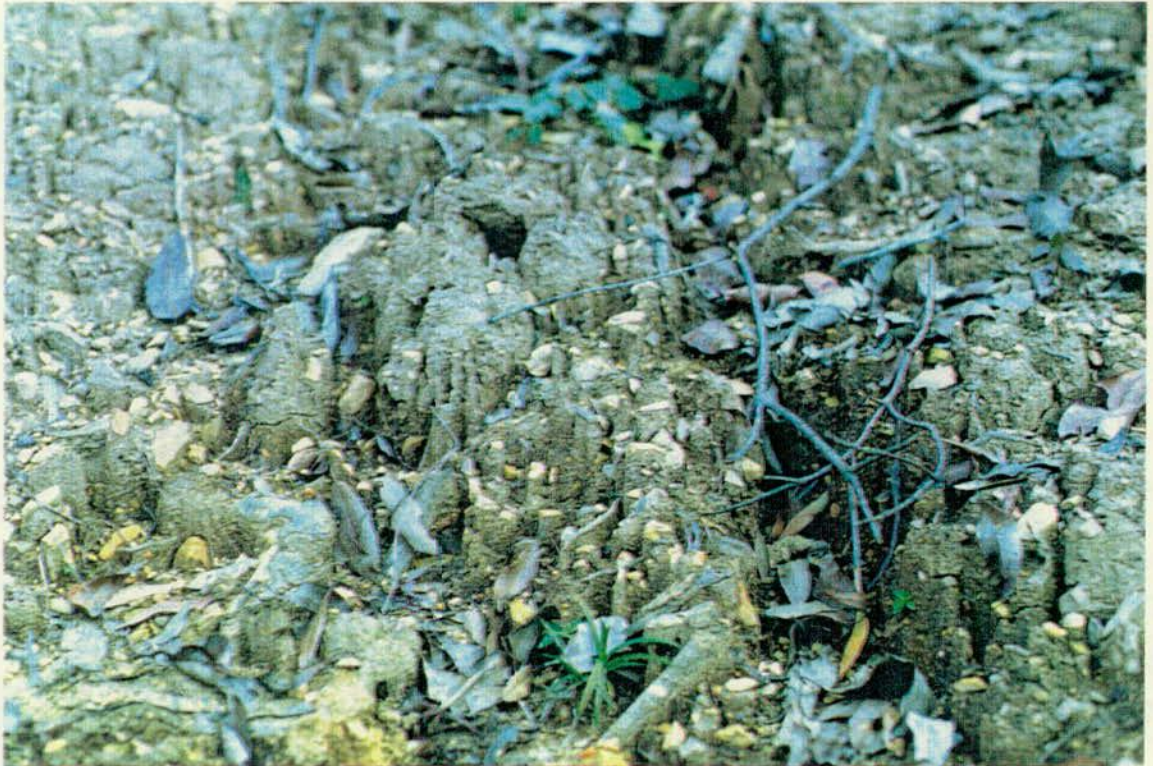
SIDECUT SNIG TRACK RILLED AS ABOVE. HIGH WINDROW

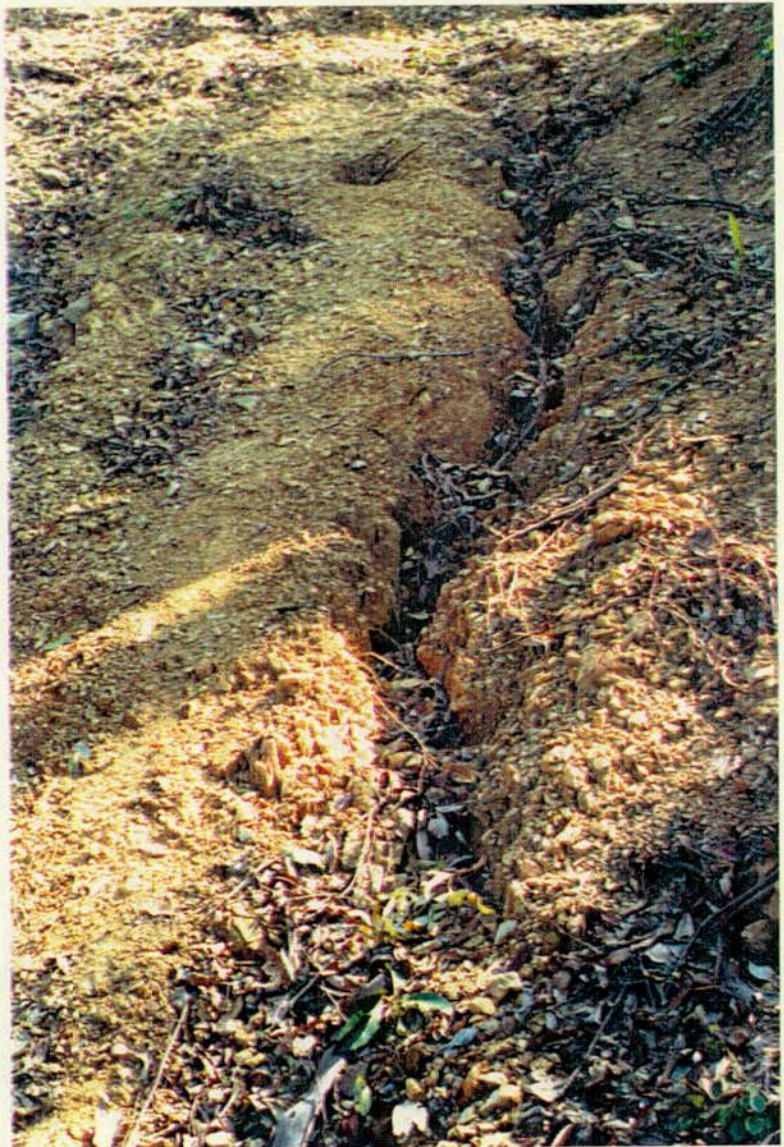
PEDESTALS AND RILLS OF SNIGTRACK  
SURFACE. SOME RE-VEGETATION  
COMMENCED.

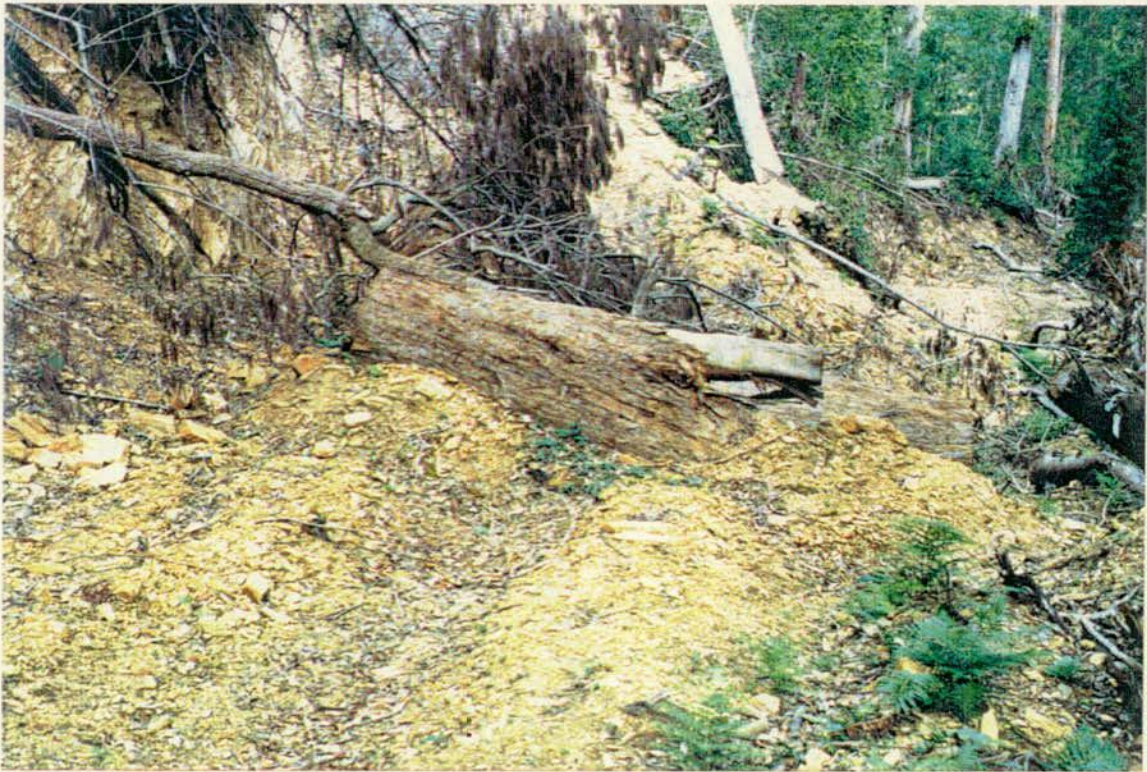
SIDECUT SNIG TRACK, RILLED TO  
30cm. LEAF LITTER AND SOME  
RE-VEGETATION.

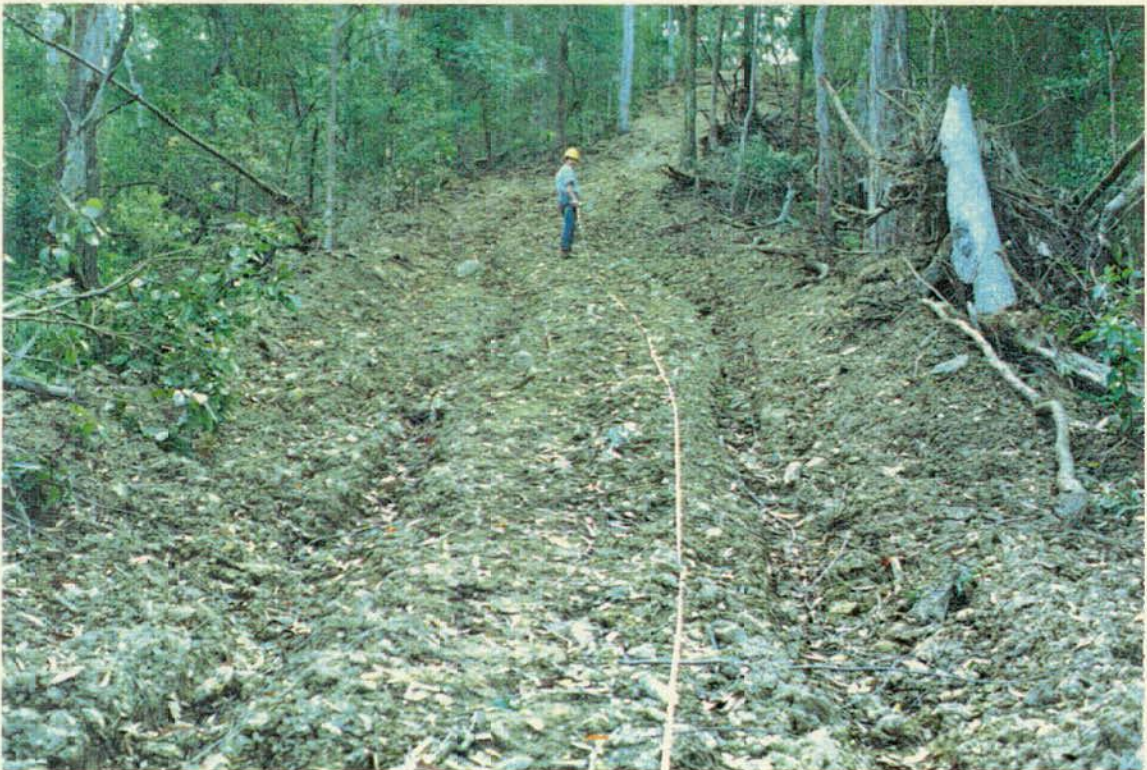
BOX CUT RIDGE TRACK SC5 HIGH WINDROWS AND RILLED.

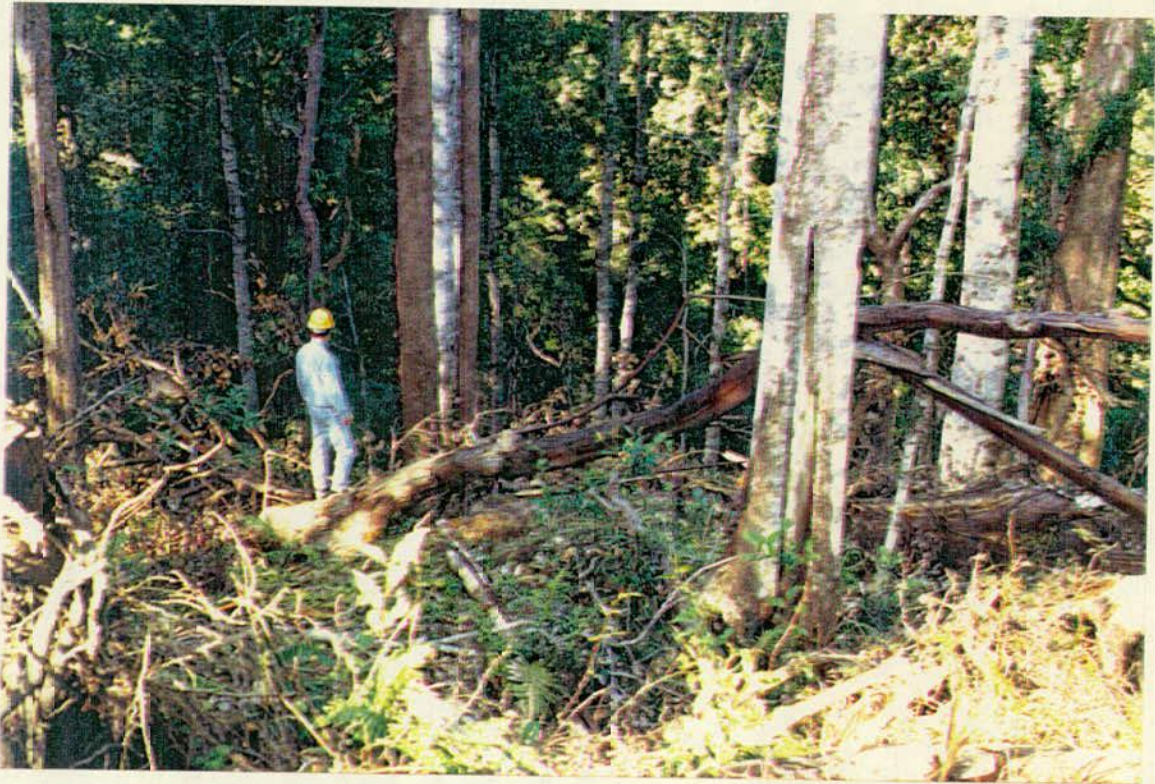
BOX CUT RIDGE TRACK SC5 HIGH WINDROWS RILLED DOWN  
DOZER TRACKS.

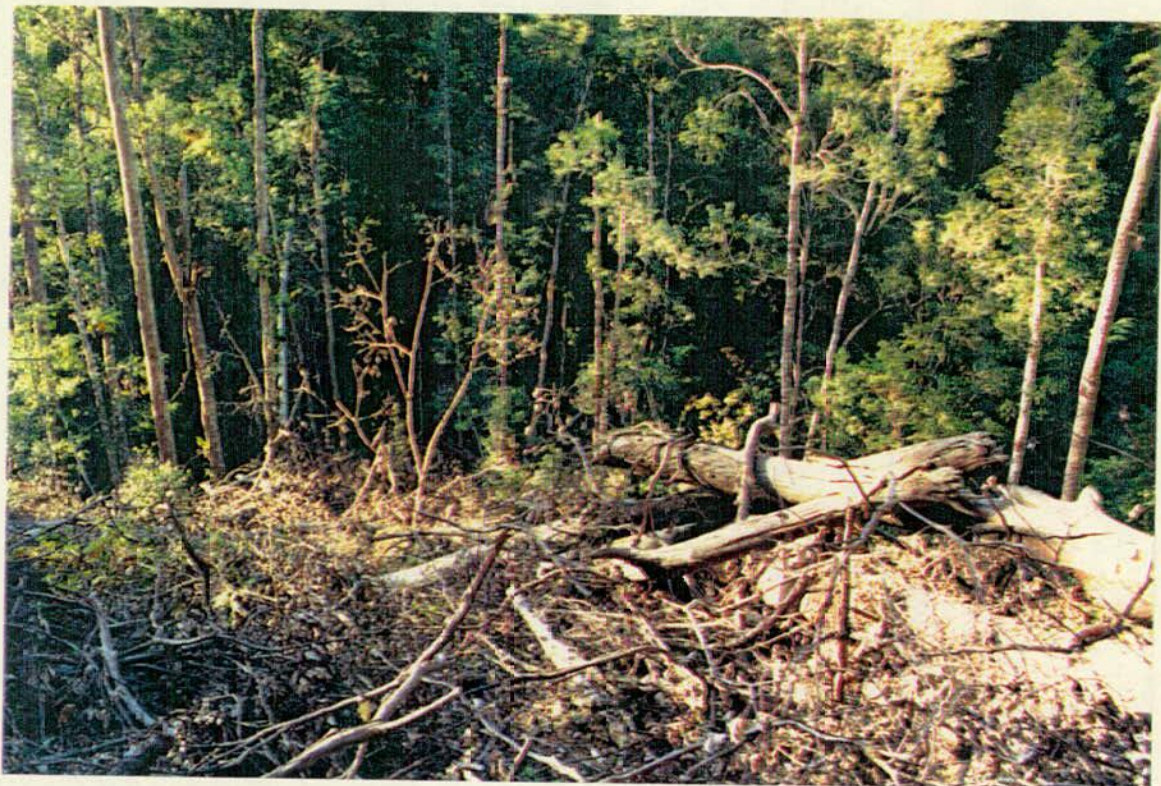
SNIG TRACK INTRUSION INTO FILTERSTRIP ON SUNDAY CREEK  
DAMAGE TO COACHWOOD STAND.

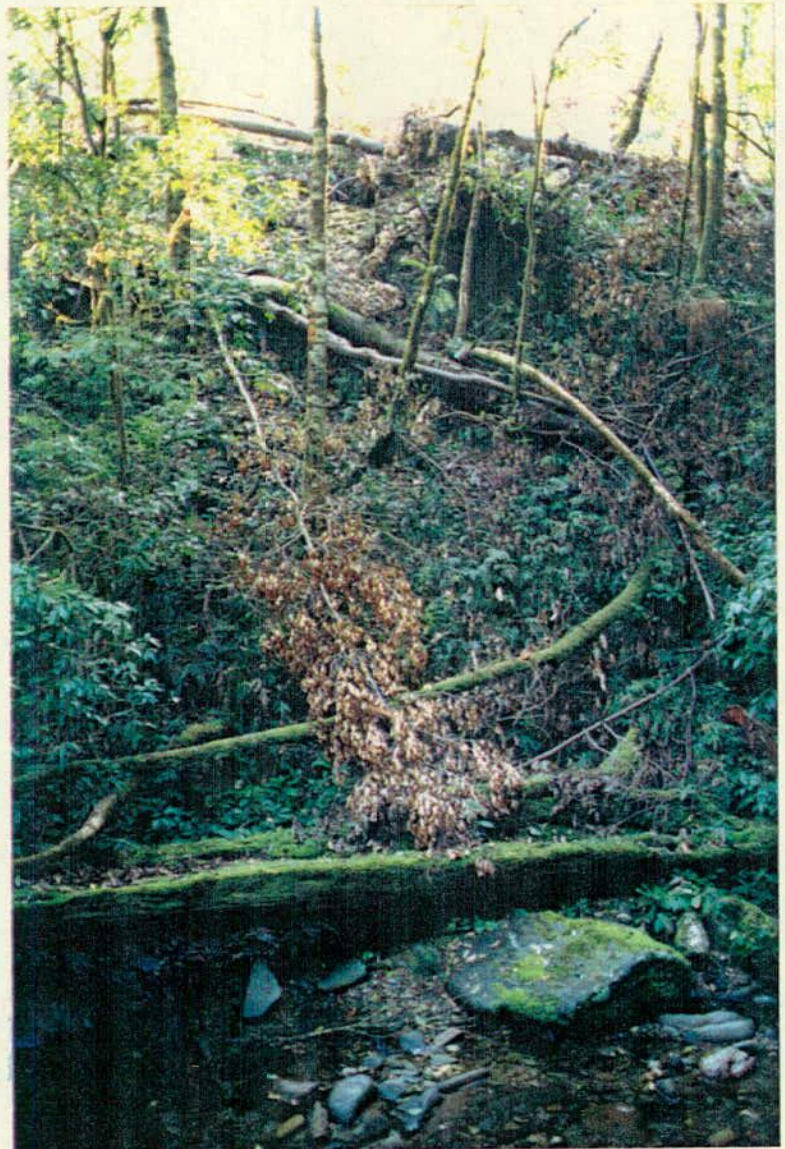
SNIG TRACK INTRUSION INTO  
PROTECTION STRIP IN SCRAGGY  
CREEK CATCHMENT.

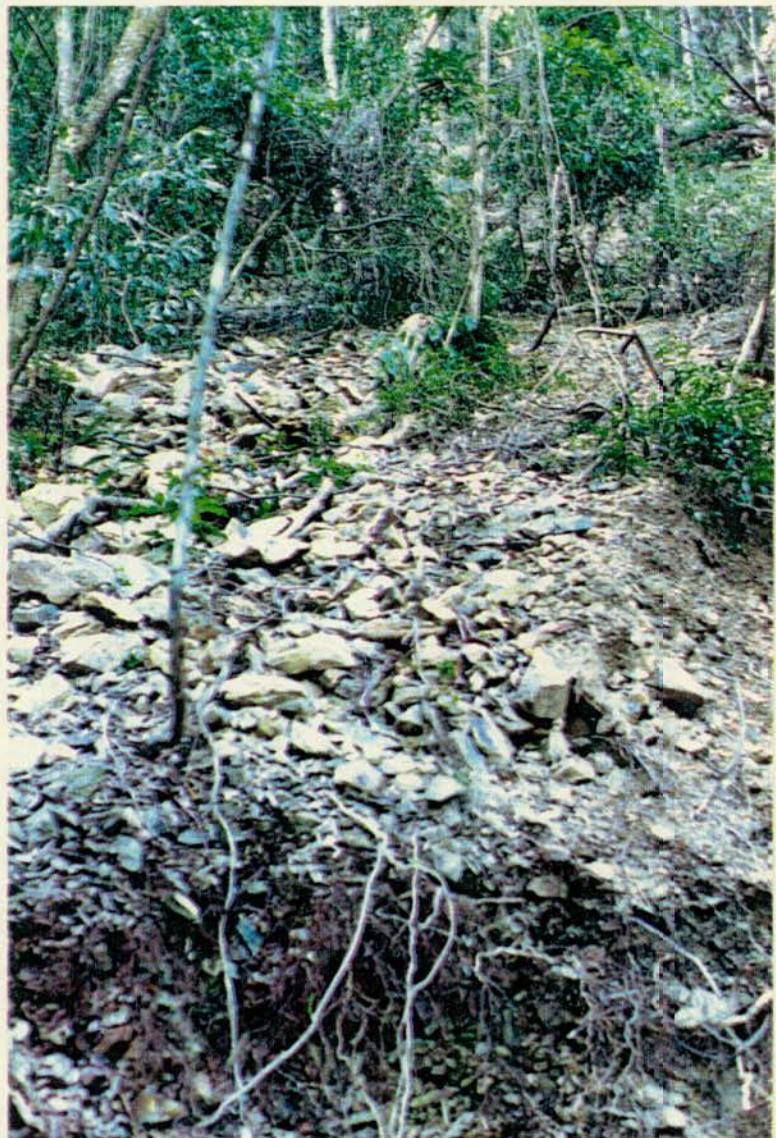
TALUS COVERED STEEP SLOPE  
UNDER CATBIRD ROAD ABOVE  
SNIGTRACK SC6

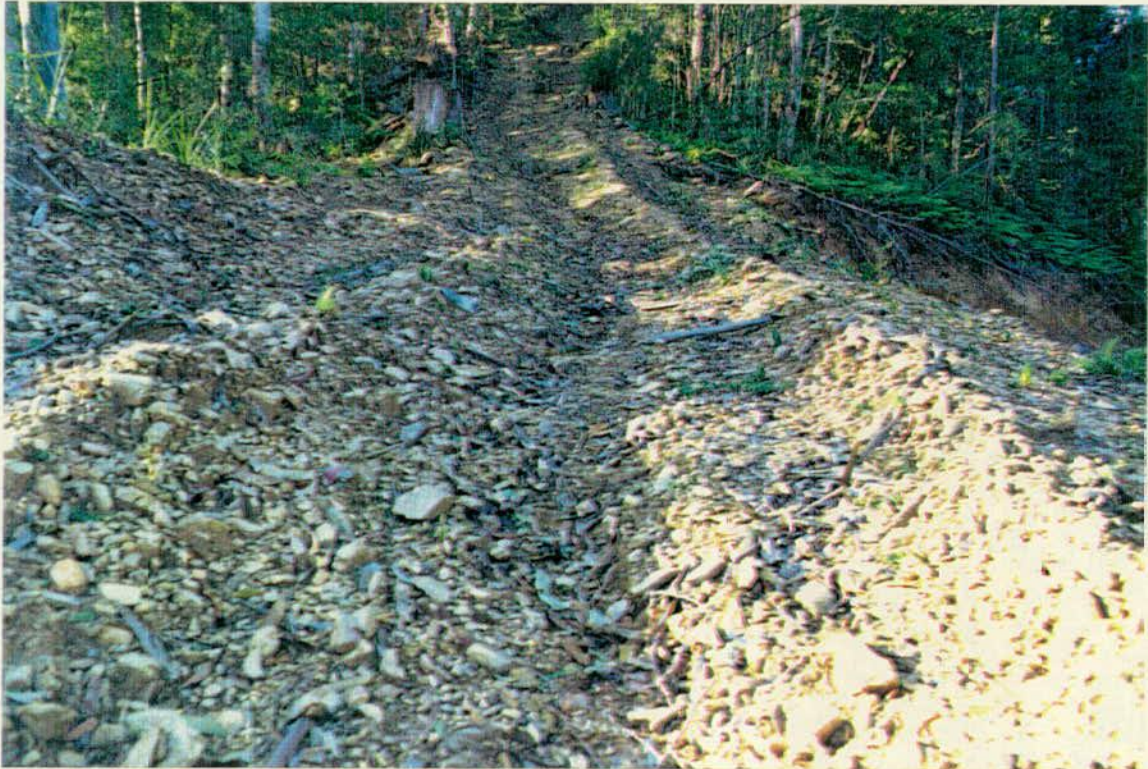
RESHAPED DUMP 6 AFTER THE LOGGING EXTRACTION CEASED.

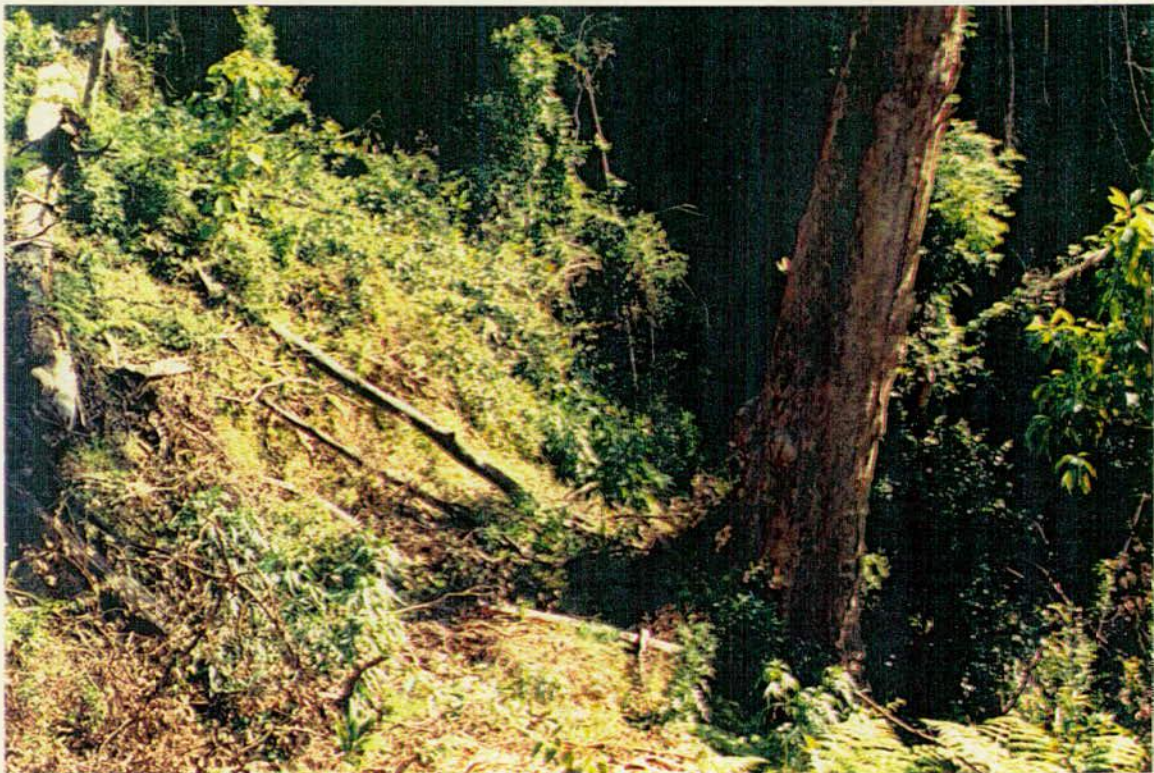
RIDGE SNIG TRACK WITH DEEP LOG SCOUR.

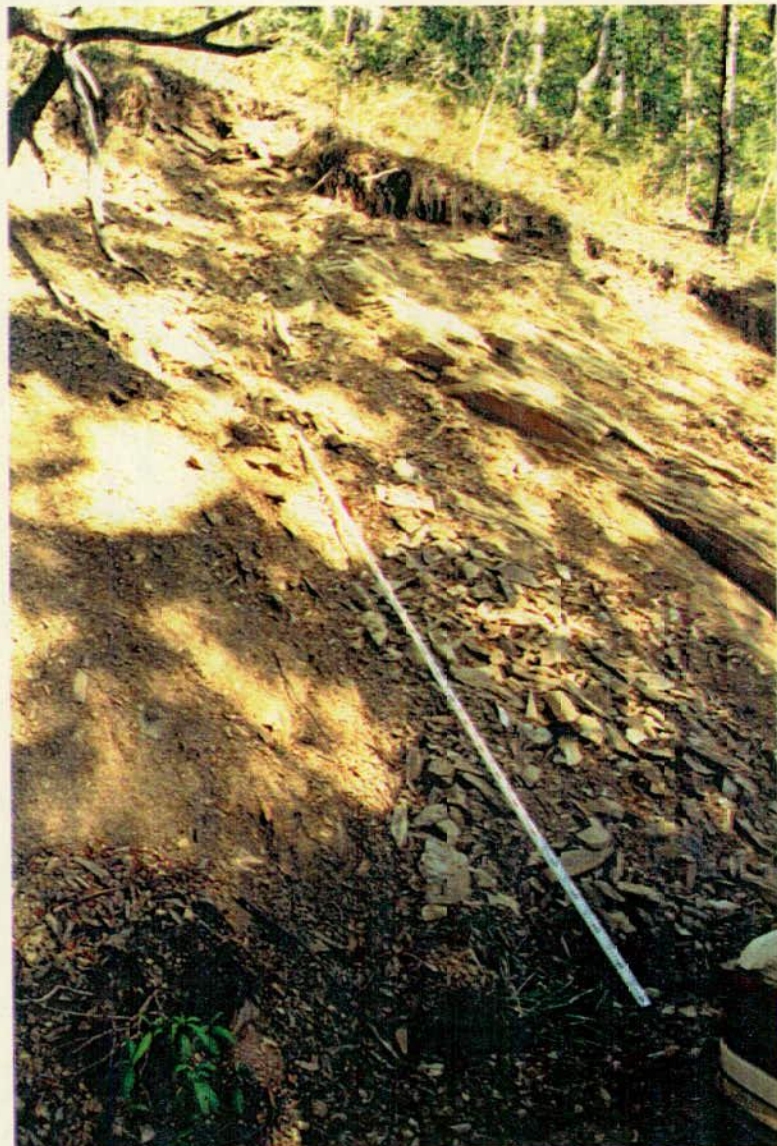
CATBIRD ROAD WITH SLIPS

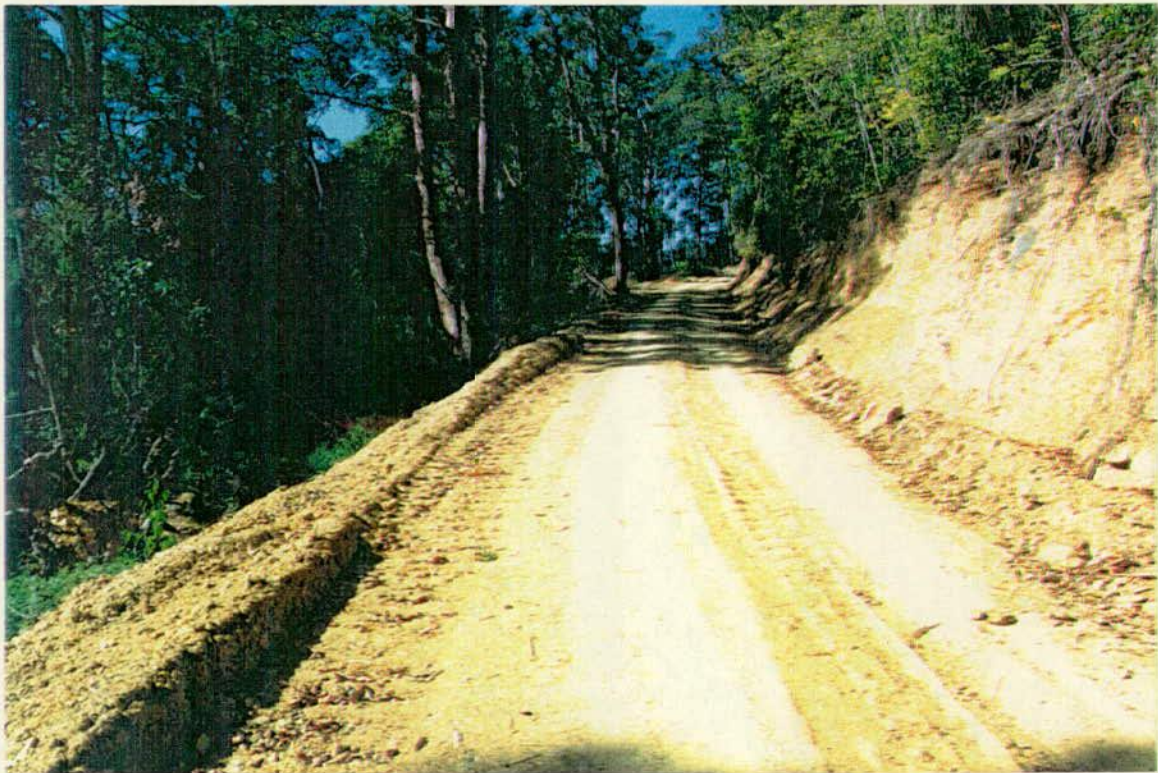
CATBIRD ROAD AT 0.25kms  
SLIP ON ROCK.

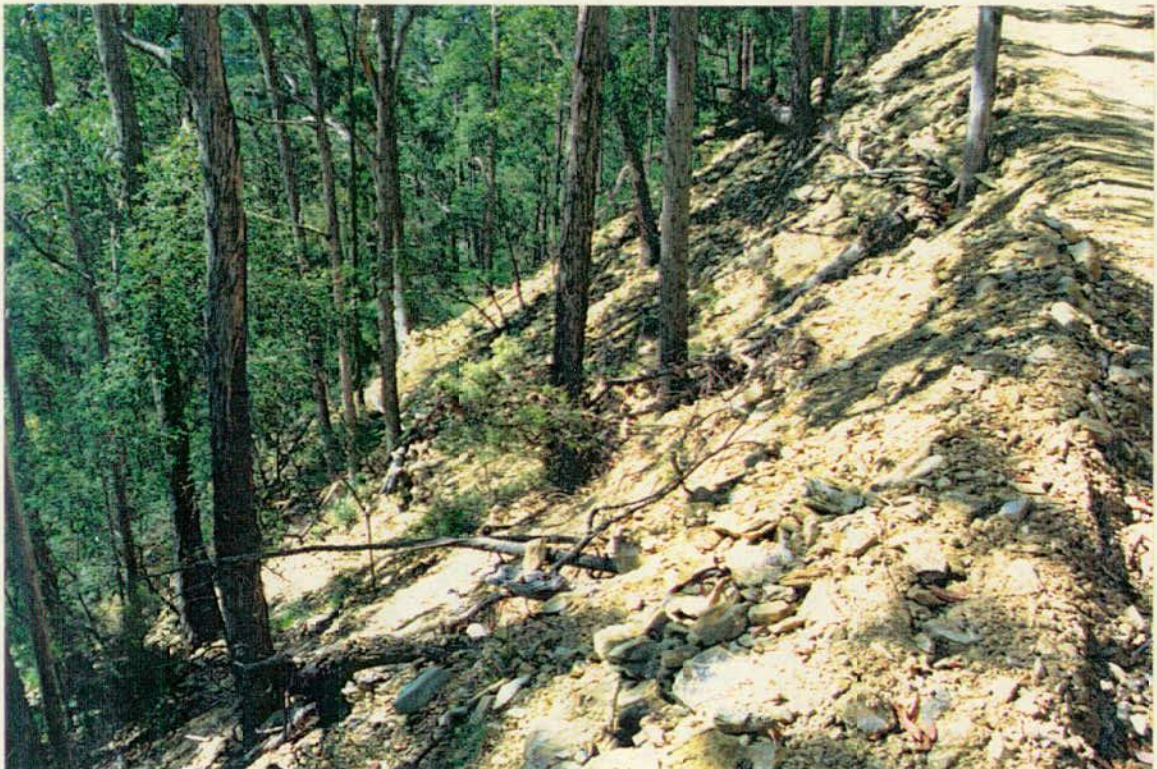
CATBIRD ROAD WITH SLIP

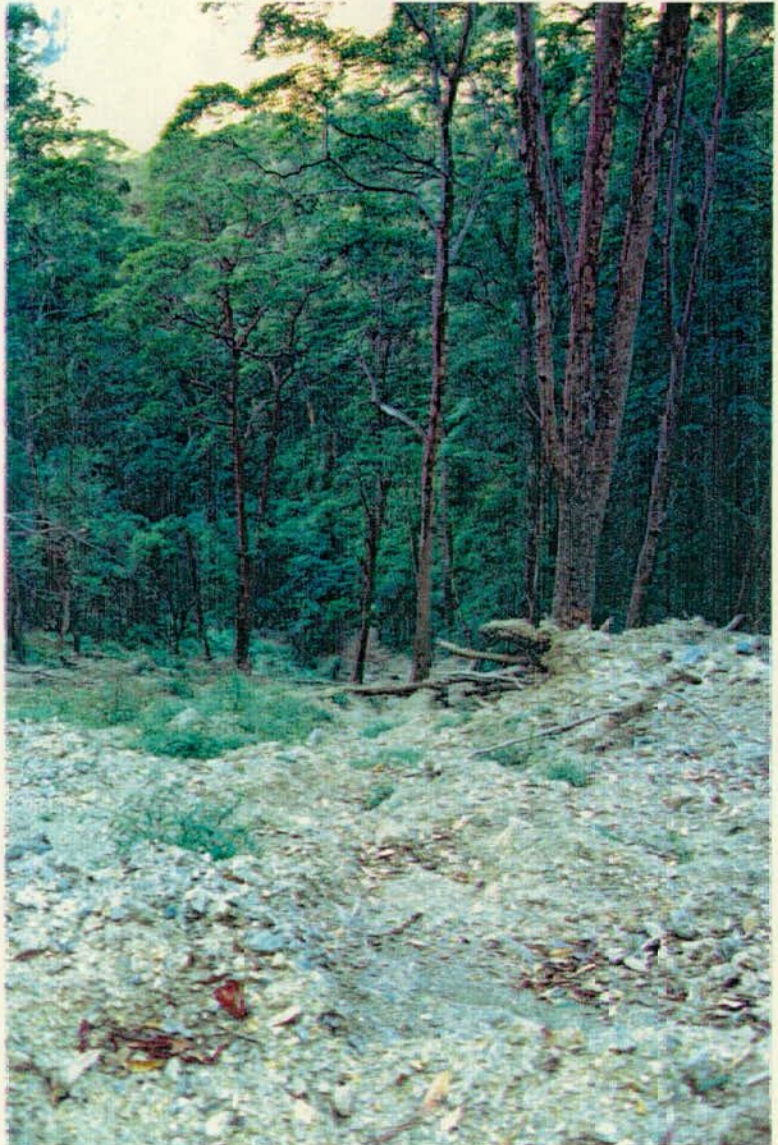
CATBIRD ROAD WITH TALUS  
AT 2.49kms

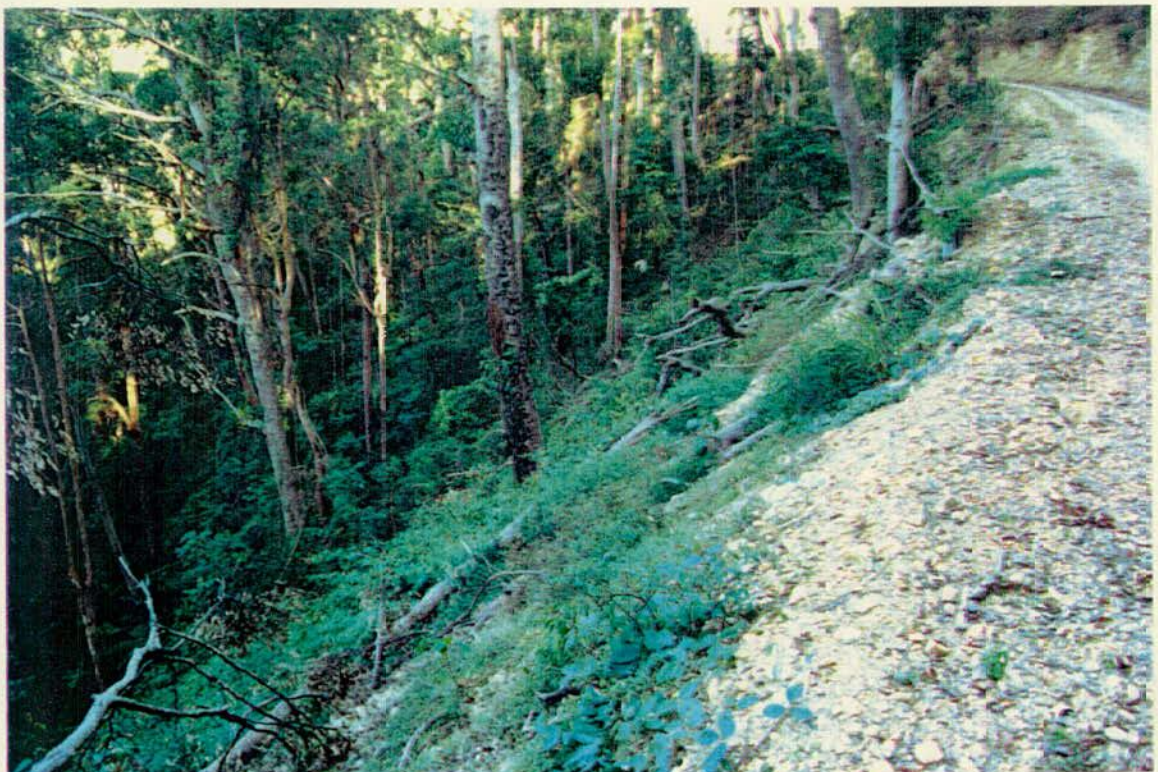
CATBIRD ROAD WITH TALUS  
AT 4.17kms.

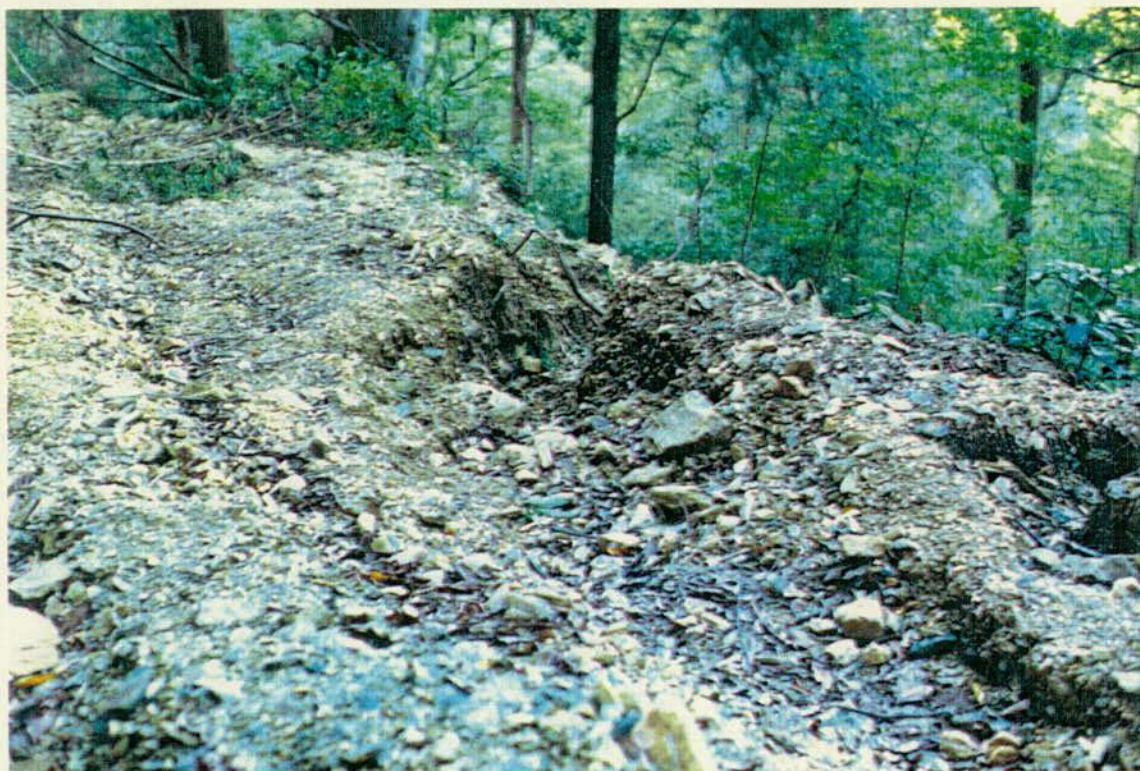
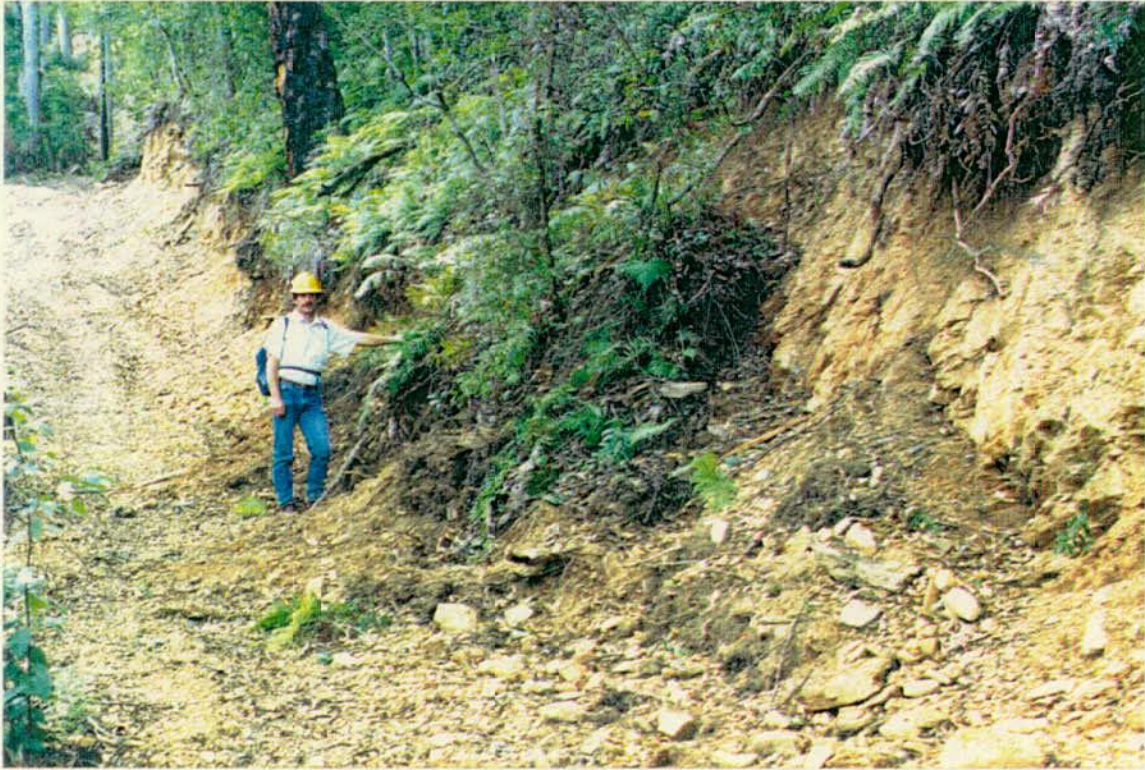
SLUMPS OF SNIG TRACK PAVEMENT.

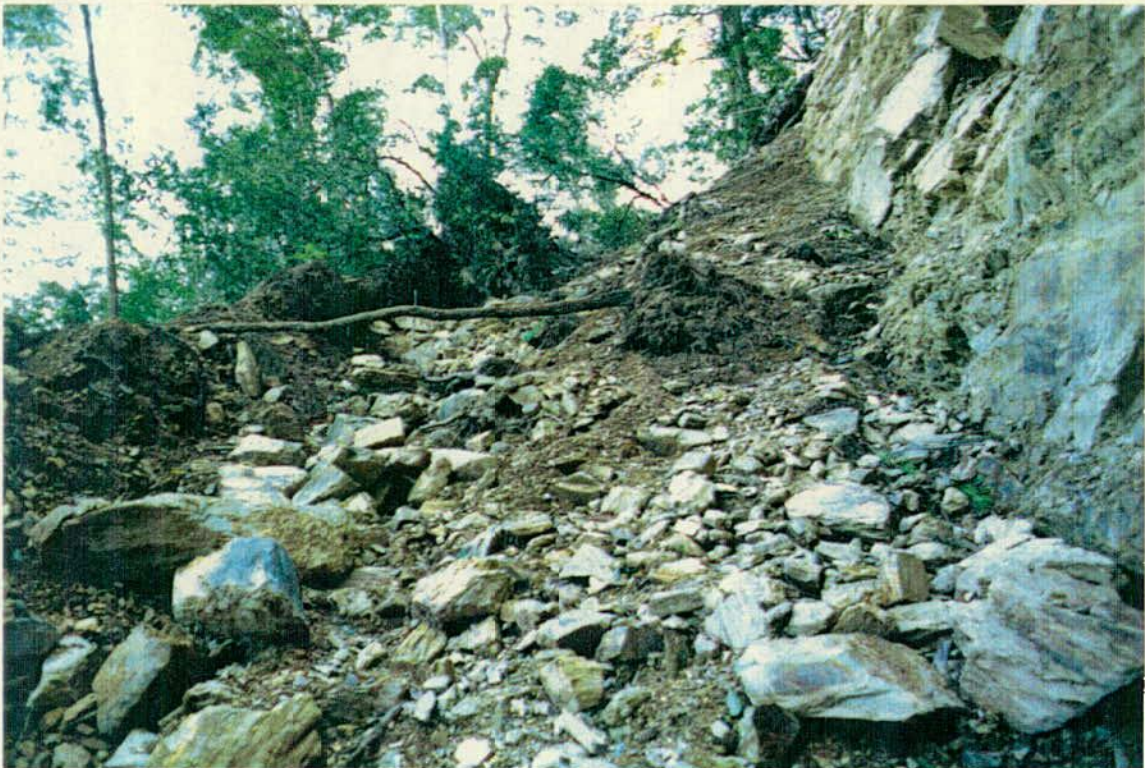
CUT BATTER FAILURE ON SNIG TRACK SC1

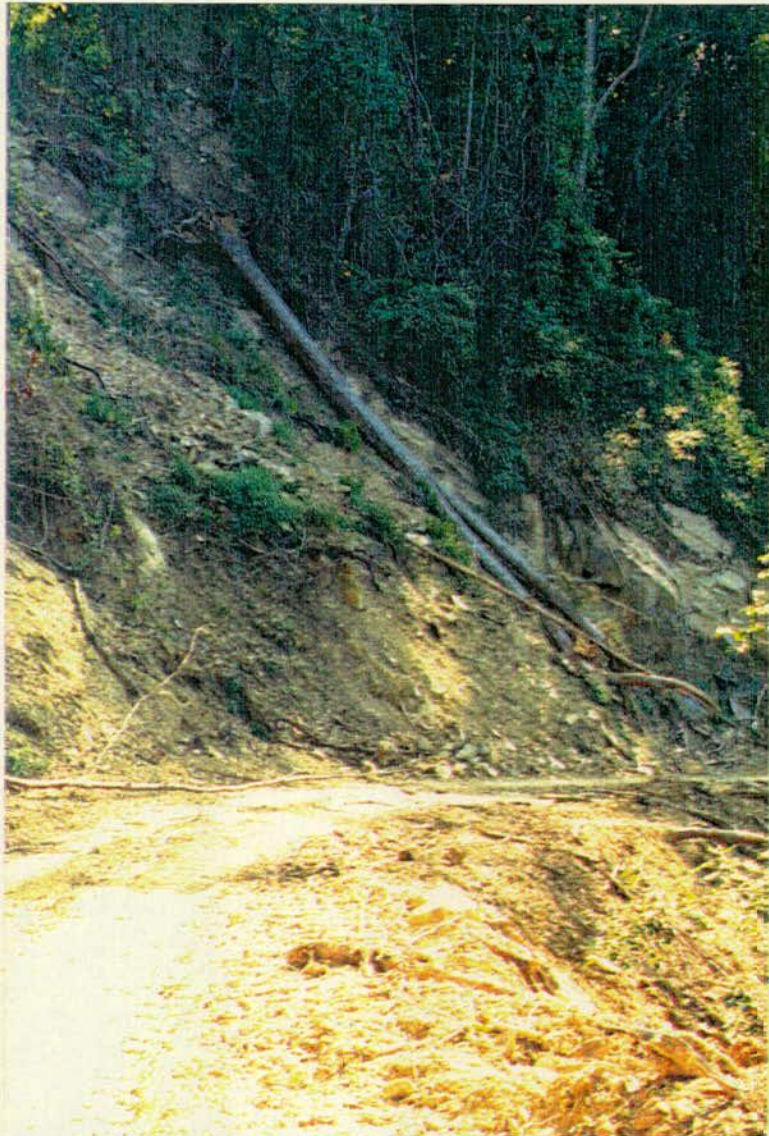
CUT BATTER FAILURE  
ON CATBIRD ROAD

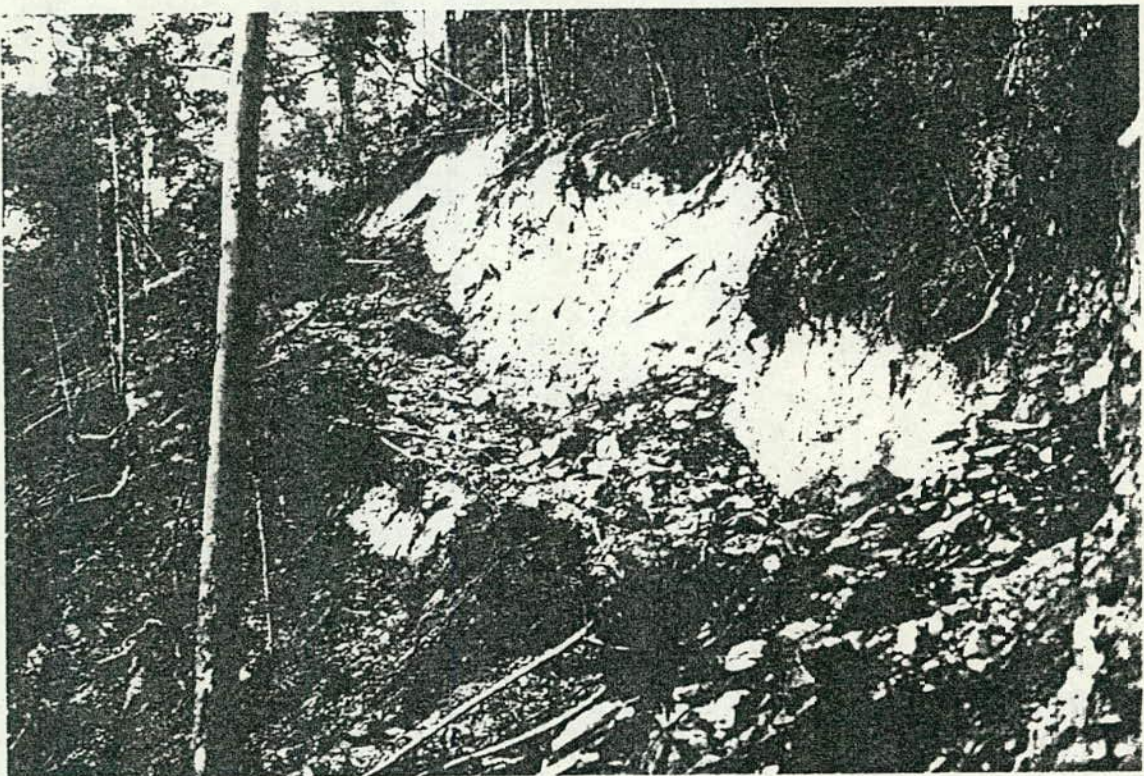
SLIP OF ROCK ON SNIG TRACK SUS FROM DUMP 5  
DOWNSLOPE.
