- i) to report on the recent logging activities in compartments 168 - 170 of Oakes State Forest within the context of the July, 1990 Standard Erosion Mitigation Conditions for Logging (SEMC's);
- ii) to compile recommendations necessary to rehabilitate any soil conservation problems identified in i) above; and
- iii) to prepare recommendations for the Forestry Commission to consider when it proposes to carry out logging in areas of a similar nature to Oakes State Forest.

OAKES STATE FOREST

Compartments 168 - 170.

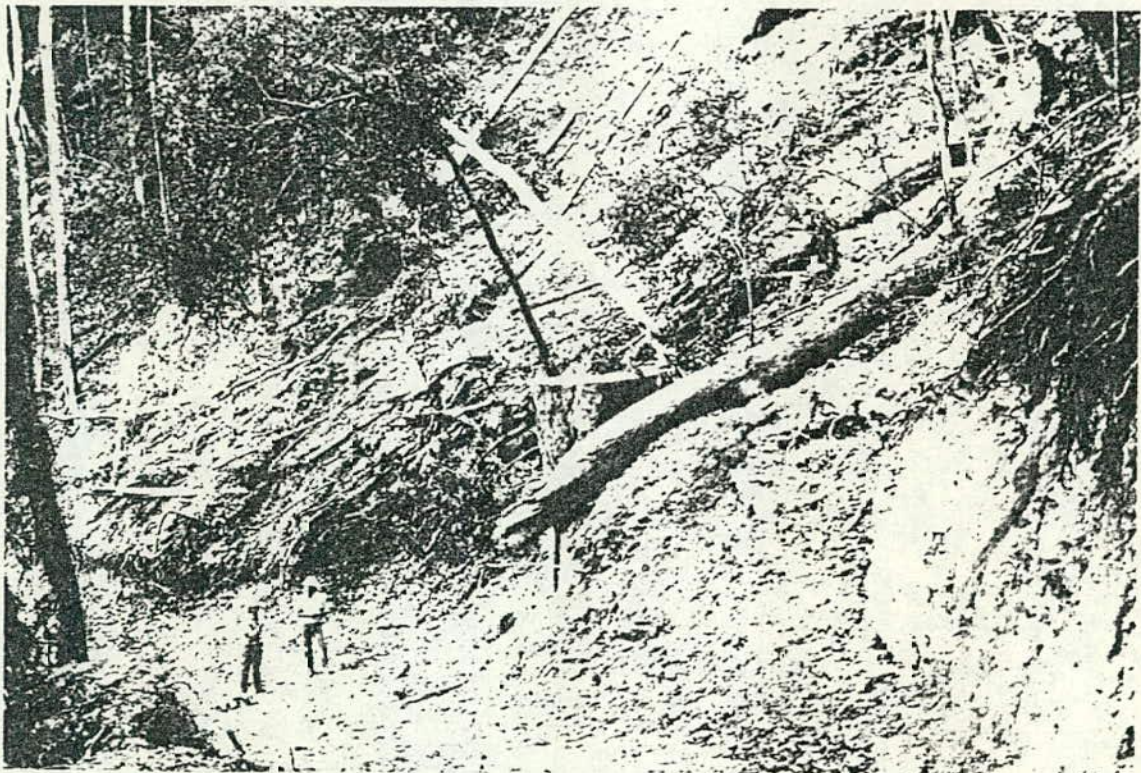
SLIP ON SNIG TRACK SU6 FROM DUMP 7  
DOWNSLOPE. NOTE WINDROW

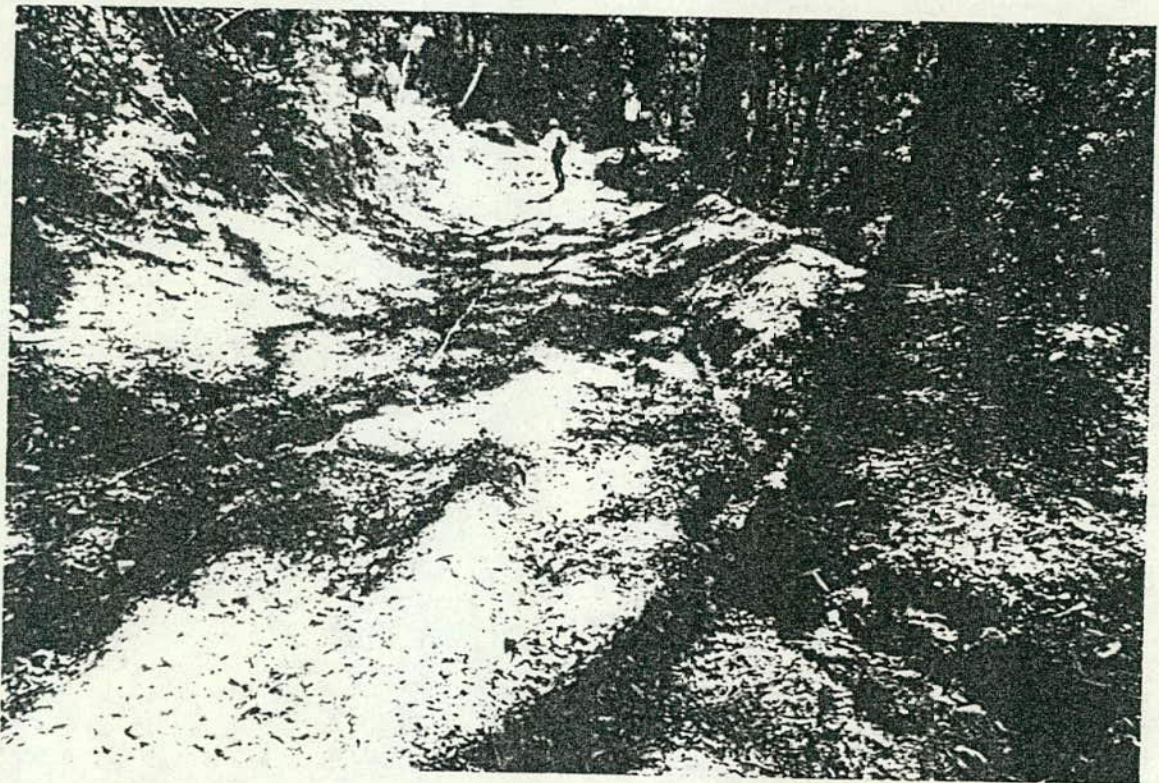
TALUS COVERED. SLOPE FROM CATBIRD ROAD TO  
SNIG TRACK SC6 FROM DUMP 4

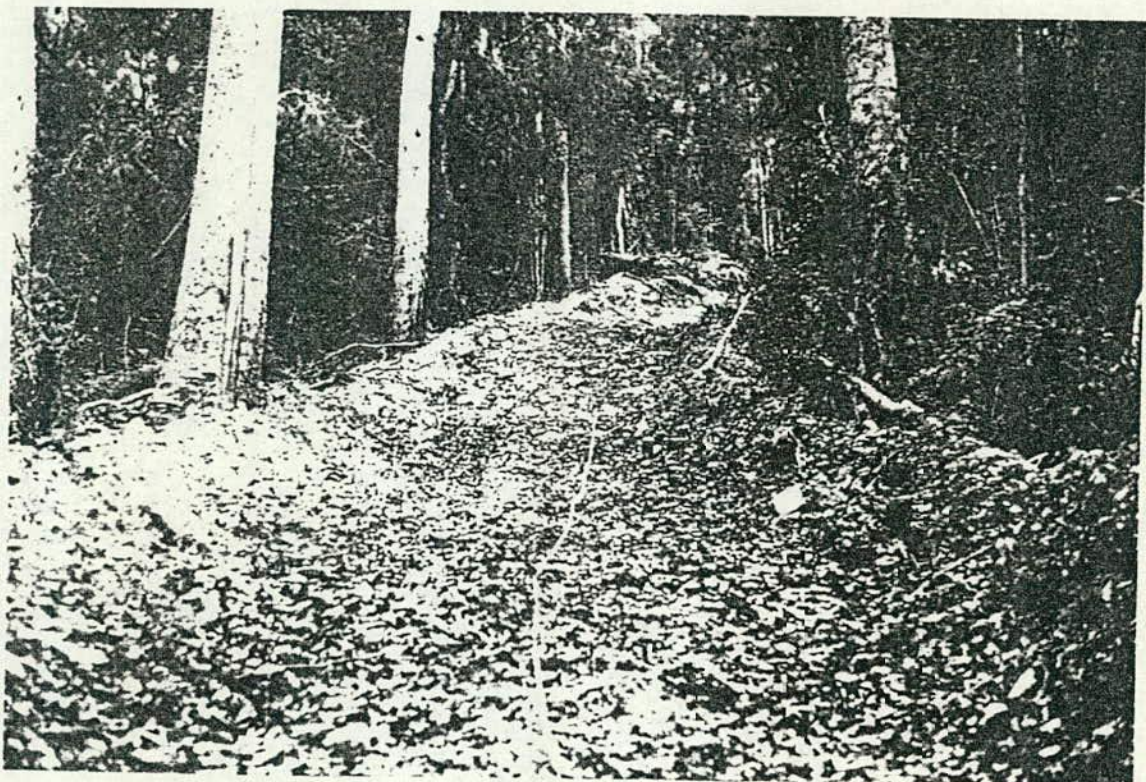
BOX CUT SIDECUT SNIG TRACK WITH HIGH WINDROW PREVENTING  
WATER EXIT. RILL ON WINDROW TOE.

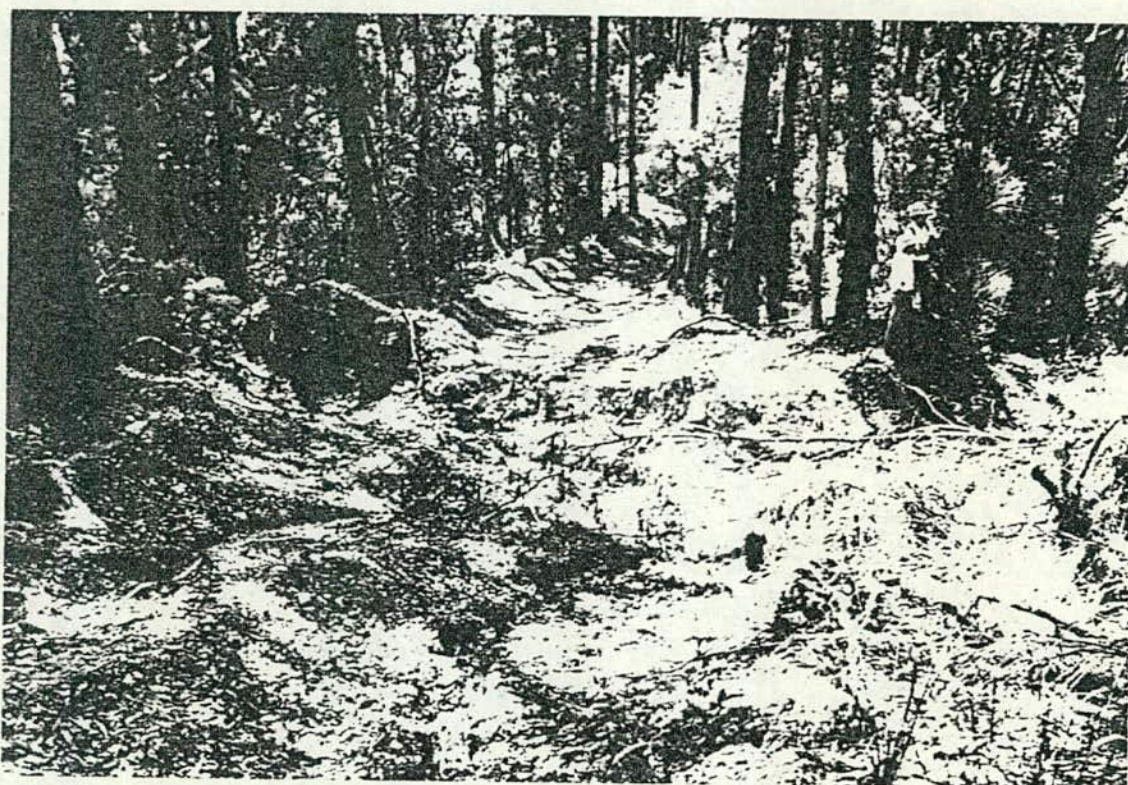
SIDECUT SNIGTRACK, UPSLOPE WITH HIGH WINDROW  
AND DEEP RILL.

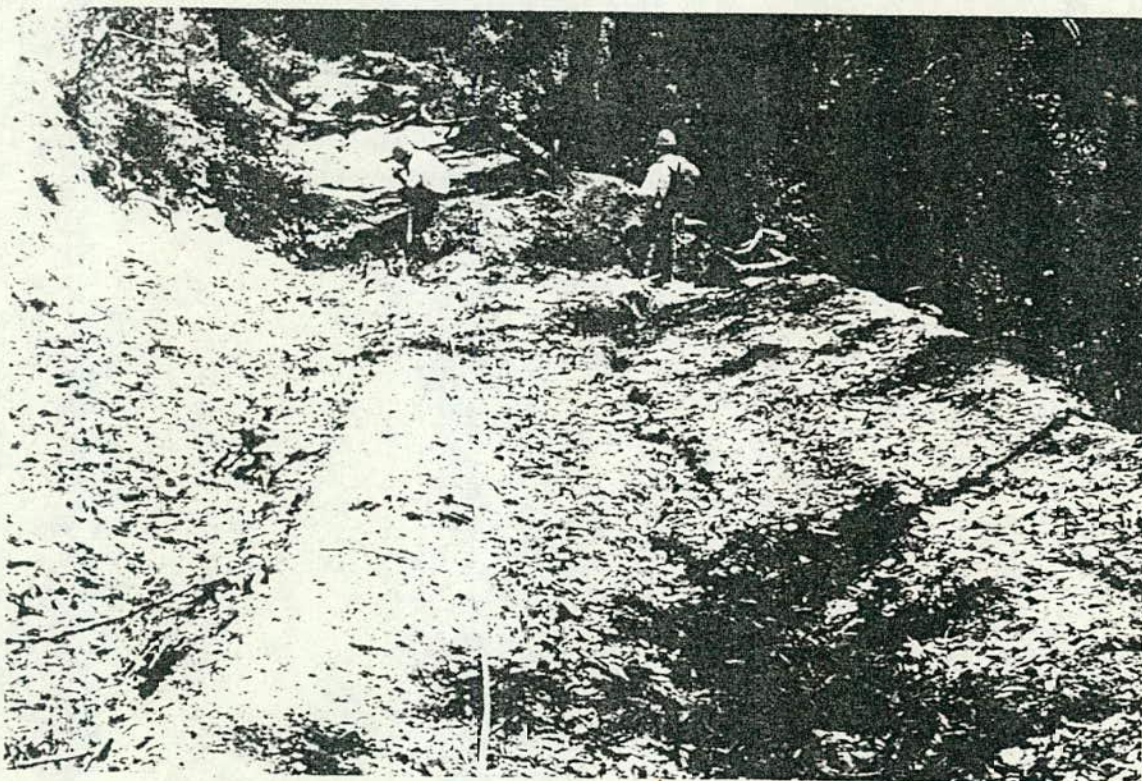
INEFFECTIVE BANK ON SIDECUT SNIG TRACK. RILLED DOWN  
TRACK AND THROUGH OUTLET.

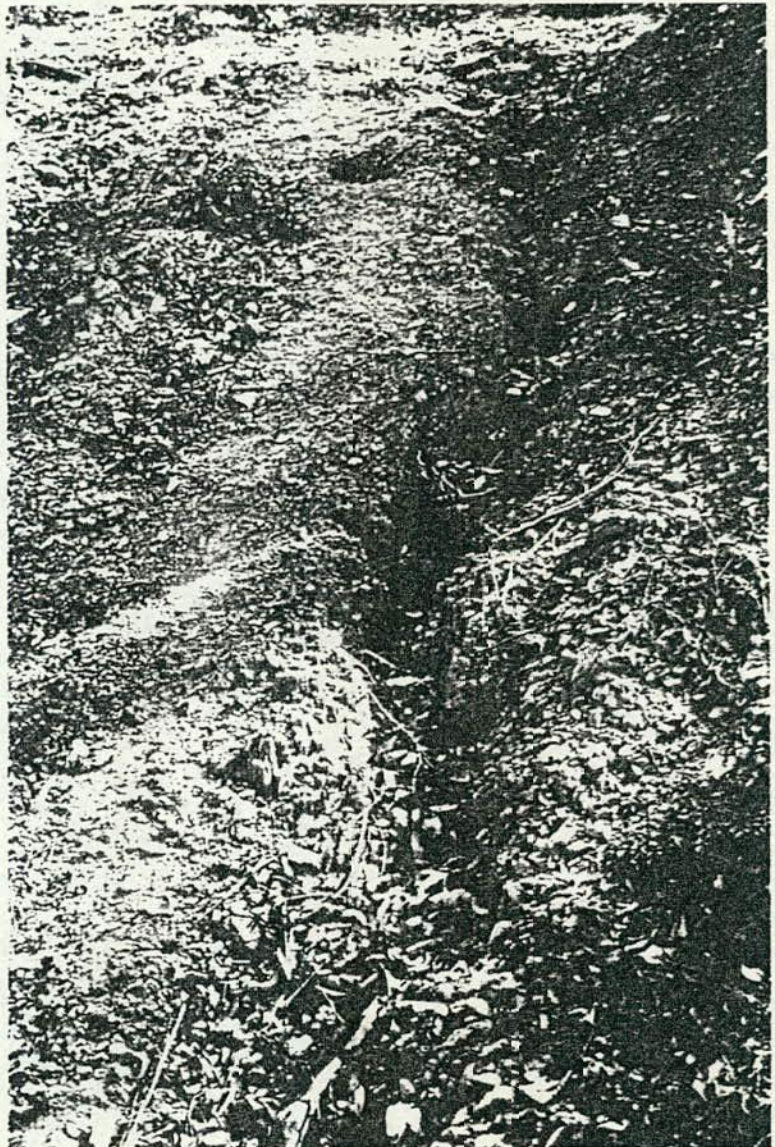
PEDESTALS AND RILLS OF SNIGTRACK  
SURFACE. SOME RE-VEGETATION  
COMMENCED.

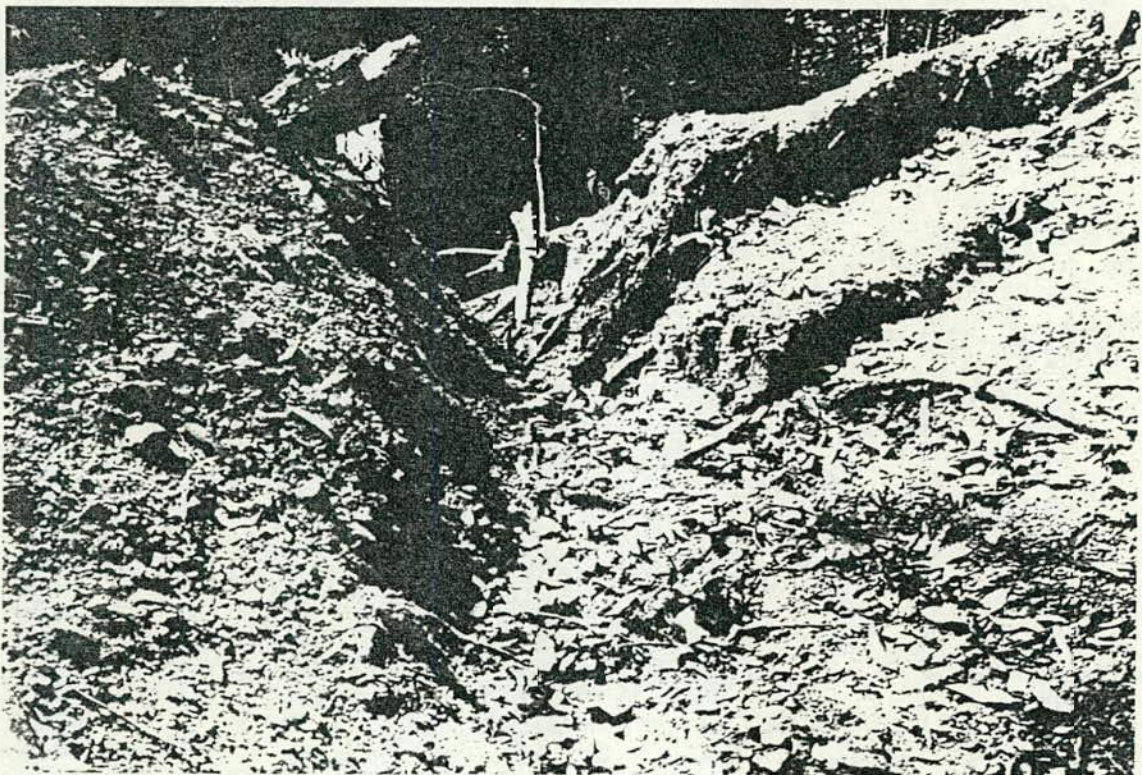
SIDECUT SNIG TRACK SU6 FROM DUMP 7  
INEFFECTIVE BANK.

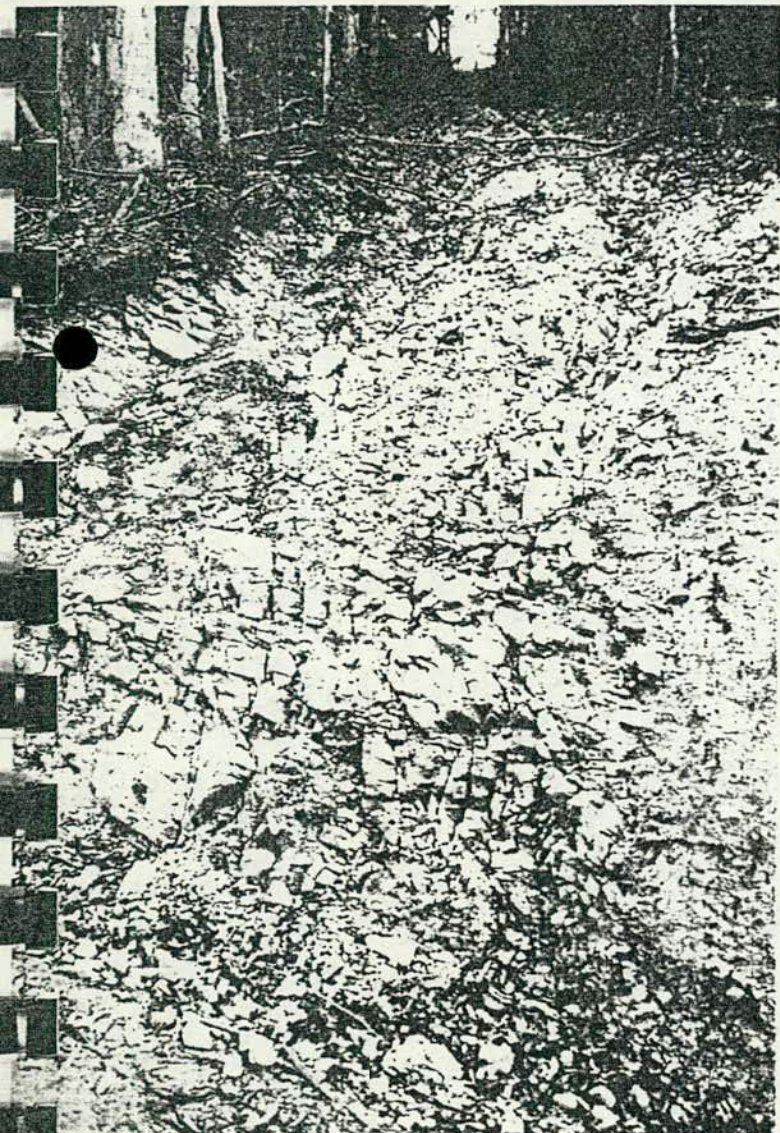
RIDGE SNIG TRACK,  
NOT BANKED AND RILLED.

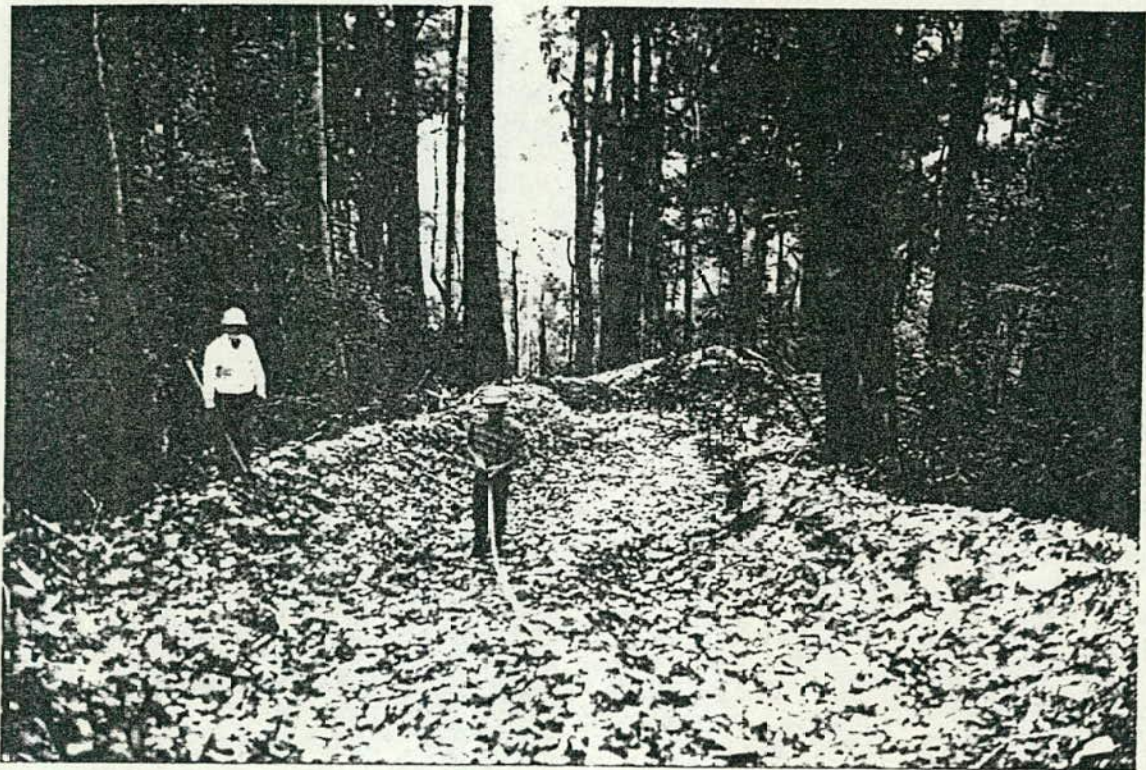
SNIG TRACK UPSLOPE FROM  
CATBIRD ROAD EXCAVATED  
TO ROCK, FINES GONE.

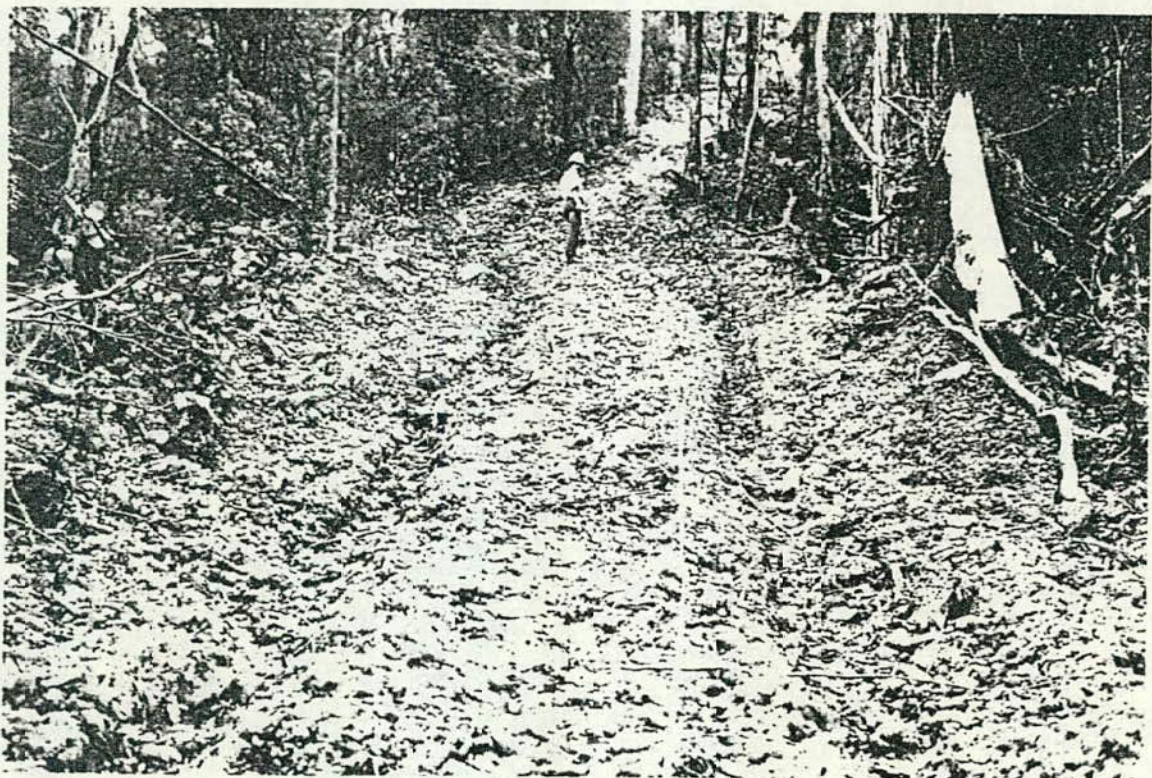
BOX CUT RIDGE TRACK SC5 HIGH WINDROWS AND RILLED.

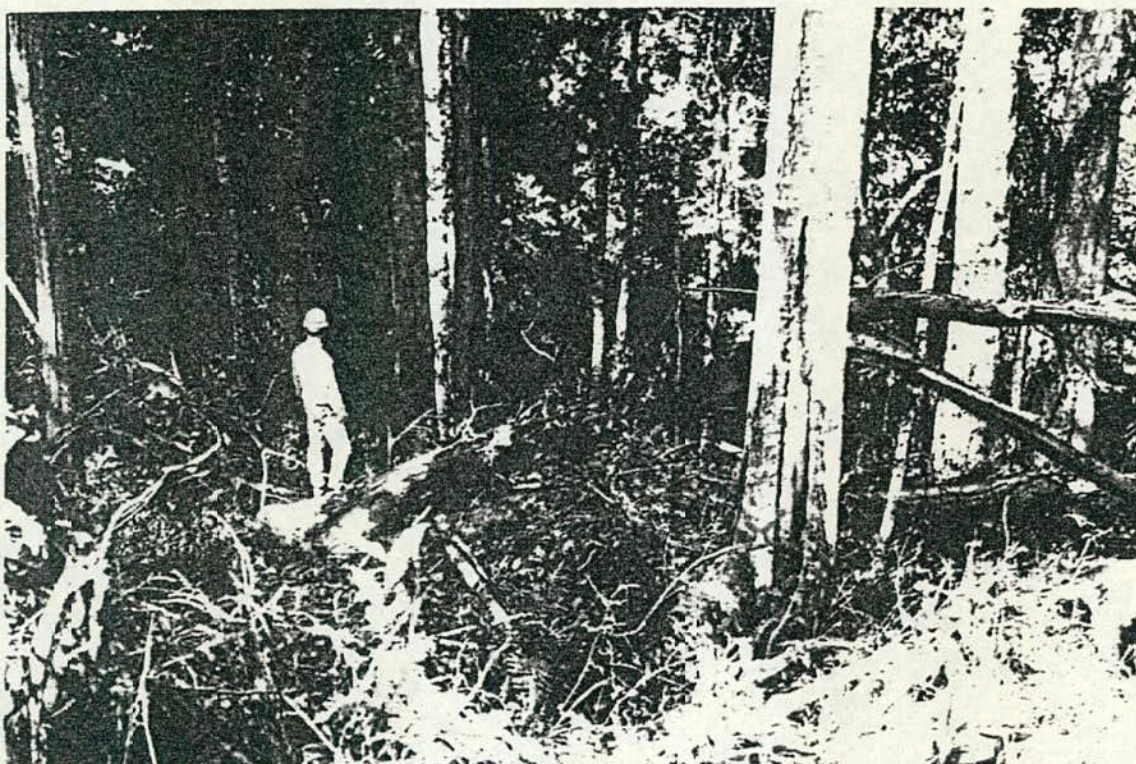
BOX CUT RIDGE TRACK SC5 HIGH WINDROWS RILLED DOWN  
DOZER TRACKS.

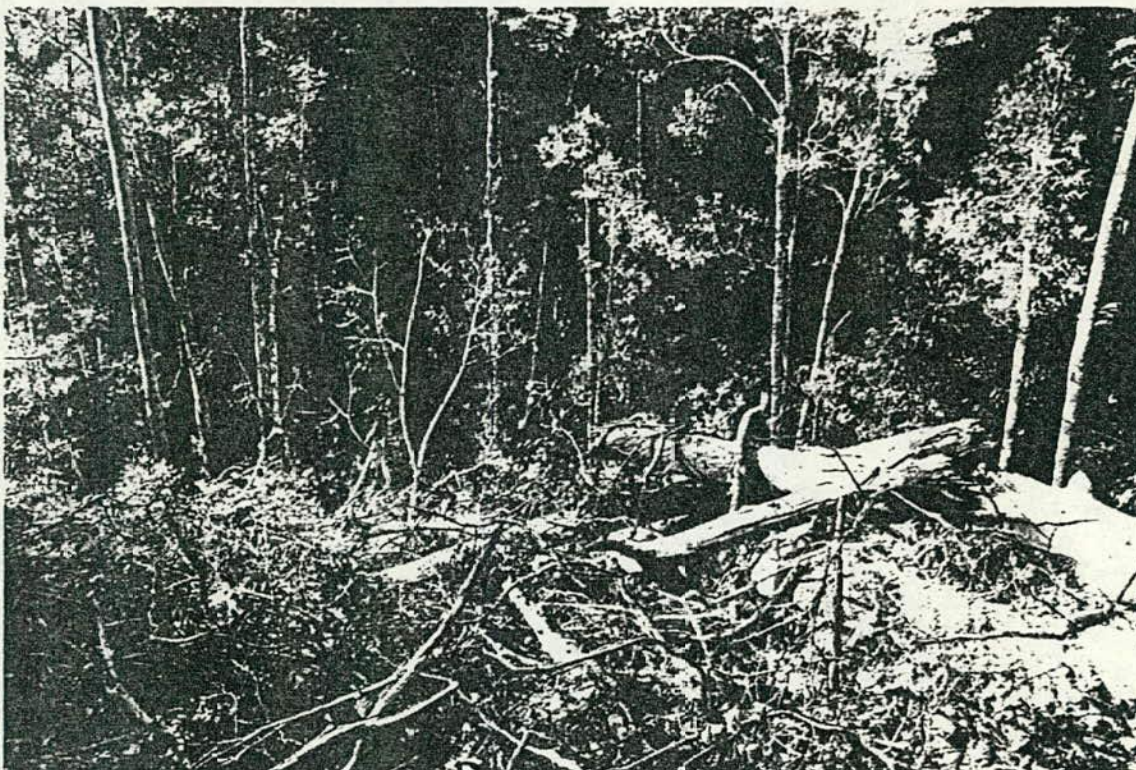
SNIG TRACK INTRUSION INTO FILTERSTRIP ON SUNDAY CREEK  
DAMAGE TO COACHWOOD STAND.

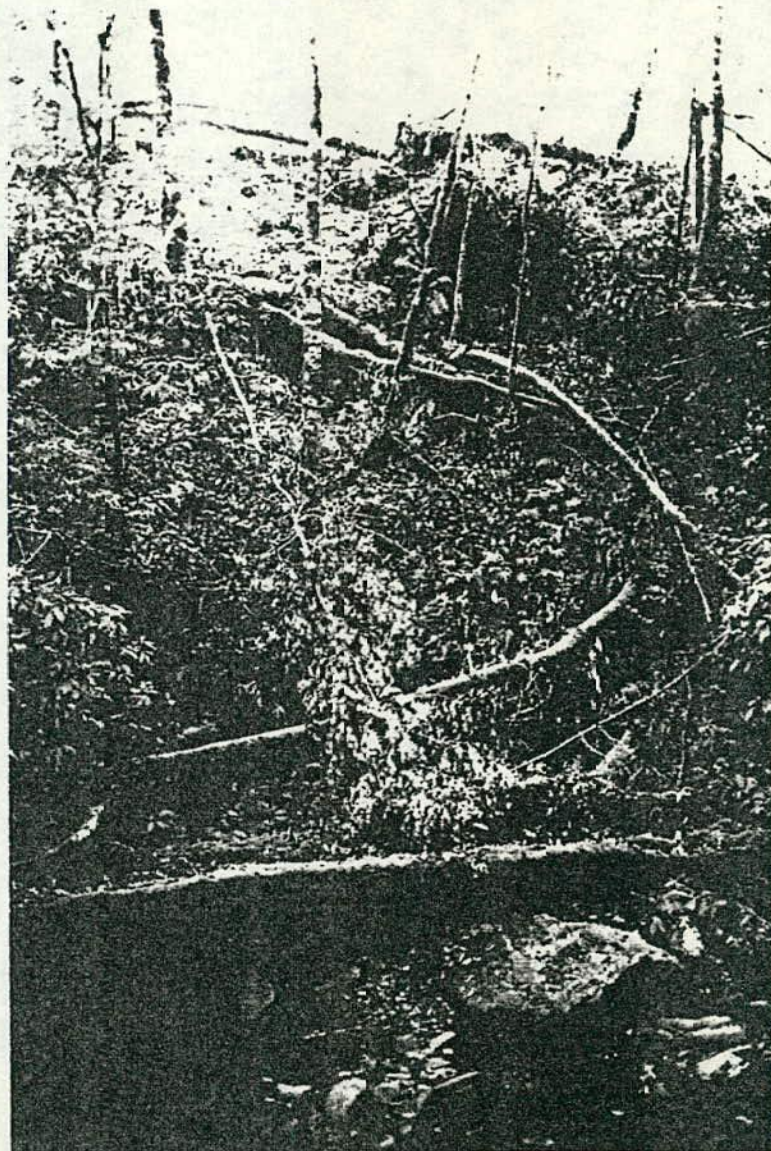
SNIG TRACK INTRUSION INTO  
PROTECTION STRIP IN SCRAGGY  
CREEK CATCHMENT.

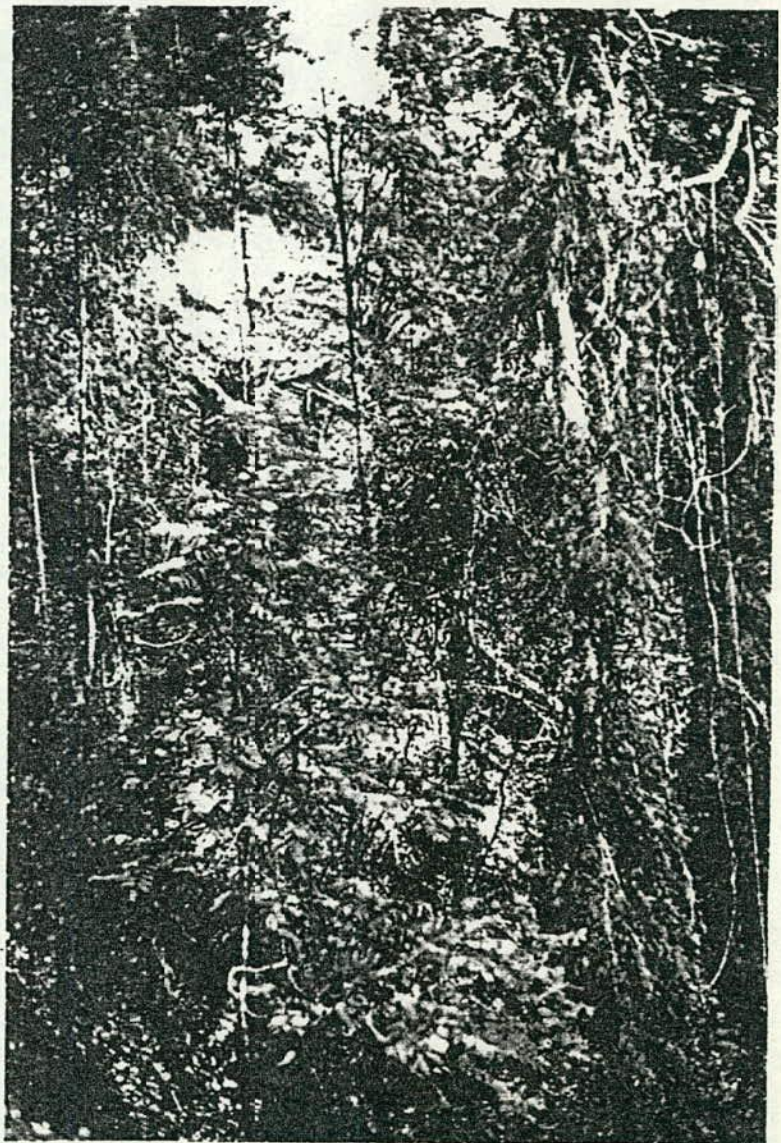
TALUS COVERED STEEP SLOPE  
UNDER CATBIRD ROAD ABOVE  
SNIGTRACK SC6.

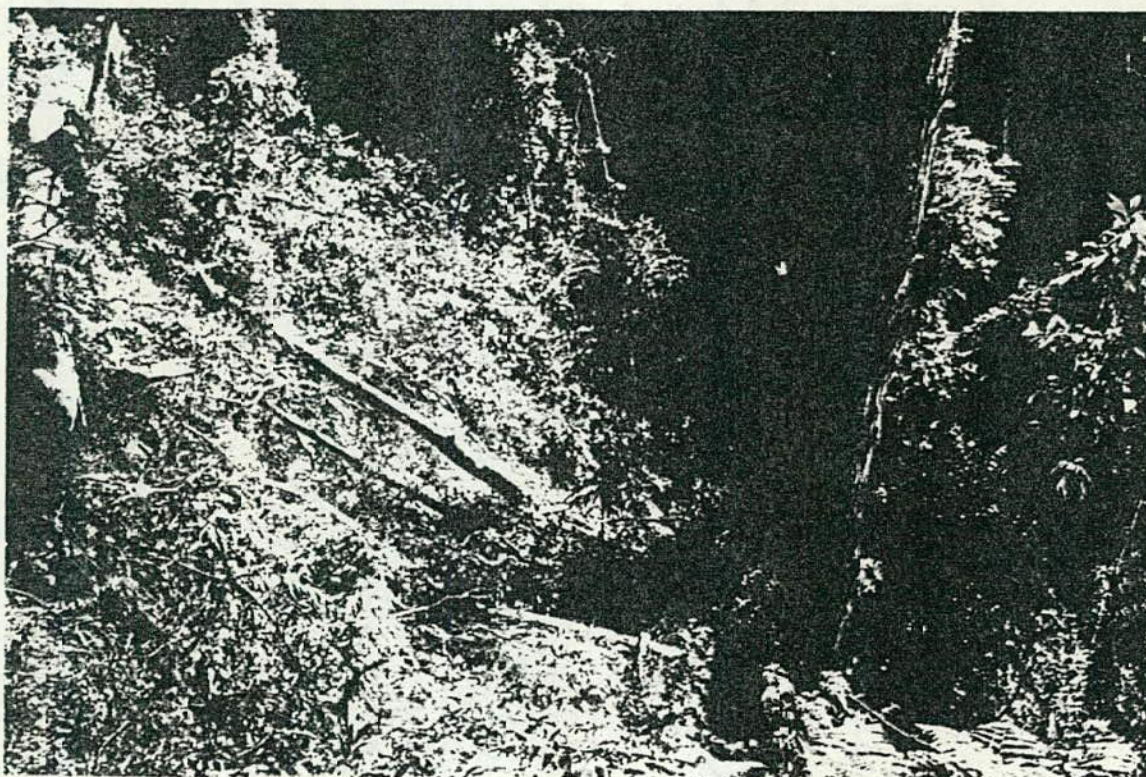
RIDGE SNIG TRACK WITH DEEP LOG SCOUR.

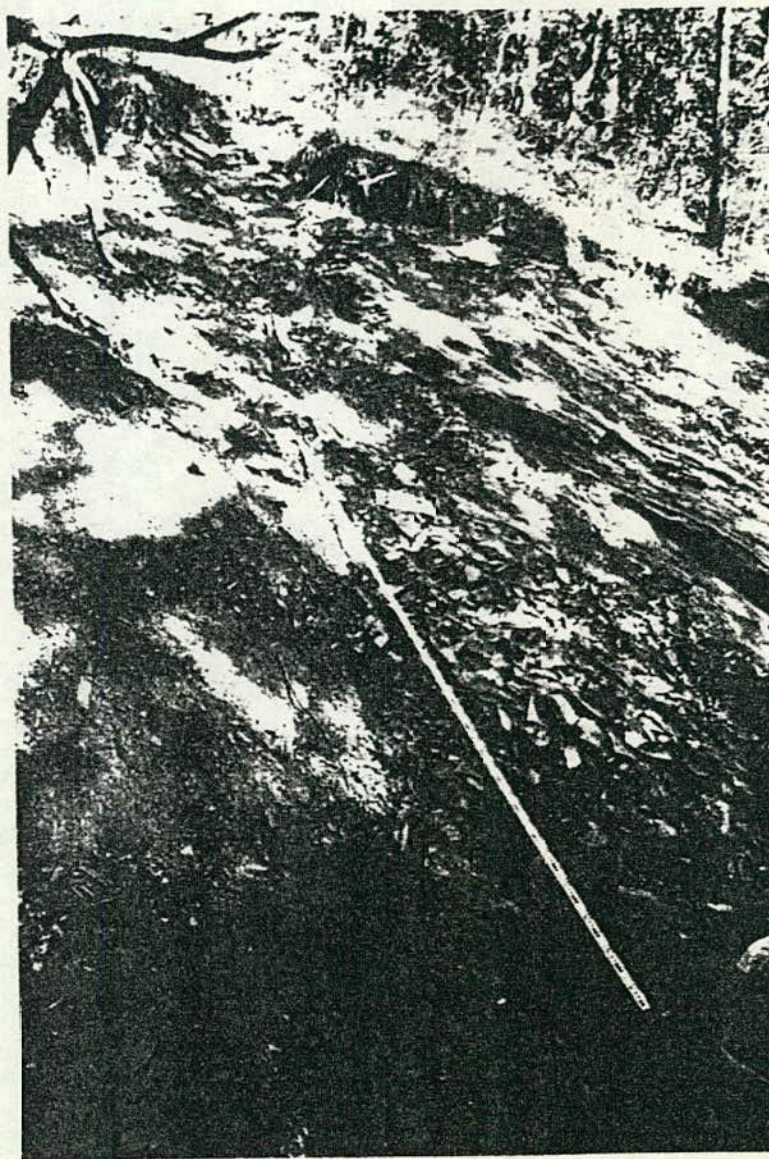
CATBIRD ROAD WITH SLIPS

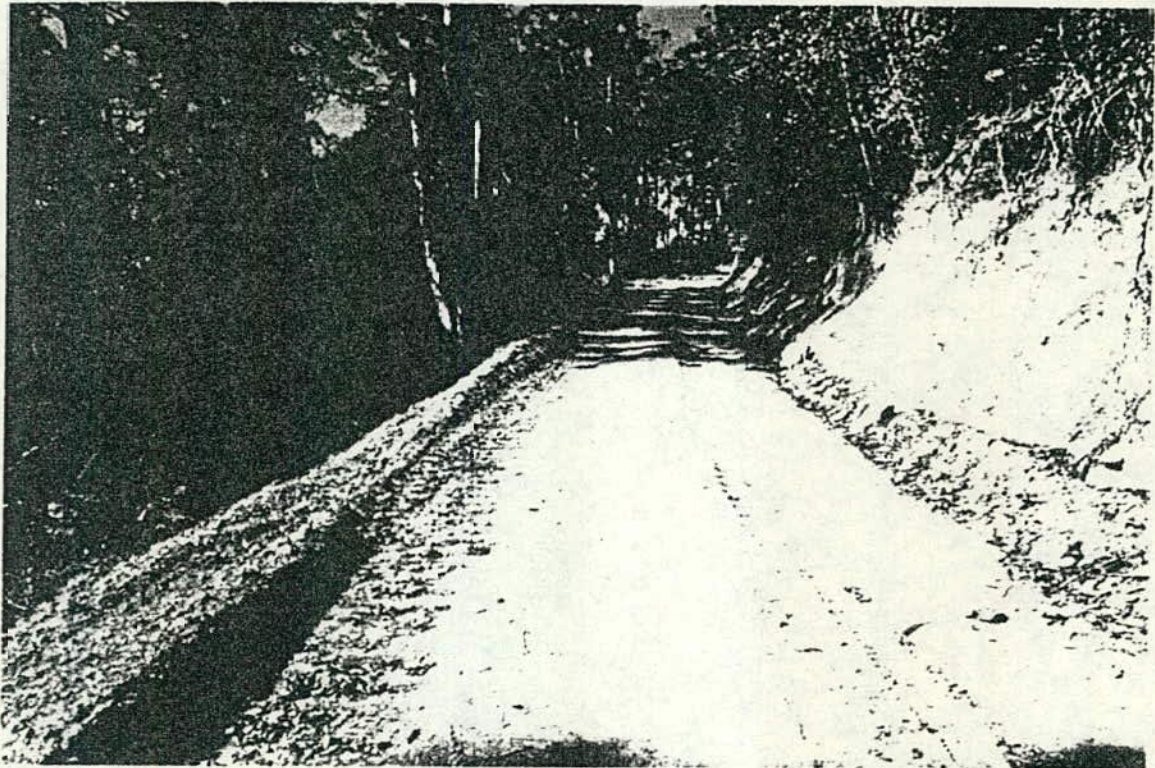
CATBIRD ROAD AT 0.25kms  
SLIP ON ROCK.

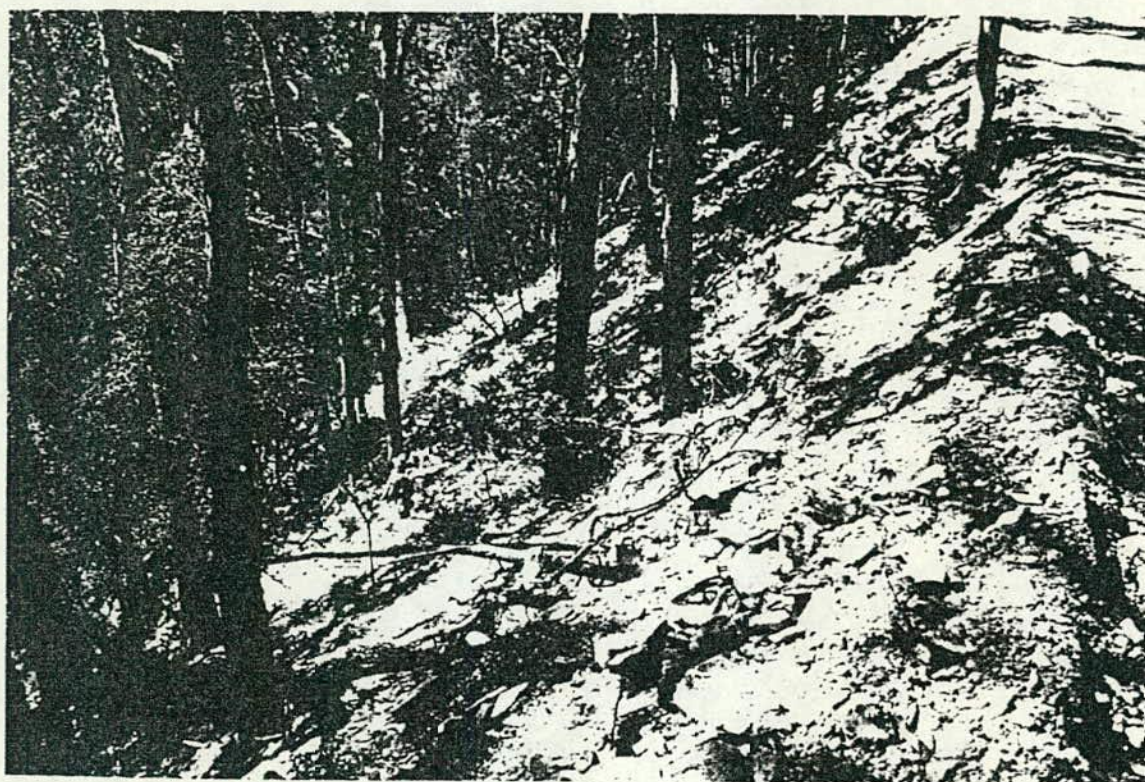
CATBIRD ROAD WITH SLIP

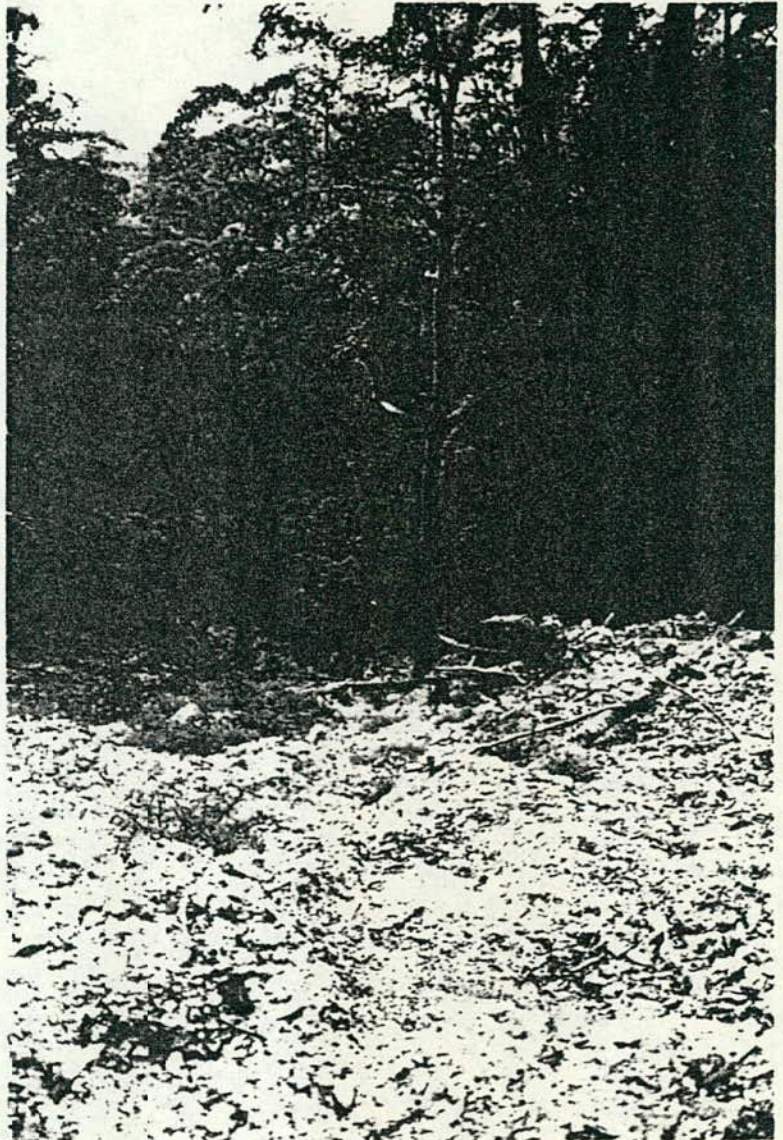
CATBIRD ROAD WITH TALUS  
AT 2.49kms

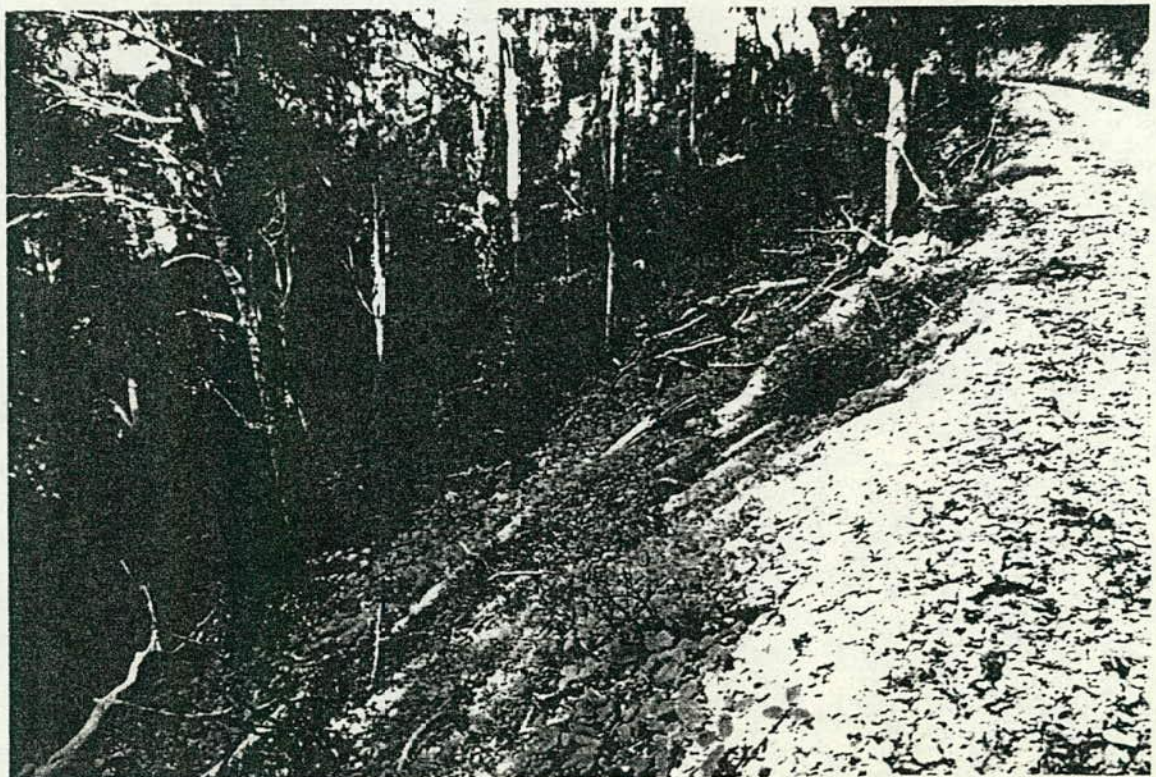
CATBIRD ROAD WITH TALUS  
AT 4.17kms.

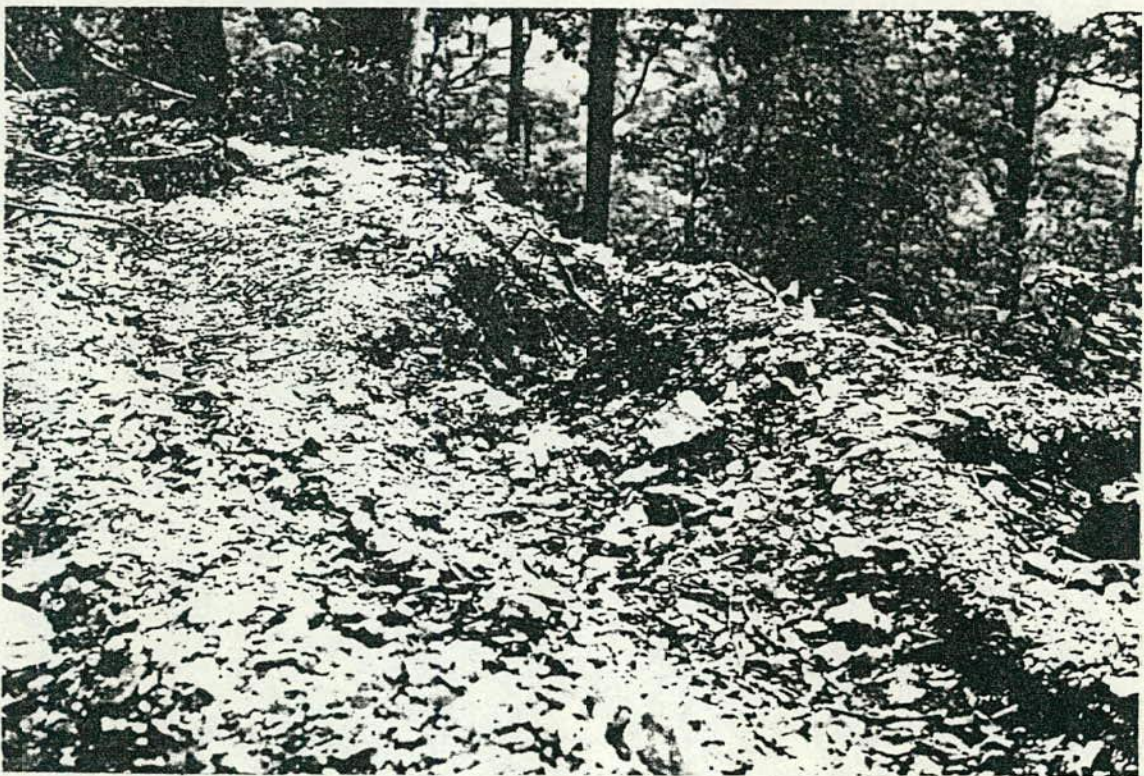
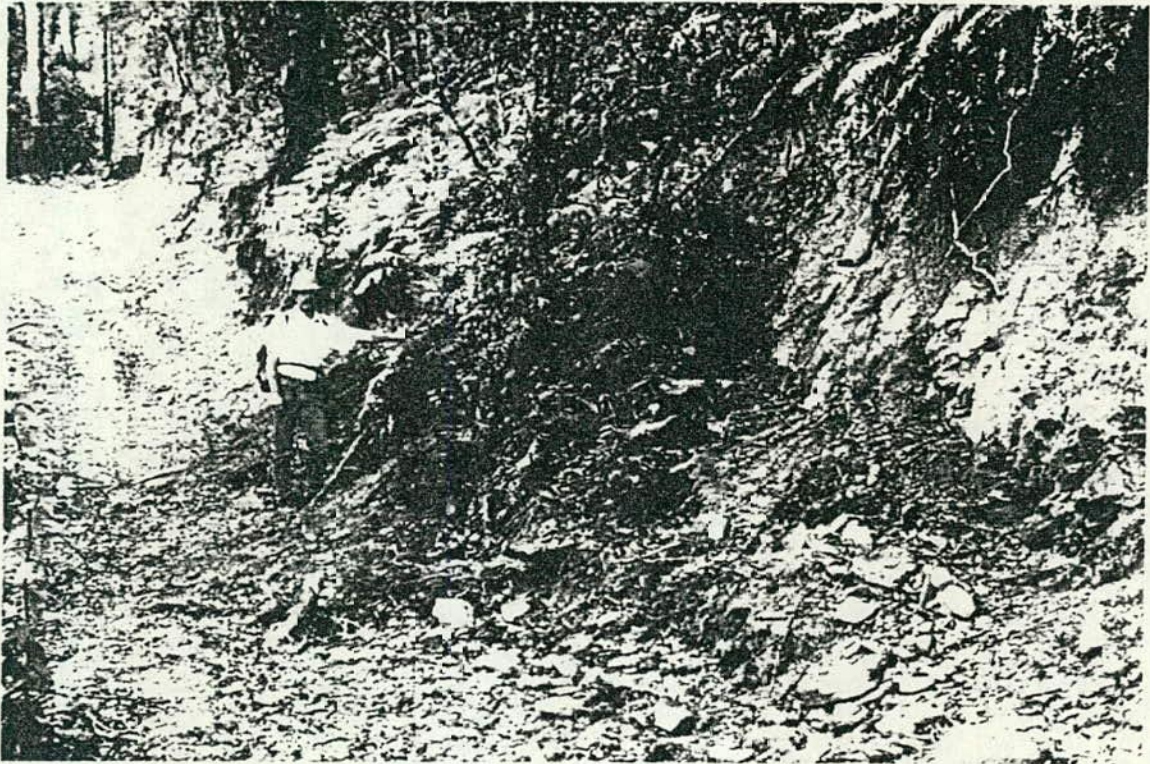
SLUMPS OF SNIG TRACK PAVEMENT.

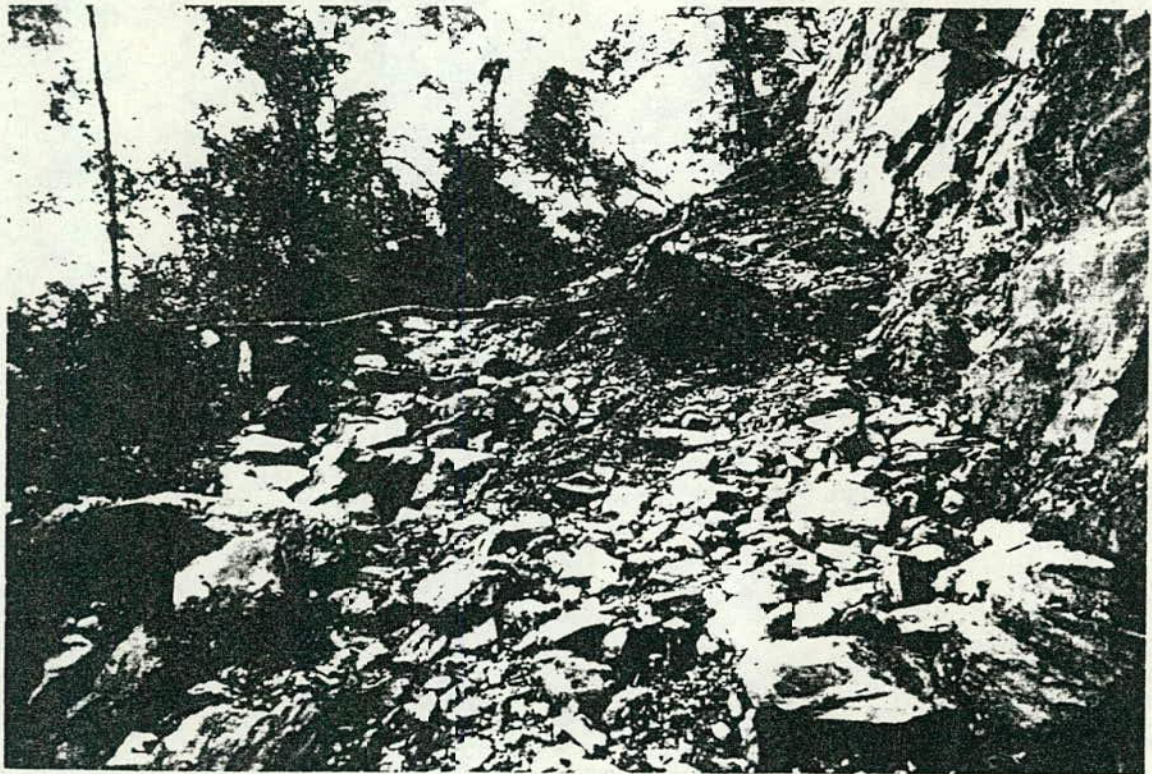
CUT BATTER FAILURE ON SNIG TRACK SC1

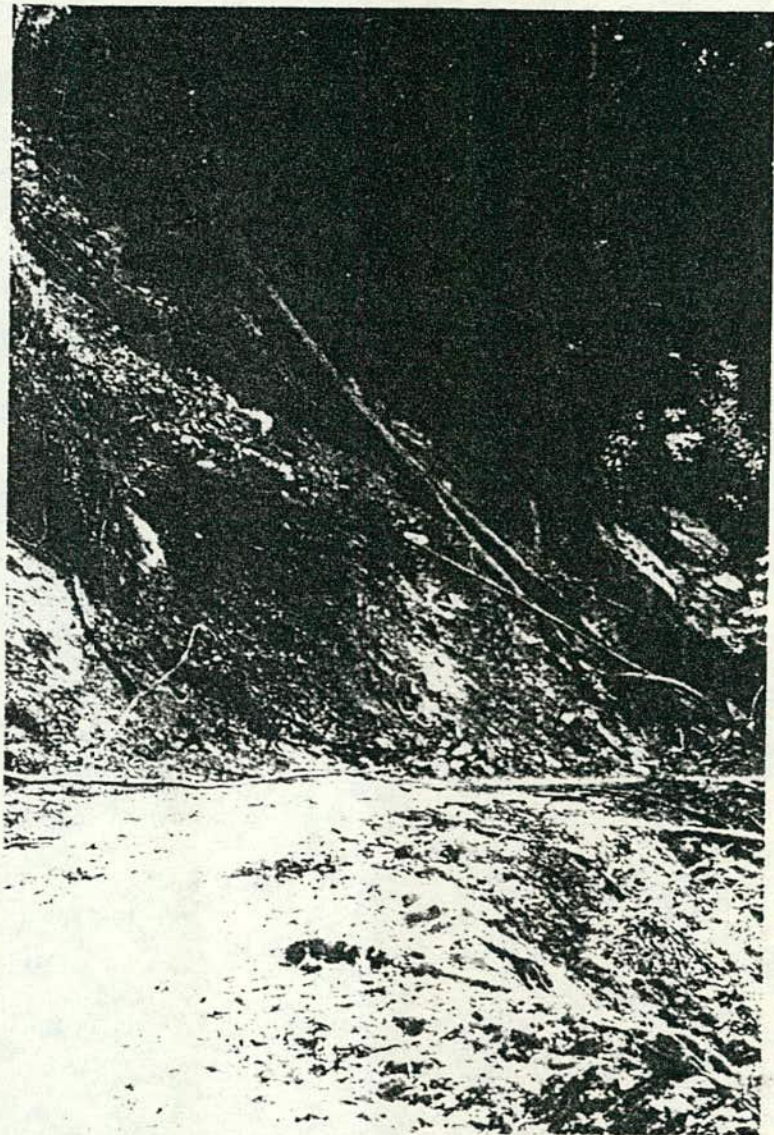
CUT BATTER FAILURE  
ON CATBIRD ROAD

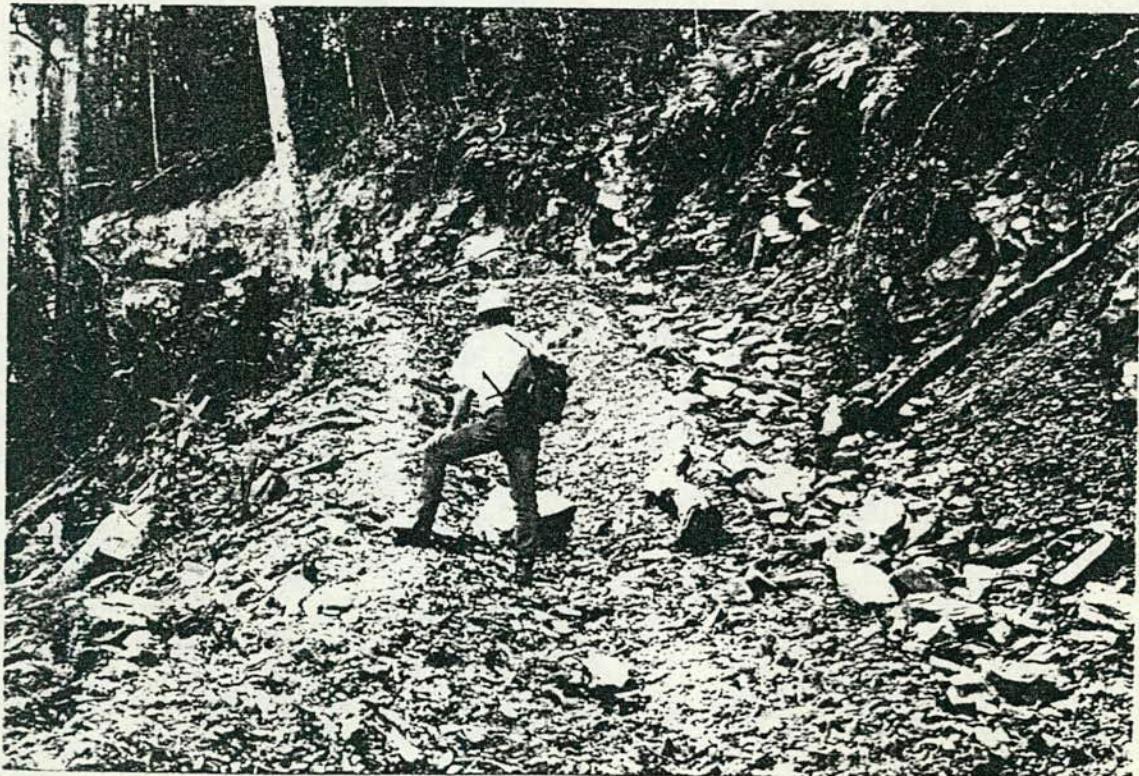
SIDECUT SNIG TRACK  
WITH HIGH WINDROW  
ON SC1
