- i) to report on the recent logging activities in compartments 168 - 170 of Oakes State Forest within the context of the July, 1990 Standard Erosion Mitigation Conditions for Logging (SEMC's);
- ii) to compile recommendations necessary to rehabilitate any soil conservation problems identified in i) above; and
- iii) to prepare recommendations for the Forestry Commission to consider when it proposes to carry out logging in areas of a similar nature to Oakes State Forest.

OAKES STATE FOREST

Compartments 168 - 170.

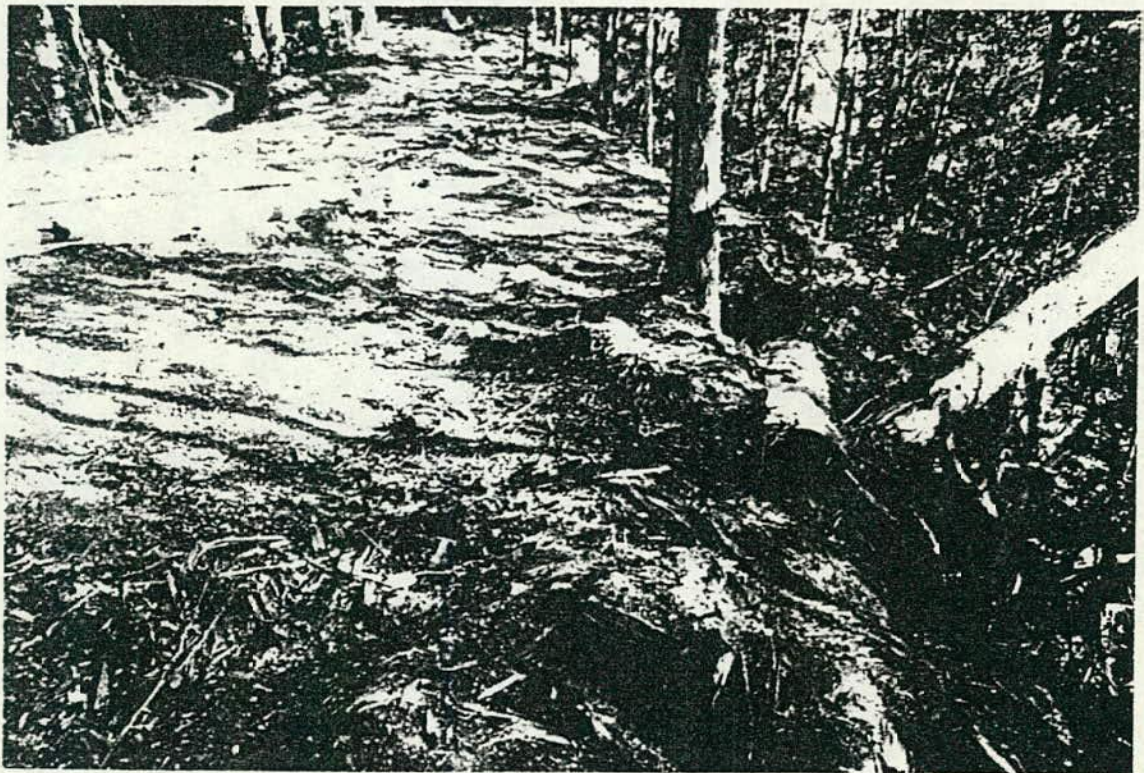
DEBRIS DOZED INTO PROTECTION STRIP ON SC7a
