NEVASAE ROAD, Upper Wilsons Creek.

AN ENGINEERING ASSESSMENT

NEVASAE ROAD - ENGINEERING ASSESSMENT

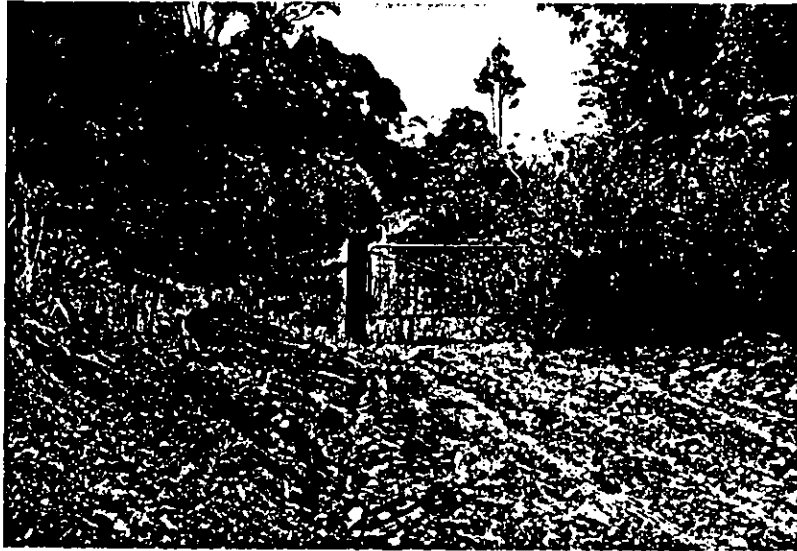
PHOTOGRAPH 1 (left)

- c) Active soil erosion was noted in the table drain of the road in the first 50 m from the locked gate. The erosion gully measured 1.5 X 0.7 m in width and depth - seepage water was flowing. This is at the point where the run-off from a major side catchment would cross the road as shown on the topographic map. No provision for the control of this water was

At 00 m, gate on boundary of reserved road and PORTION 55
Note table drain erosion on high side of Nevasae Road.

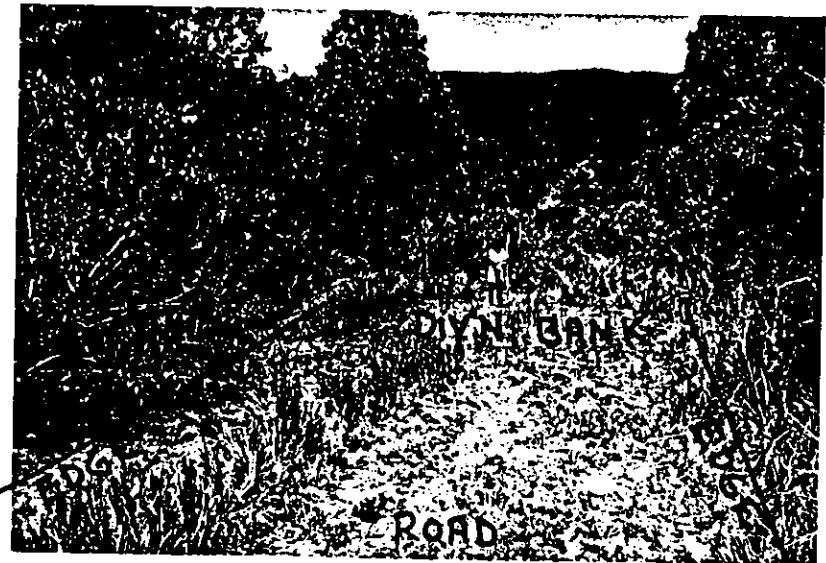
PHOTOGRAPH 2 (right)

At about 500 m, shows typical diversion bank constructed to reduce damage by concentrated rainfall run off. Person with 2 m ranging poles gives idea of size. In background is Koonyum Range (eastern part).

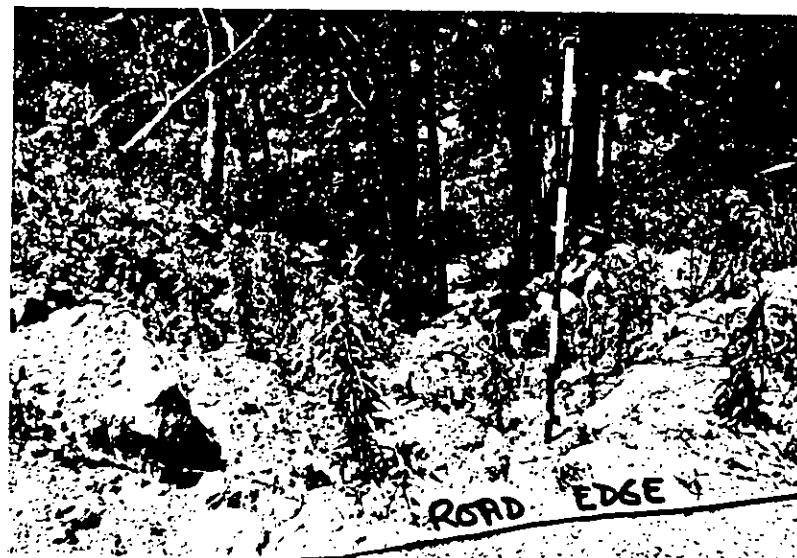
At 900 m mountainside of slope 40 - 45° rendered unstable by construction of road.

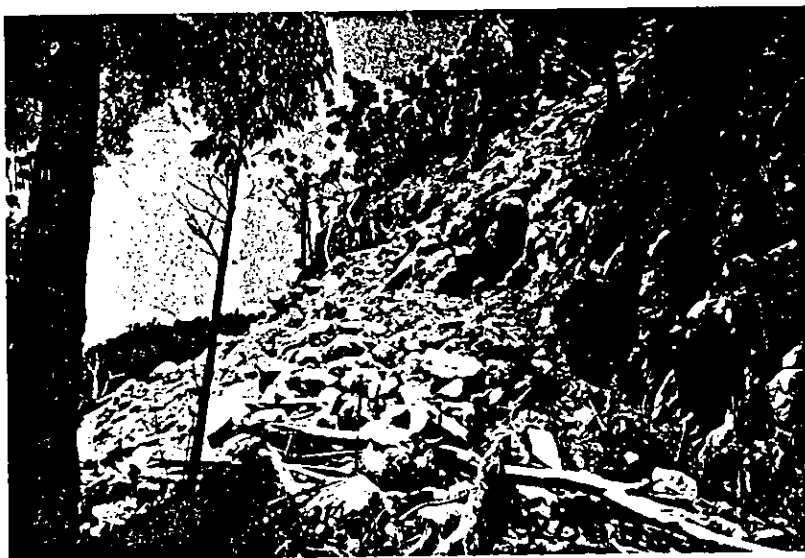
PHOTOGRAPHS 16 (above) and 17 (right)

Unstable ground above Nevasae Road.

Both photographs show cut rock faces rising above the road between 900 and 1200 m. Note cracked rock face, loose rocks, poised soil and trees typical of this section.

- d) Adjoining the rockfall and above the cut rock faces there is unstable ground. These areas should be investigated and all doubtful ground removed.
- e) There will be continuing degradation of the properties.
