- i) to report on the recent logging activities in compartments 168 - 170 of Oakes State Forest within the context of the July, 1990 Standard Erosion Mitigation Conditions for Logging (SEMC's);
- ii) to compile recommendations necessary to rehabilitate any soil conservation problems identified in i) above; and
- iii) to prepare recommendations for the Forestry Commission to consider when it proposes to carry out logging in areas of a similar nature to Oakes State Forest.

OAKES STATE FOREST

Compartments 168 - 170.

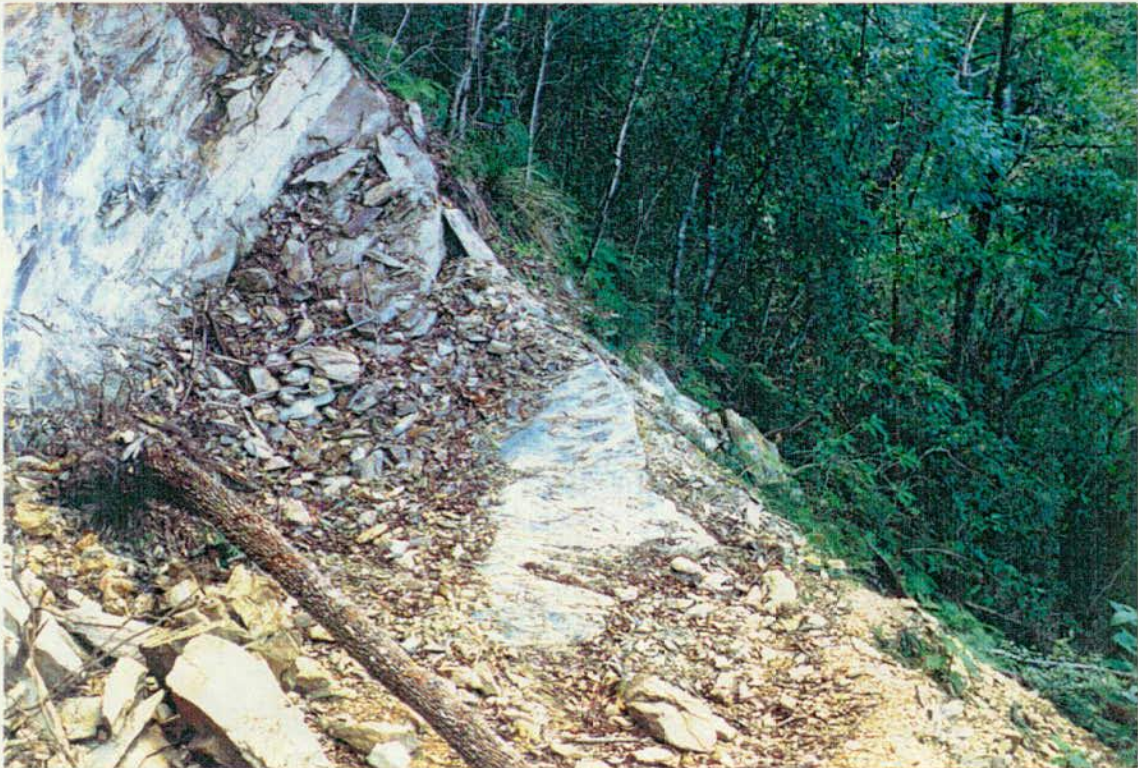
SNIG TRACK SU5 FROM DUMP 5  
STEEP SIDESLOPE, TRACK IMPEDED BY ROCK

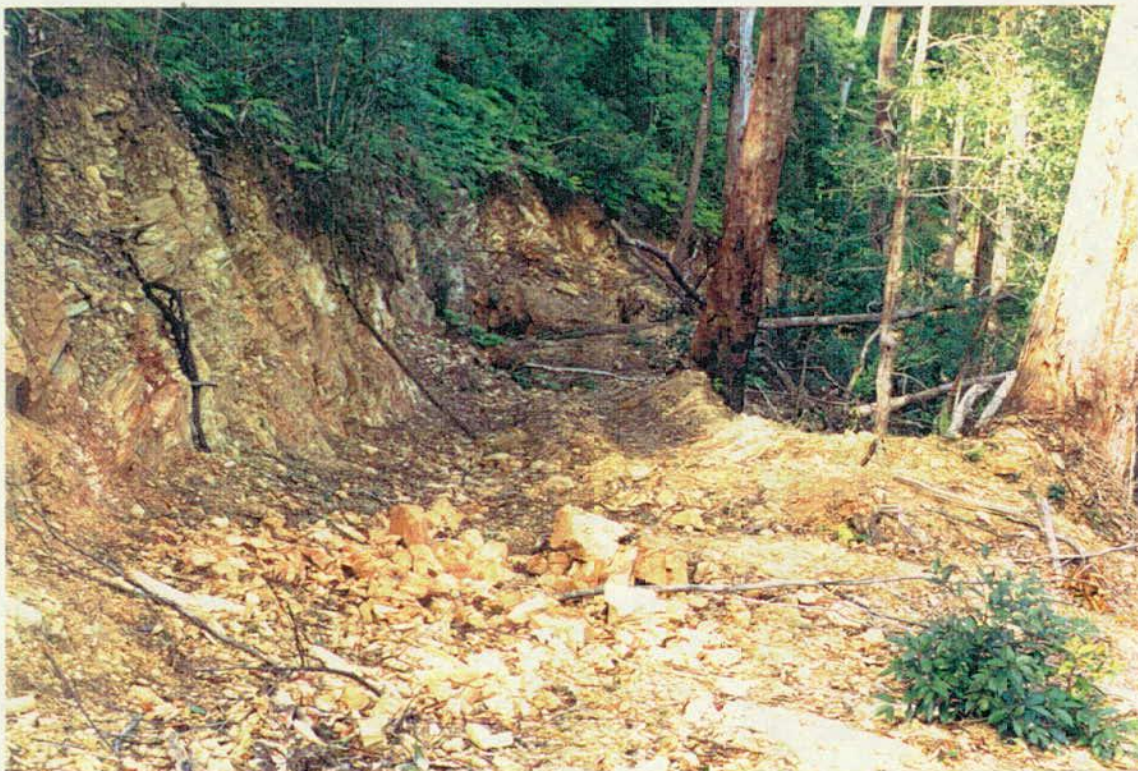
SNIG TRACK SU6  
HIGH CUT BATTER AND HIGH WINDRCW

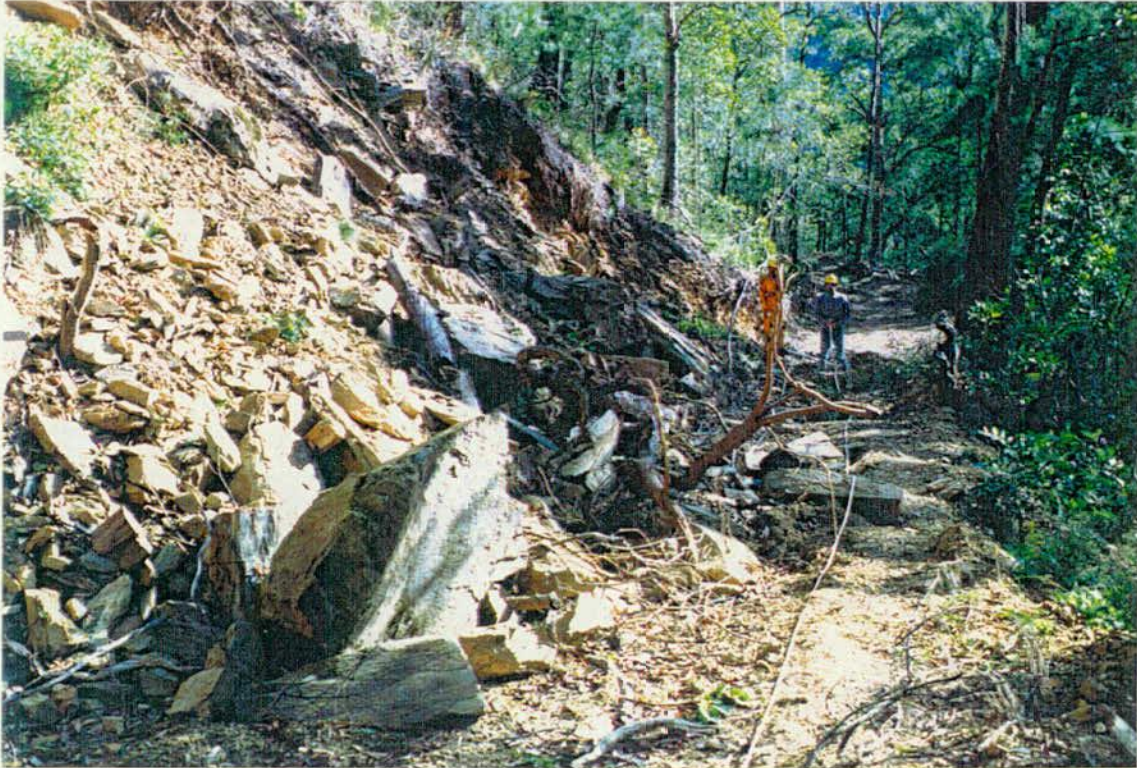
LARGE CUT BATTER AND SLIP ON SNIG TRACK SU6 FROM DUMP 7  
DOWNSLOPE.

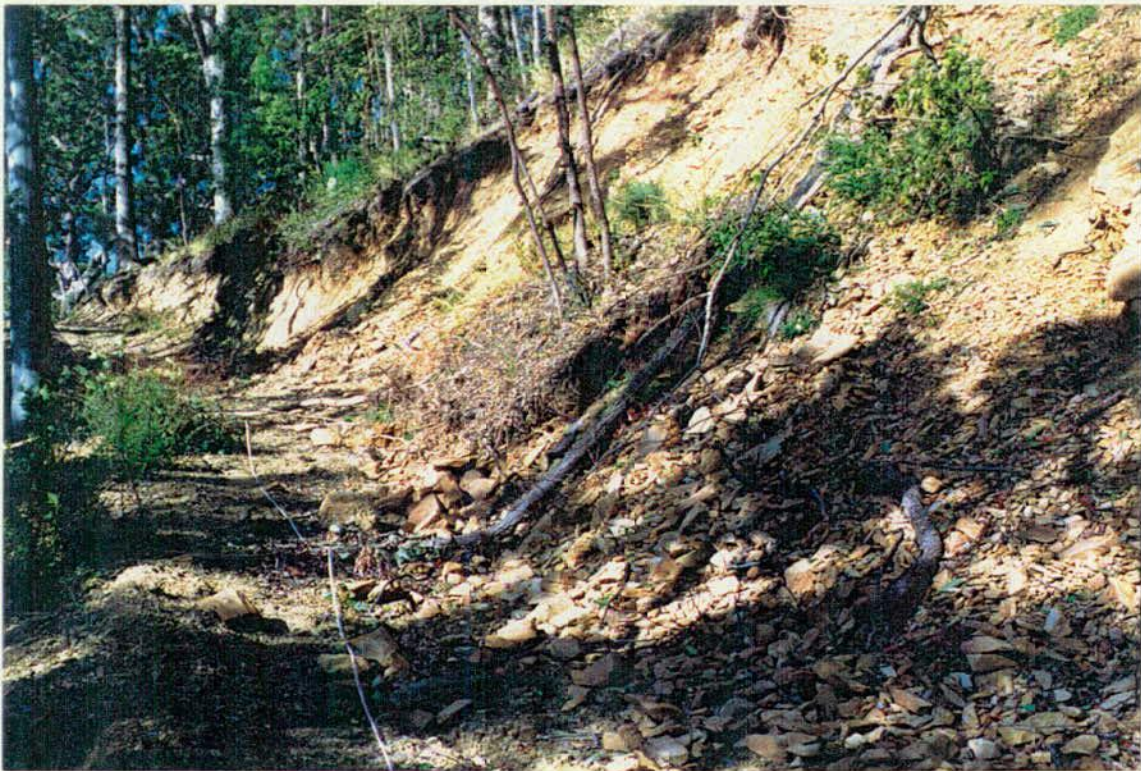
LARGE CUT BATTER AND SLIP ON SNIG TRACK SU6 FROM DUMP 7  
UPSLOPE.

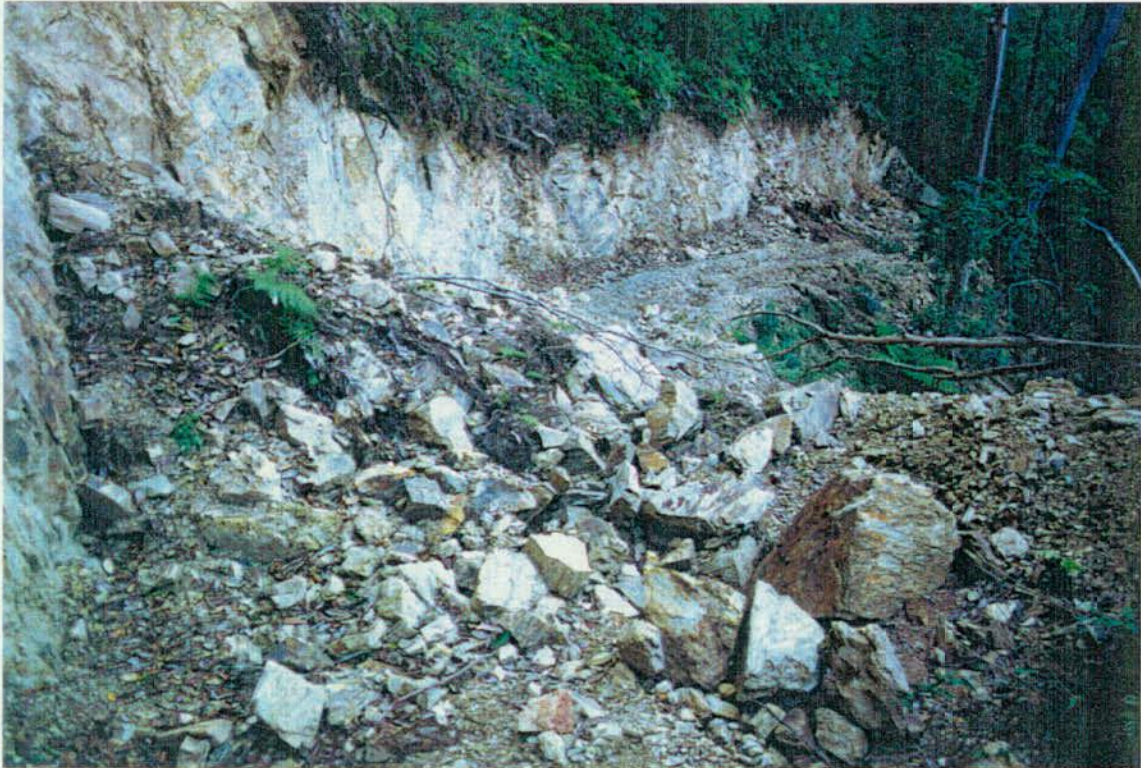
SLIP OF ROCK ON SNIG TRACK SU5 FROM DUMP 5  
DOWNSLOPE.

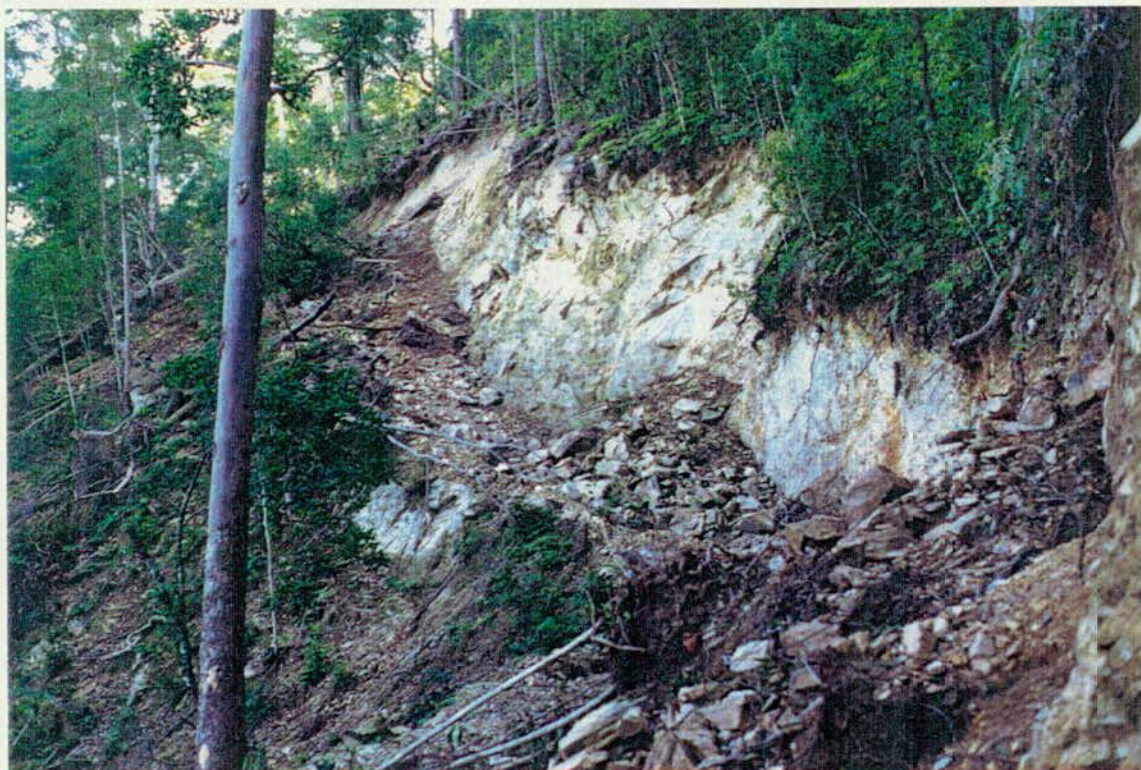
SLIP OF ROCK ON SNIG TRACK SU5 FROM DUMP 5  
UPSLOPE.

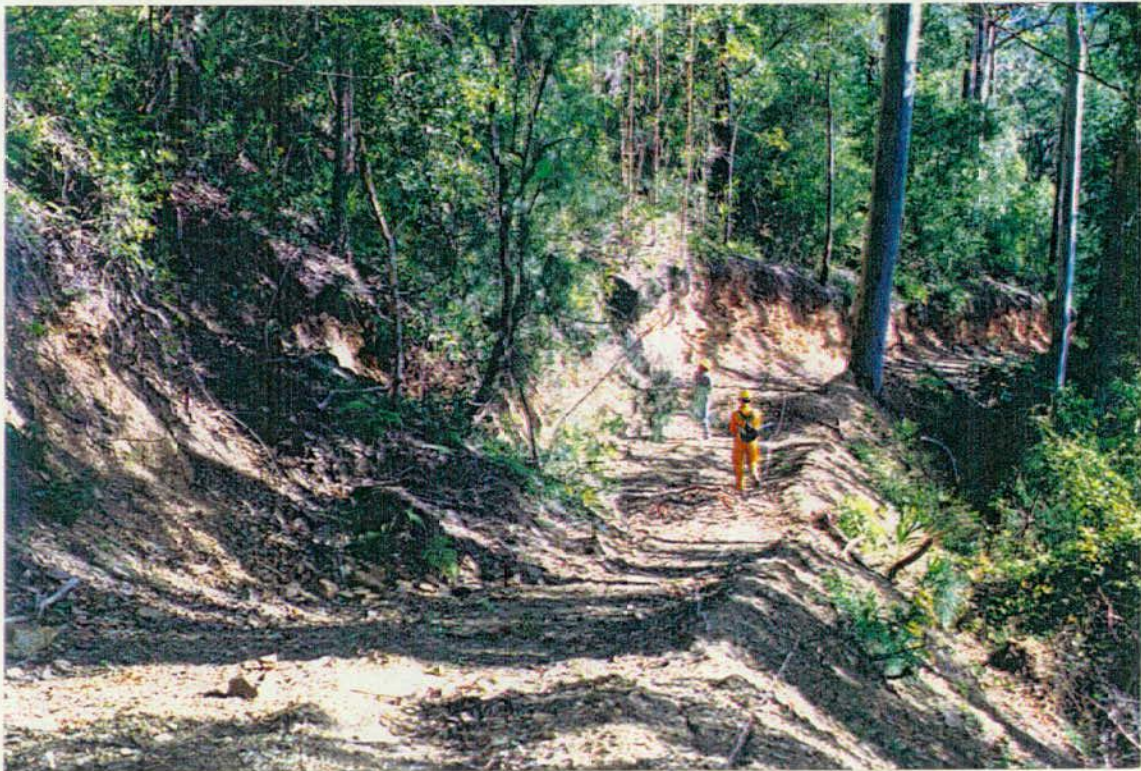
SLIP ON SNIG TRACK SU6 FROM DUMP 7  
DOWNSLOPE. NOTE WINDROW

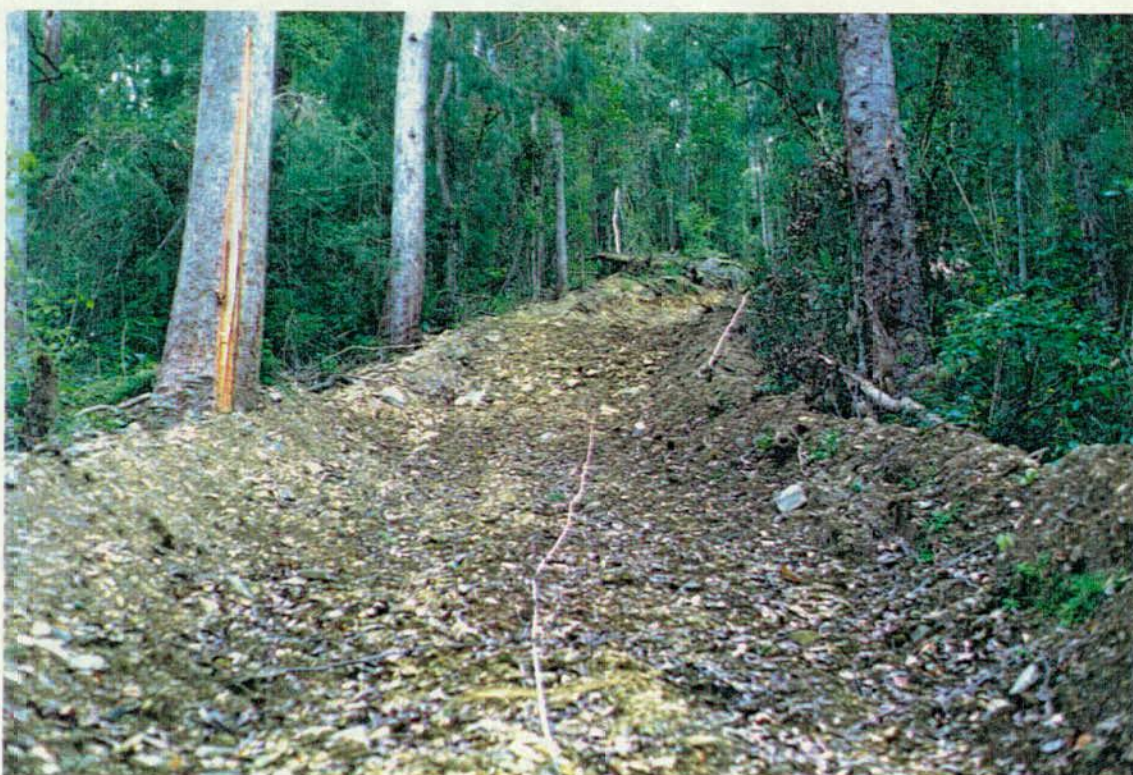
BOX CUT RIDGE LINE SNIG TRACK  
HIGH WINDROWS

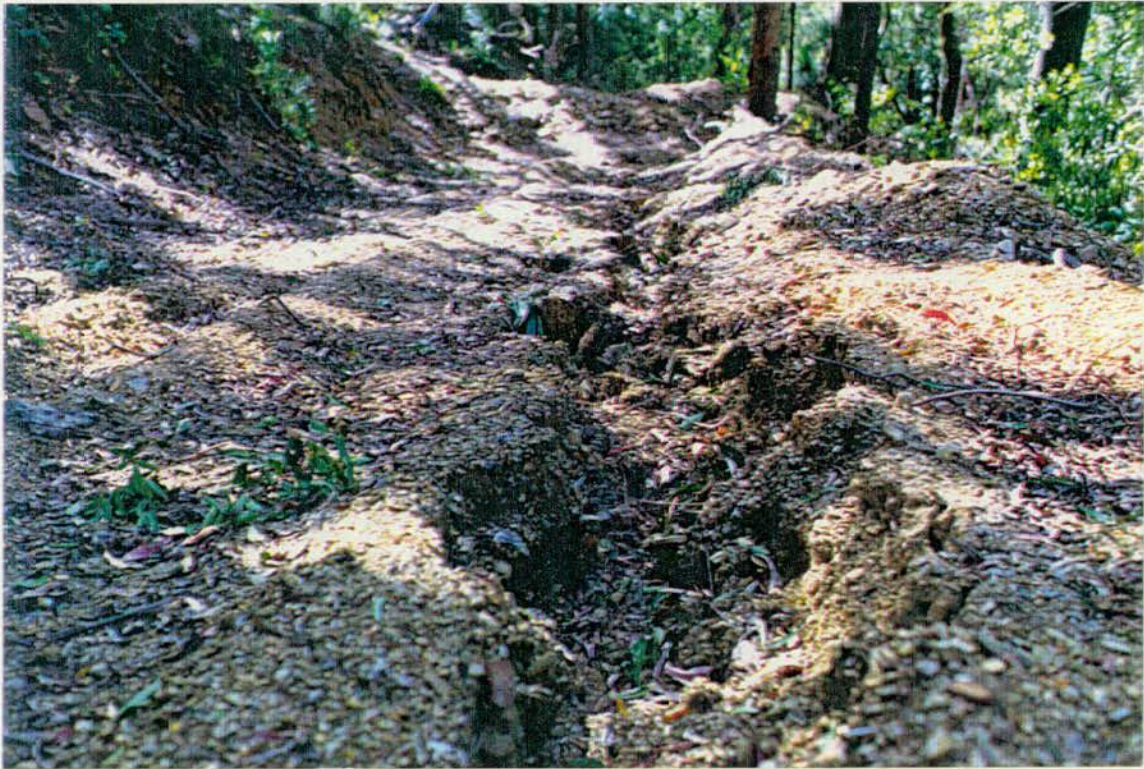
SIDECUT SNIGTRACK, UPSLOPE WITH HIGH WINDROW  
AND DEEP RILL

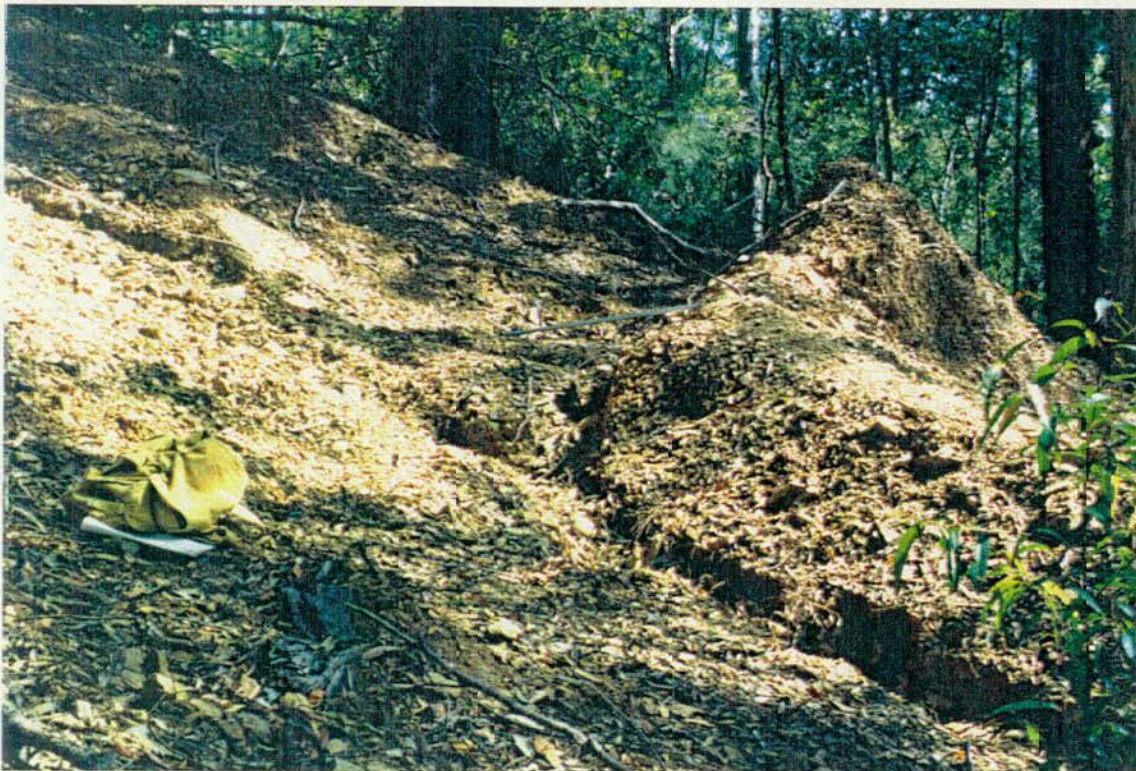
INEFFECTIVE BANK ON SIDECUT SNIG TRACK. RILLED DOWN TRACK AND THROUGH OUTLET.

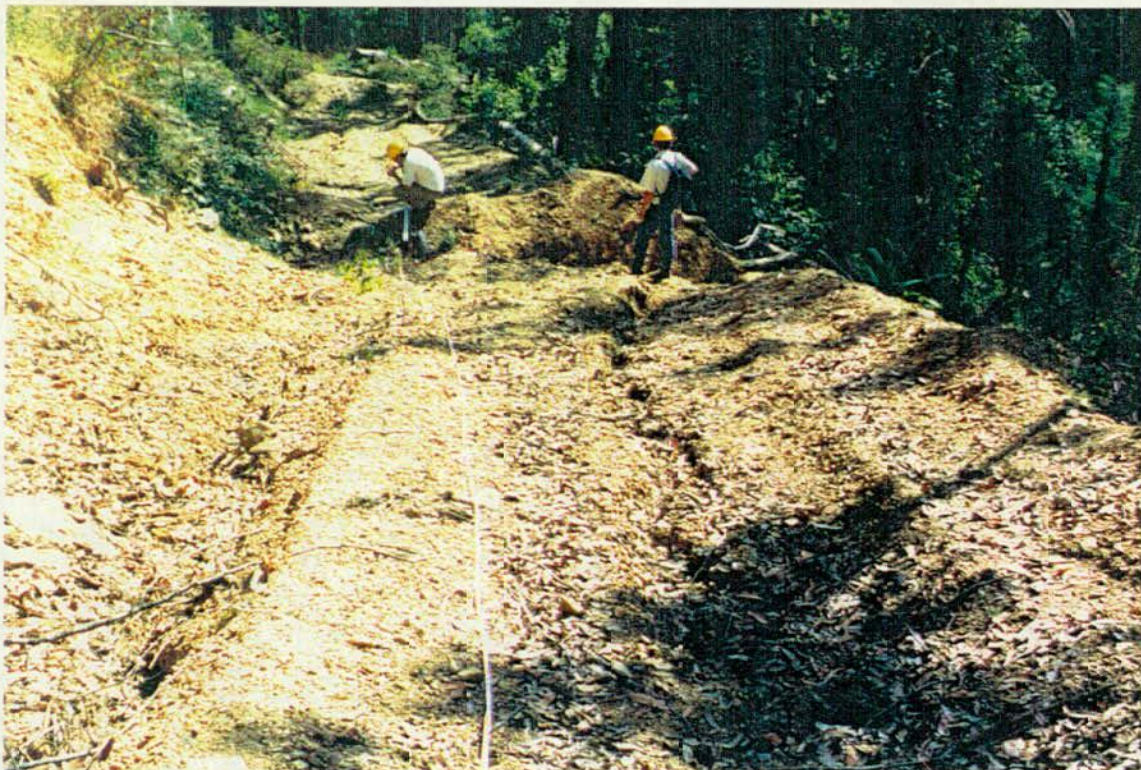
SIDECUT SNIG TRACK RILLED AS ABOVE. HIGH WINDROW

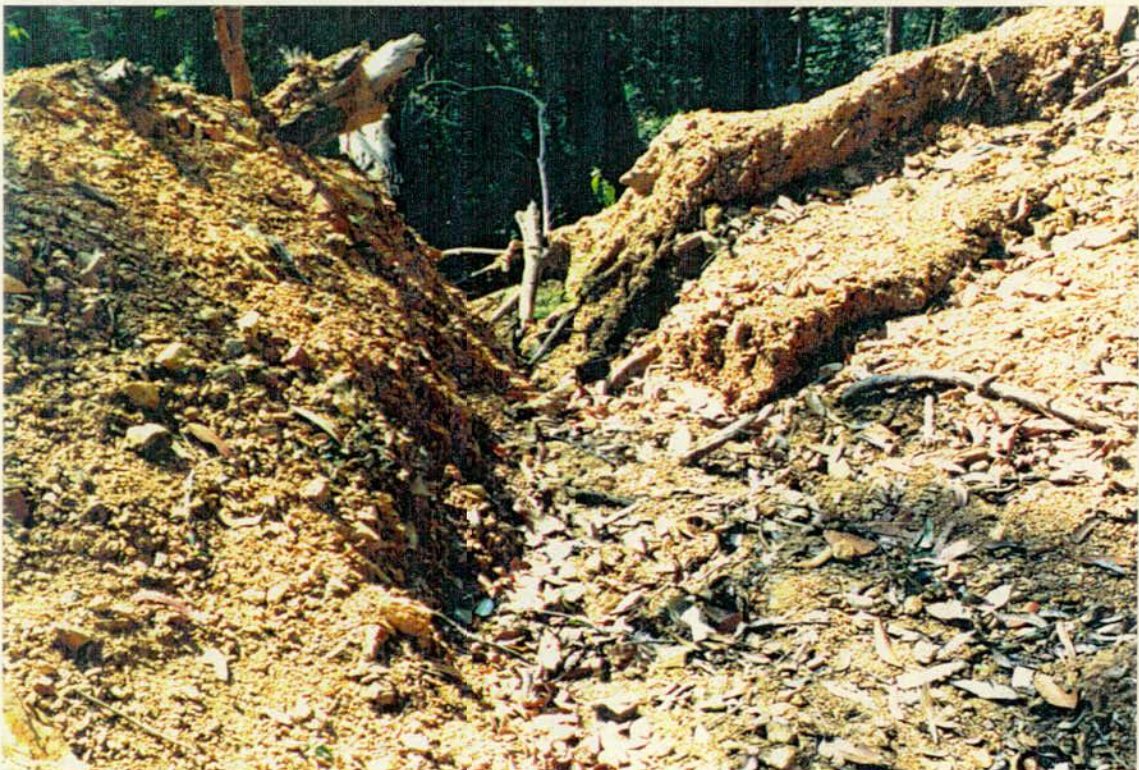
ERODED OUTLET ON CROSS BANK.

RIDGE SNIG TRACK,  
NOT BANKED AND RILLED.

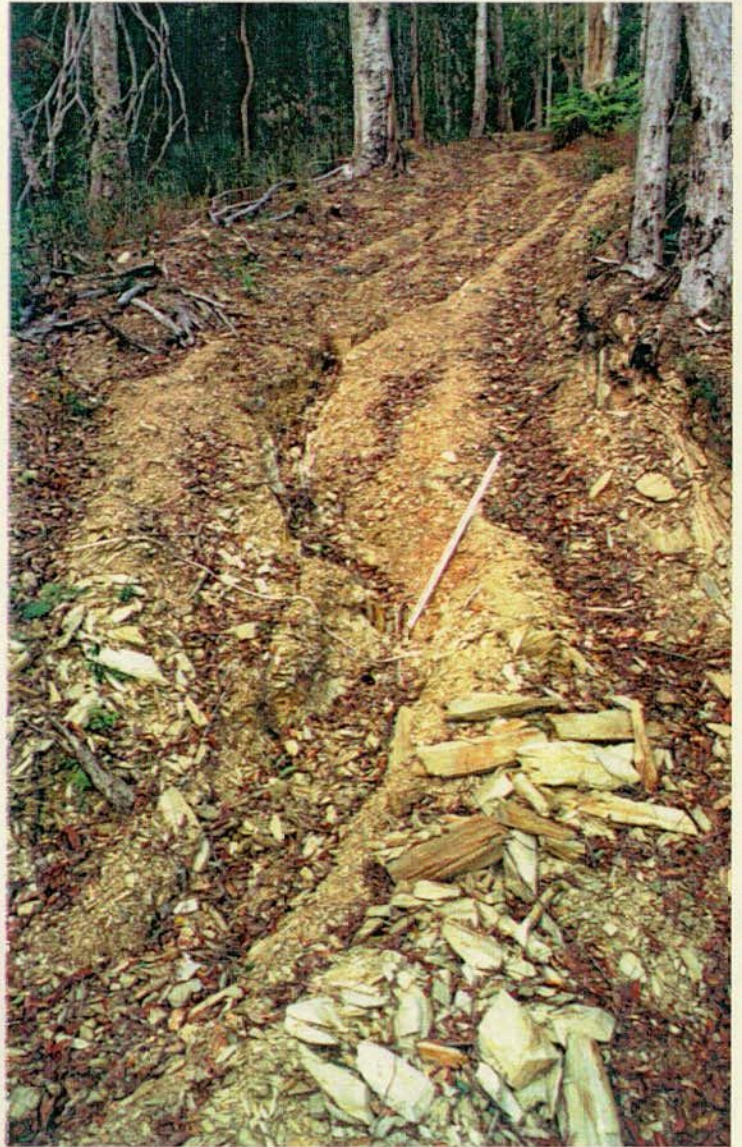
SNIG TRACK UPSLOPE FROM  
CATBIRD ROAD EXCAVATED  
TO ROCK, FINES GONE.

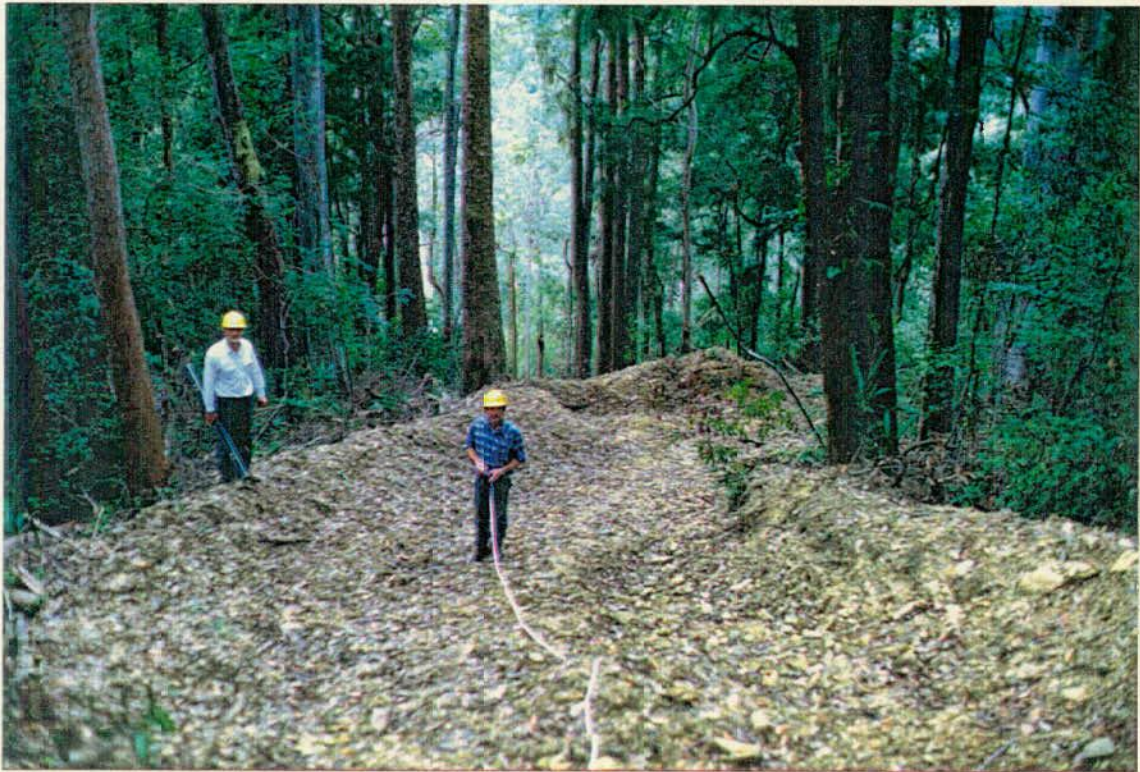
BOX CUT RIDGE TRACK SC5 HIGH WINDROWS AND RILLED.

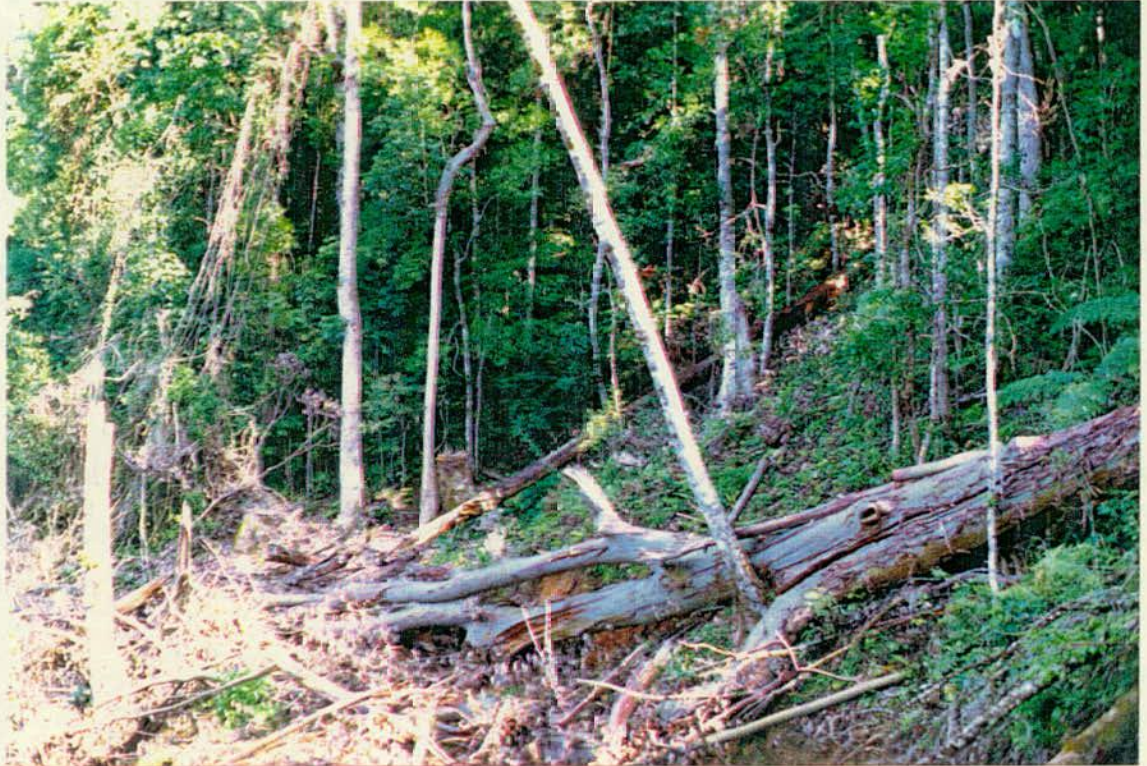
SNIG TRACK INTRUSION INTO  
PROTECTION STRIP IN SCRAGGY  
CREEK CATCHMENT.

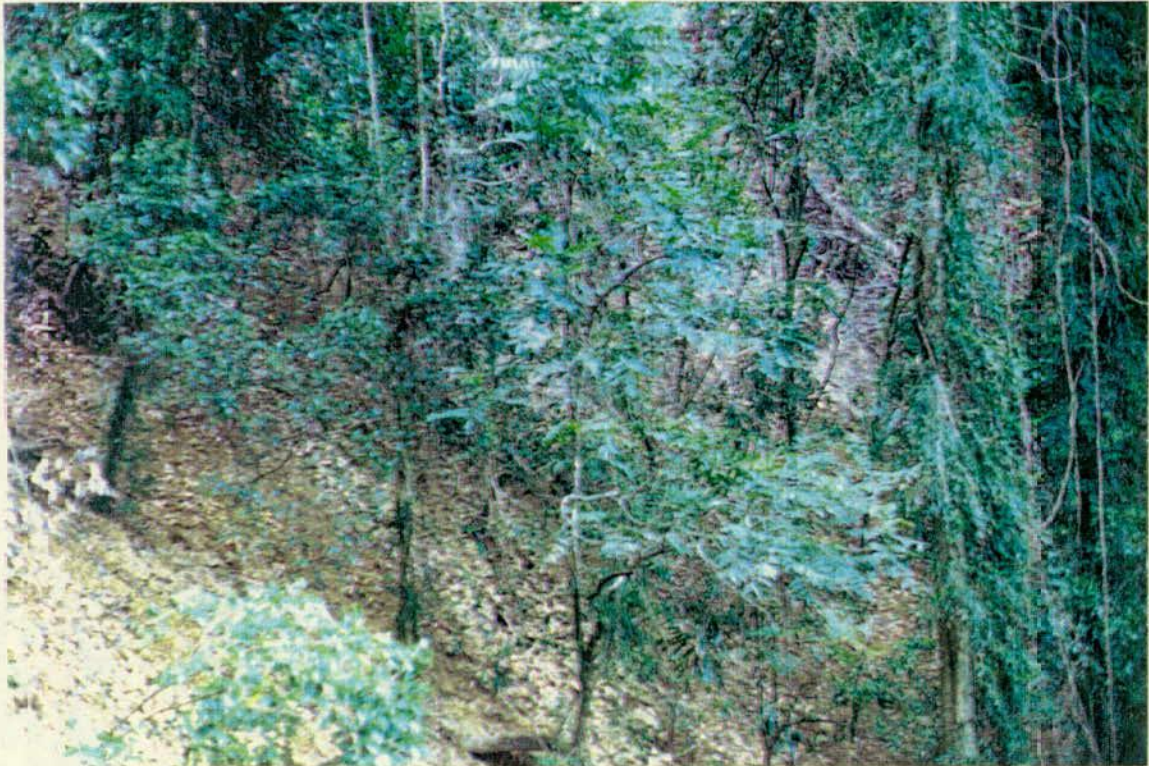
and it appears that no attempt was made to carry the spoil back to safe dump sites. The resulting talus has mantled the slopes below the road for over 100 metres in many sections. The problem has been exacerbated by the need to excavate large head batters on these steep slopes and then has been compounded in areas where the head batters failed due to landslide and the extra debris was pushed over the side.

A conservative estimate of the area of exposed talus along Catbird Road is 4.7 km x 50 m = 23.5 ha at an average slope of 36 degrees.

TALUS COVERED STEEP SLOPE  
UNDER CATBIRD ROAD ABOVE  
SNIGTRACK SC6

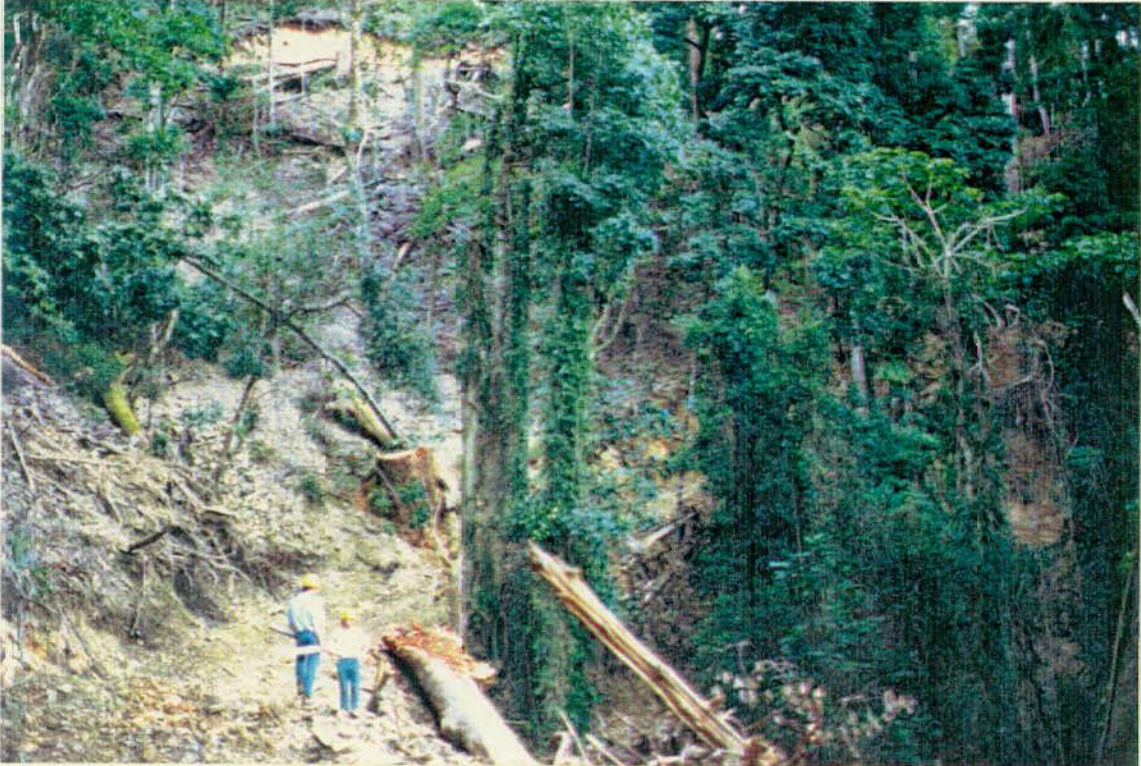
TALUS COVERED STEEP SLOPE  
UNDER CATBIRD ROAD ABOVE  
SNIGTRACK SC6.

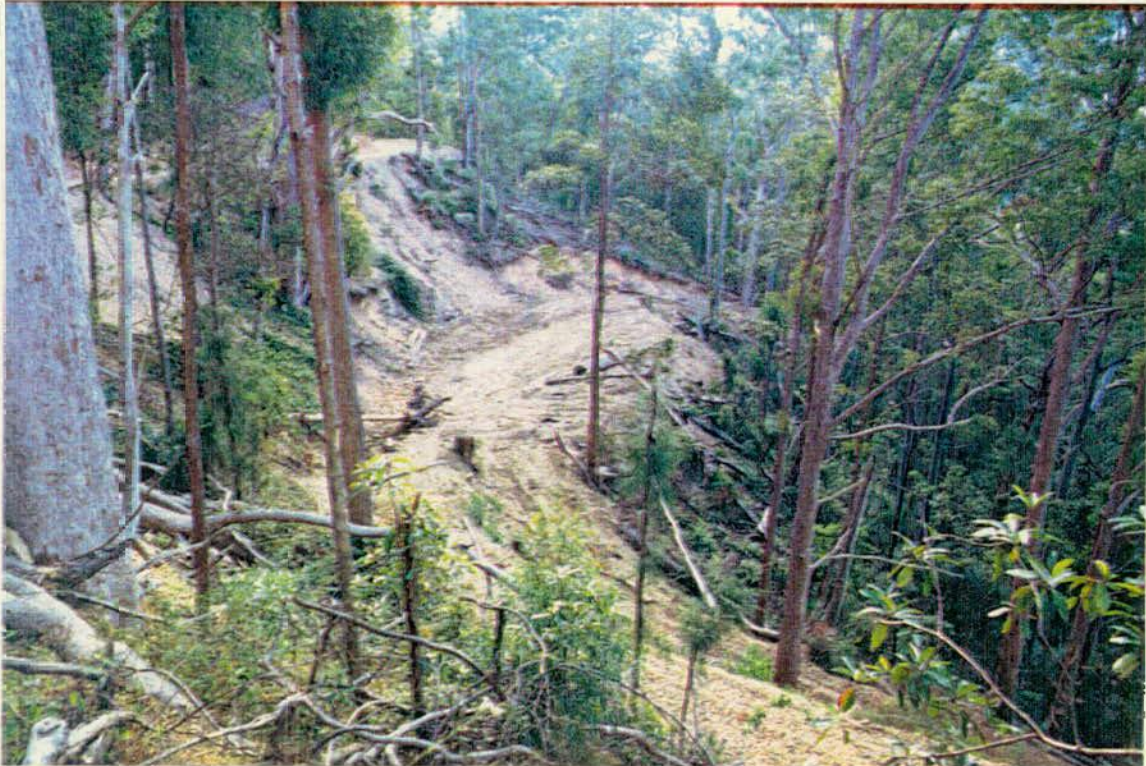
CATBIRD ROAD AND DUMP 6. ILLUSTRATING LARGE TALUS COVERED SLOPE AND EXCAVATION.

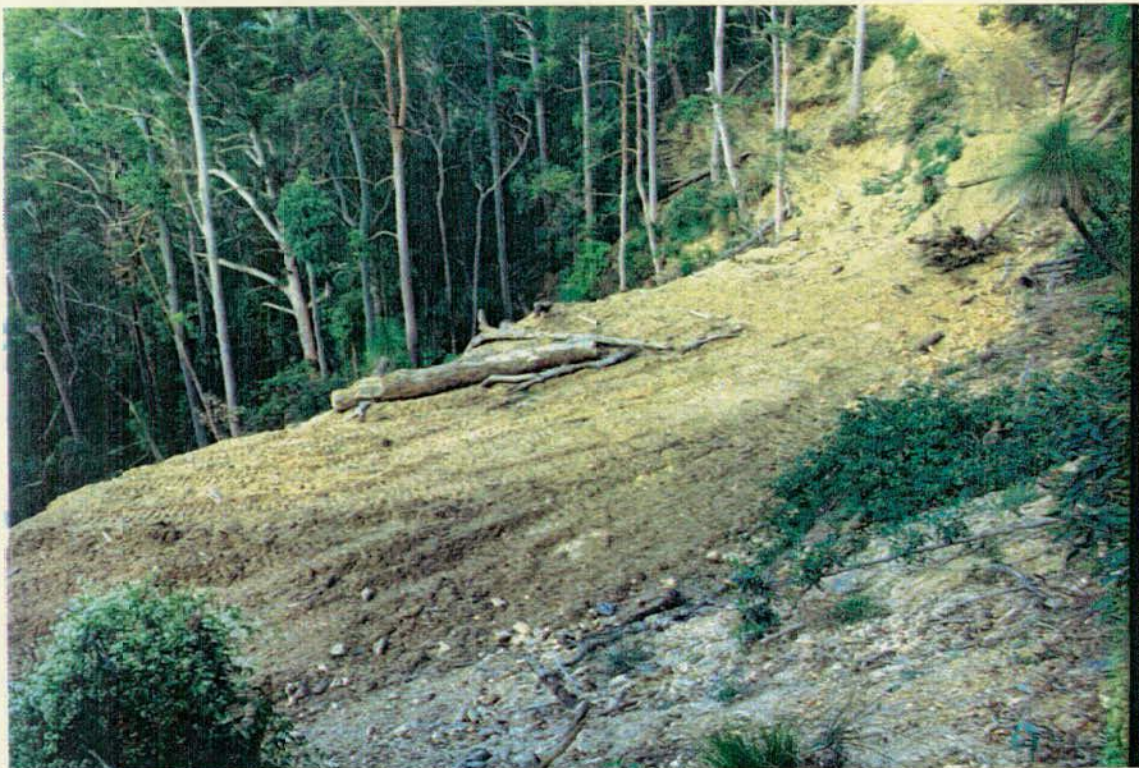
RESHAPED DUMP 6 AFTER THE LOGGING EXTRACTION CEASED.

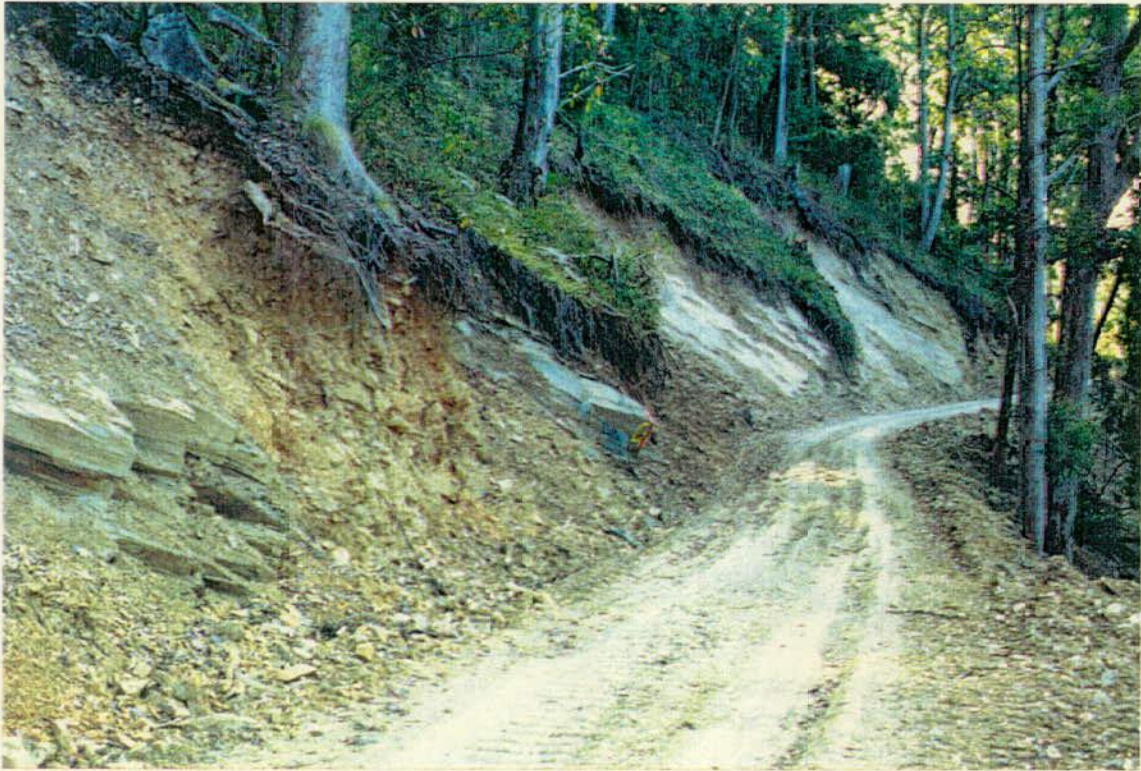
CATBIRD ROAD WITH SLIPS

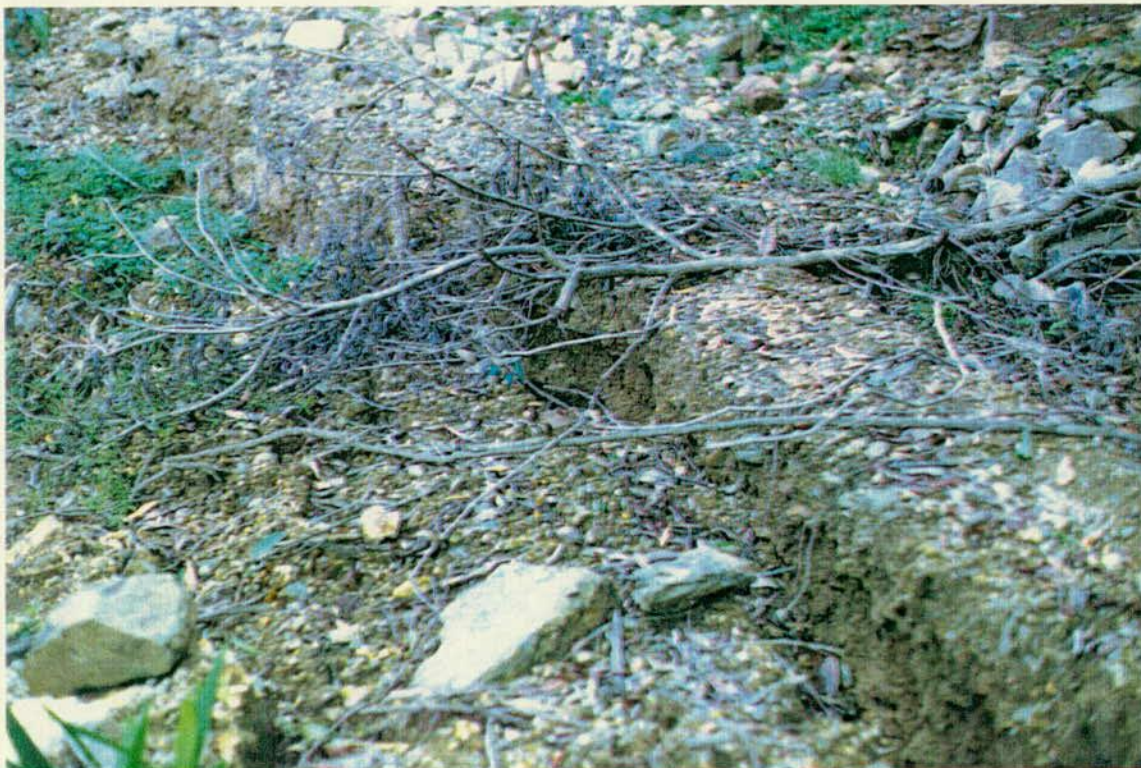
SLUMPS OF SNIG TRACK PAVEMENT.

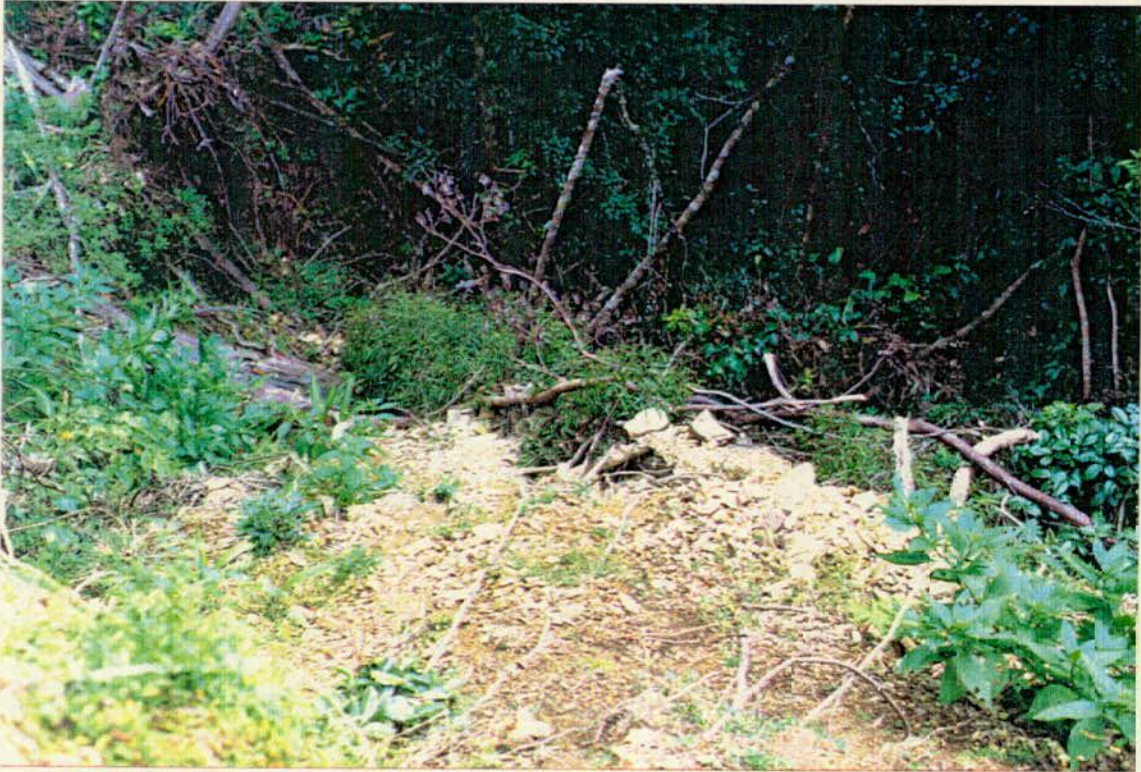
DEBRIS DOZED INTO PROTECTION STRIP ON SC7a

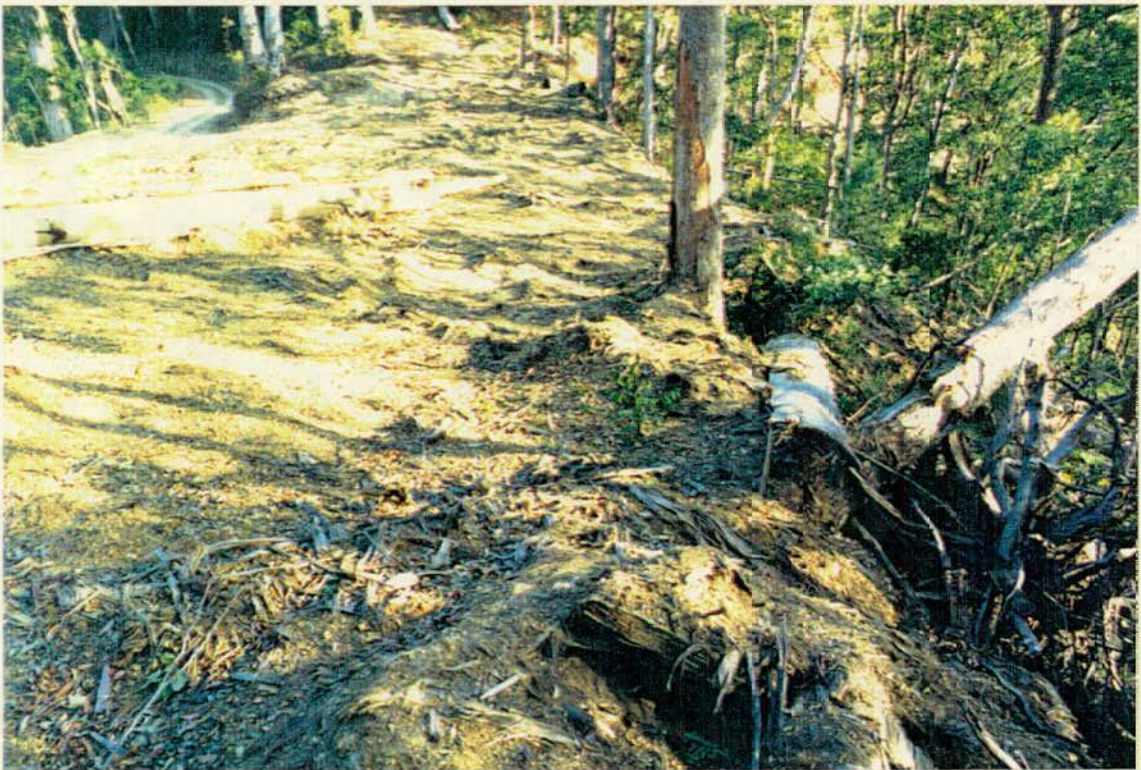
TREE DEBRIS BURIED ON LOG DUMP 7

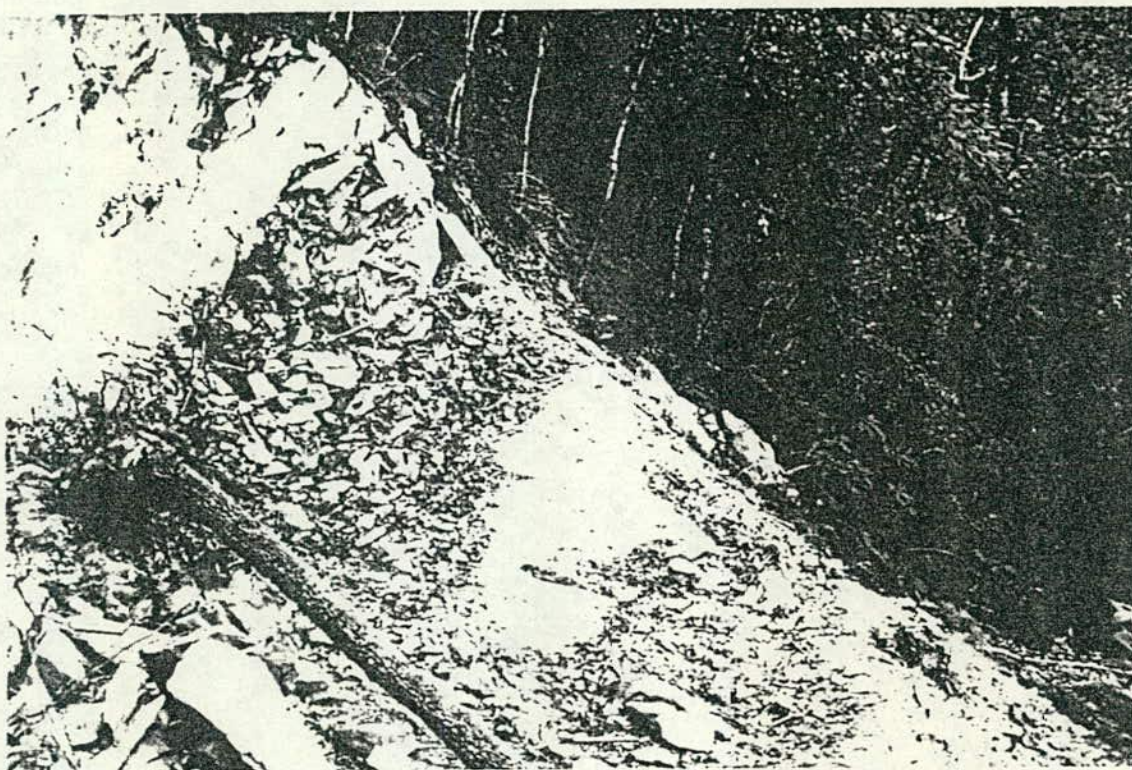
SNIG TRACK SU5 FROM DUMP 5  
STEEP SIDESLOPE, TRACK IMPEDED BY ROCK

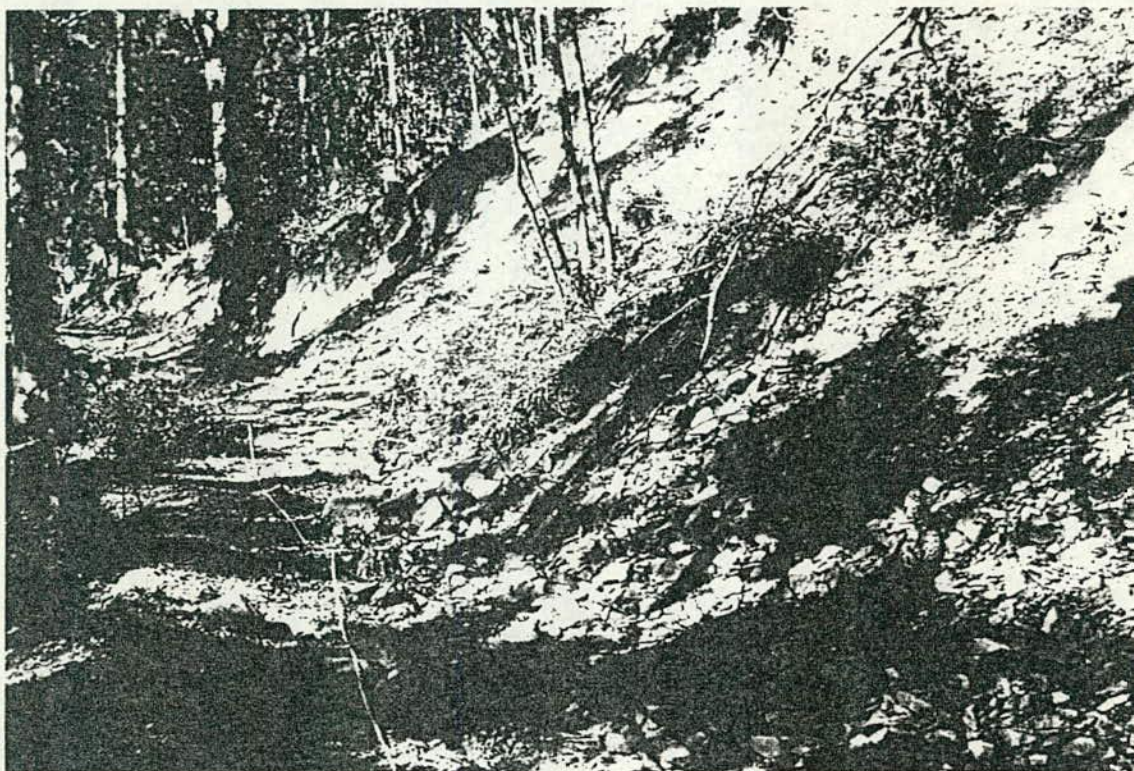
LARGE CUT BATTER AND SLIP ON SNIG TRACK SU6, FROM DUMP 7  
UPSLOPE.
