- i) to report on the recent logging activities in compartments 168 - 170 of Oakes State Forest within the context of the July, 1990 Standard Erosion Mitigation Conditions for Logging (SEMC's);
- ii) to compile recommendations necessary to rehabilitate any soil conservation problems identified in i) above; and
- iii) to prepare recommendations for the Forestry Commission to consider when it proposes to carry out logging in areas of a similar nature to Oakes State Forest.

OAKES STATE FOREST

Compartments 168 - 170.

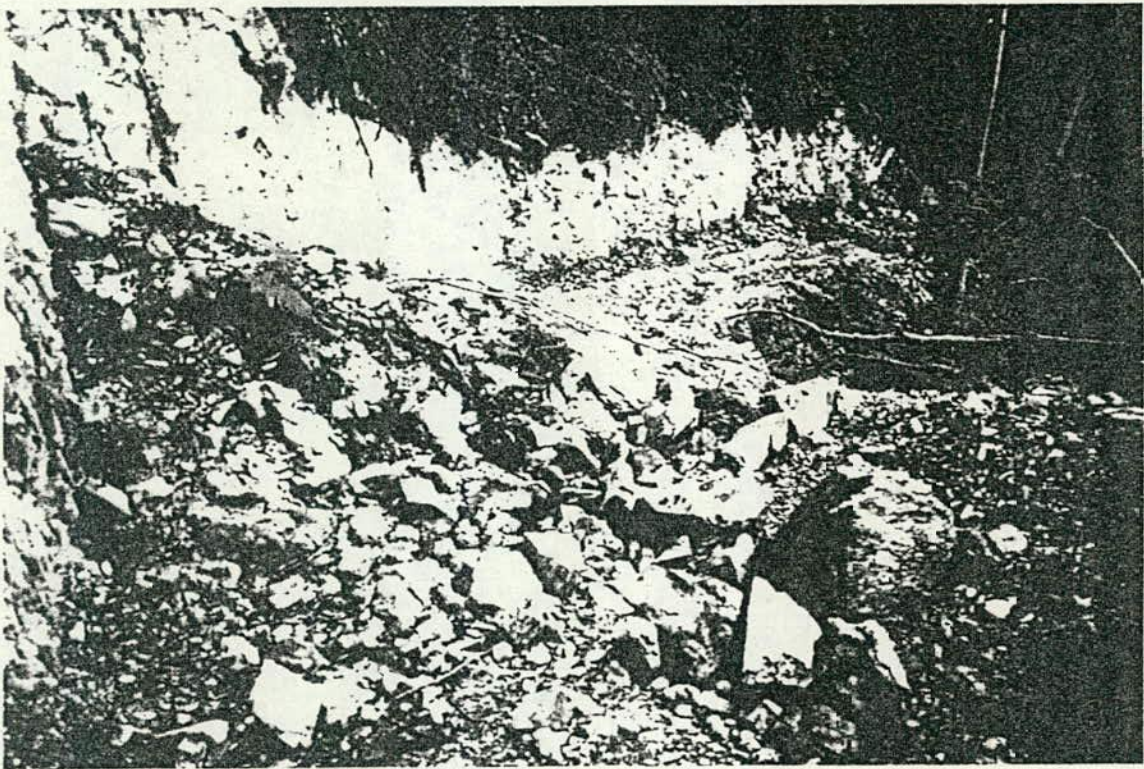
SLIP OF ROCK ON SNIG TRACK SUS FROM DUMP 5  
DOWNSLOPE.

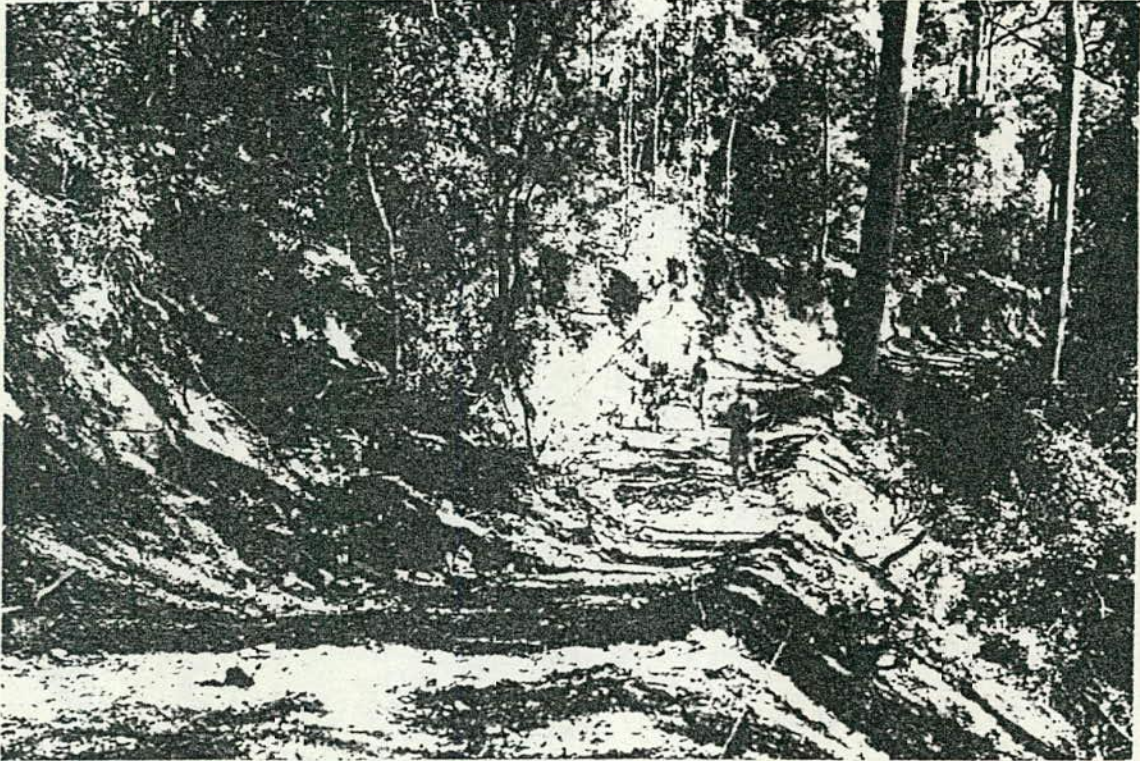
SLIP ON SNIG TRACK SU6 FROM DUMP 7  
DOWNSLOPE. NOTE WINDROW

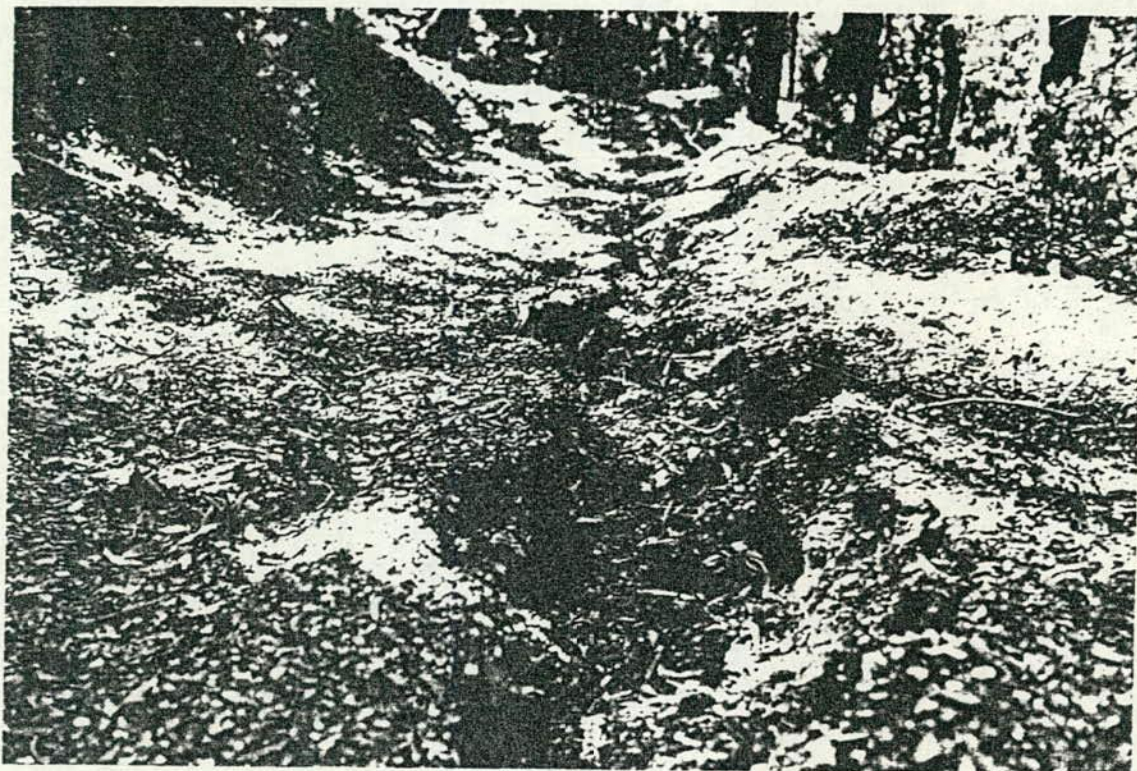
SIDECUT SNIGTRACK, UPSLOPE WITH HIGH WINDROW  
AND DEEP RILL.

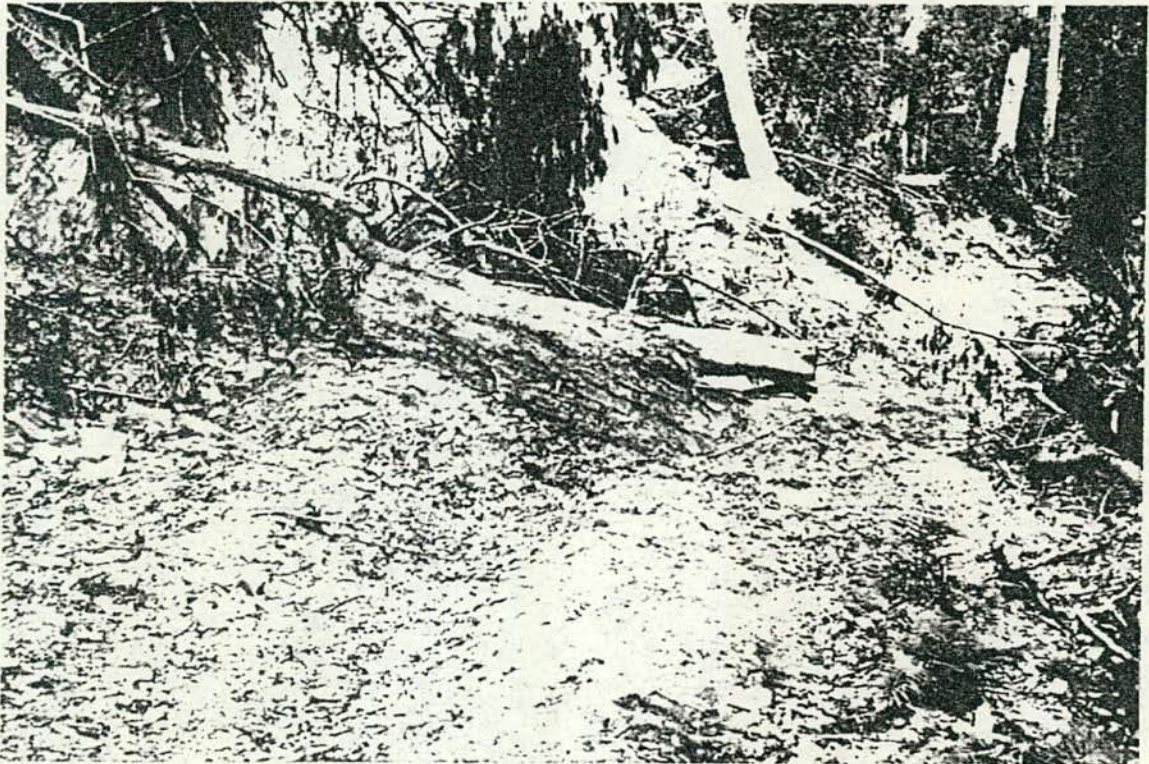
SIDECUT SNIG TRACK SU6 FROM DUMP 7  
INEFFECTIVE BANK.

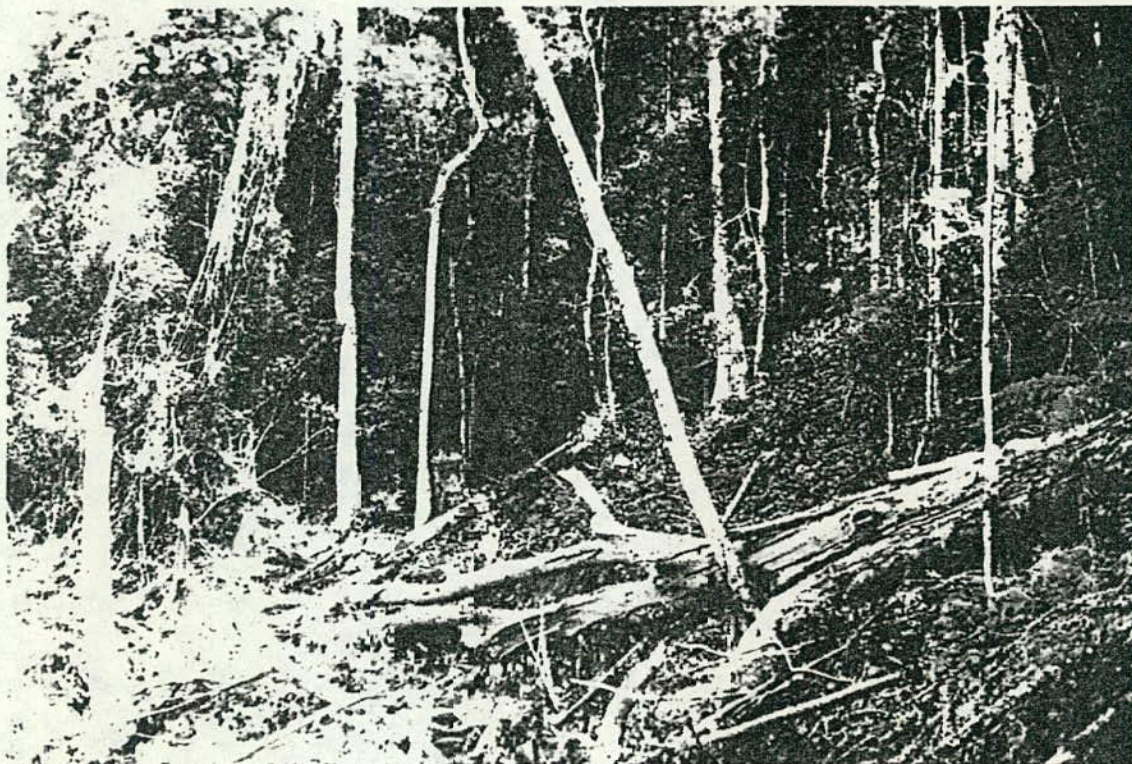
SNIG TRACK INTRUSION INTO  
PROTECTION STRIP IN SCRAGGY  
CREEK CATCHMENT.

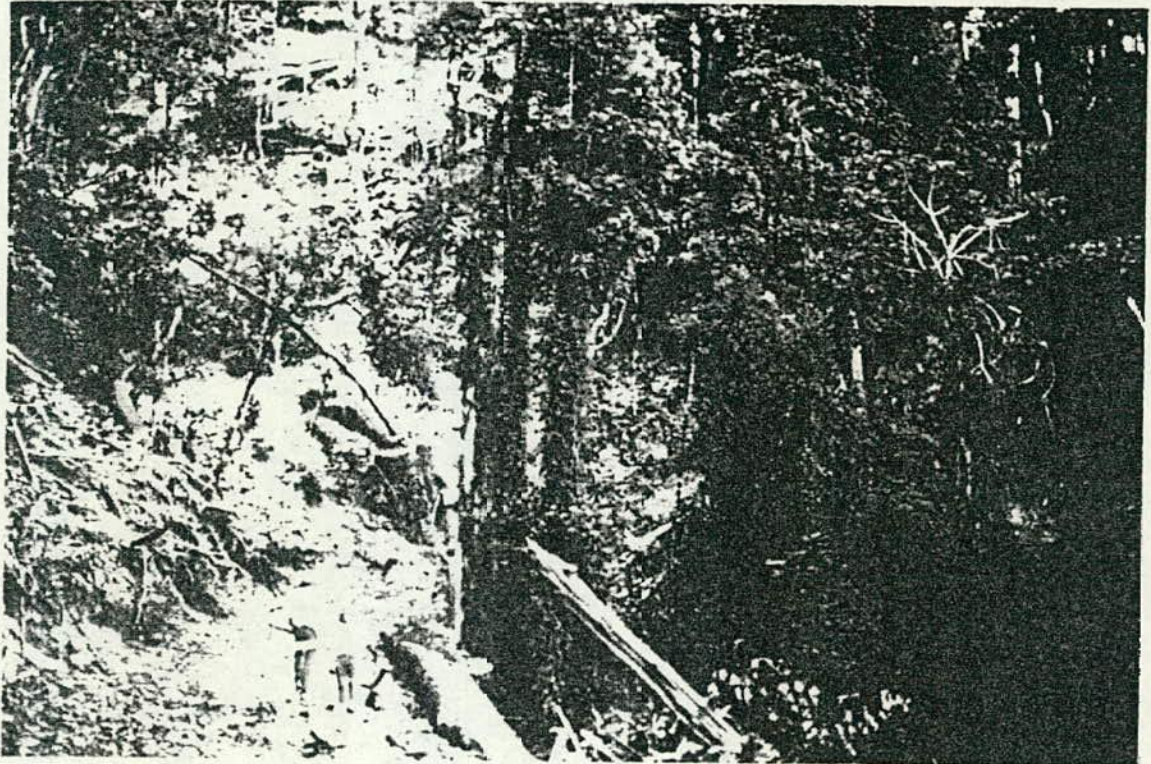
TALUS COVERED STEEP SLOPE  
UNDER CATBIRD ROAD ABOVE  
SNIGTRACK SC6.

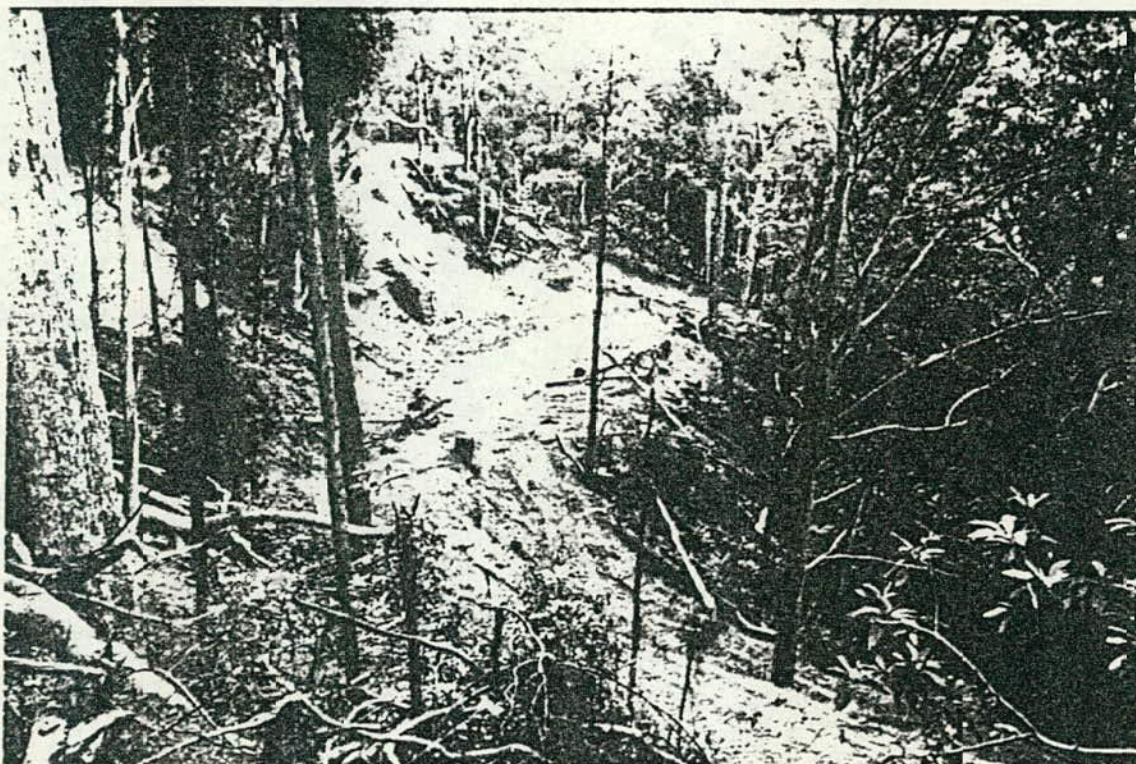
CATBIRD ROAD AND DUMP 6. ILLUSTRATING LARGE TALUS COVERED SLOPE AND EXCAVATION.

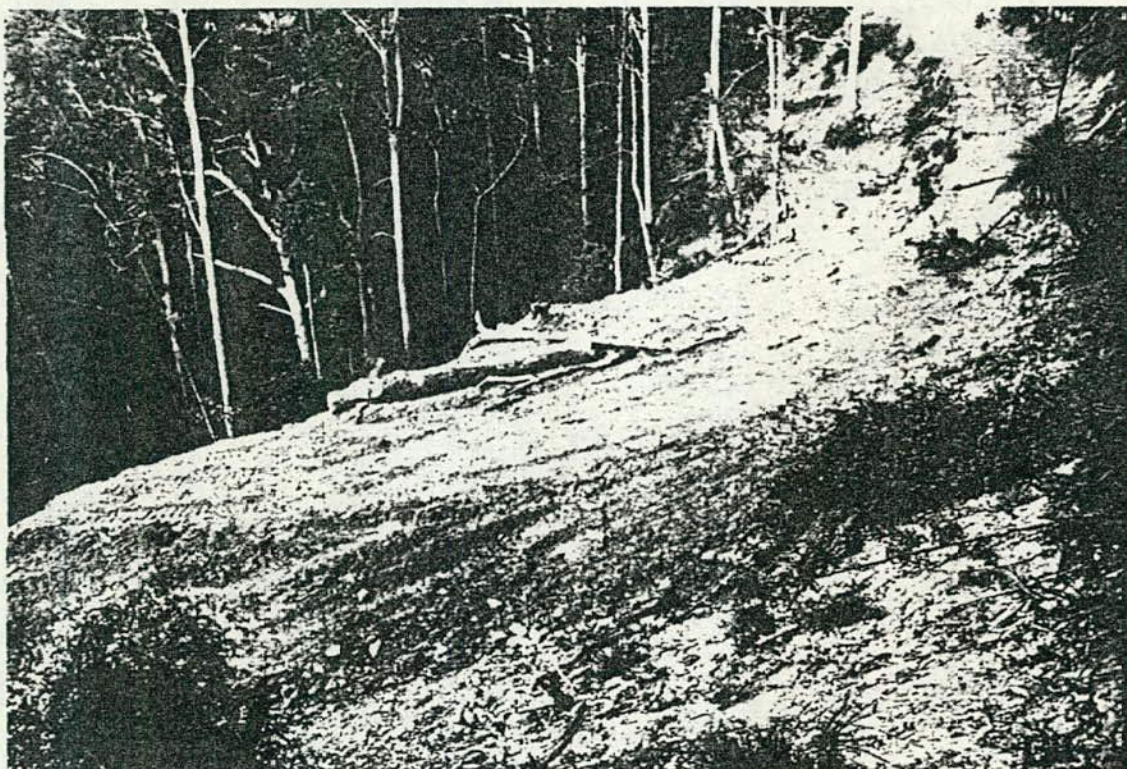
RESHAPED DUMP 6 AFTER THE LOGGING EXTRACTION CEASED.

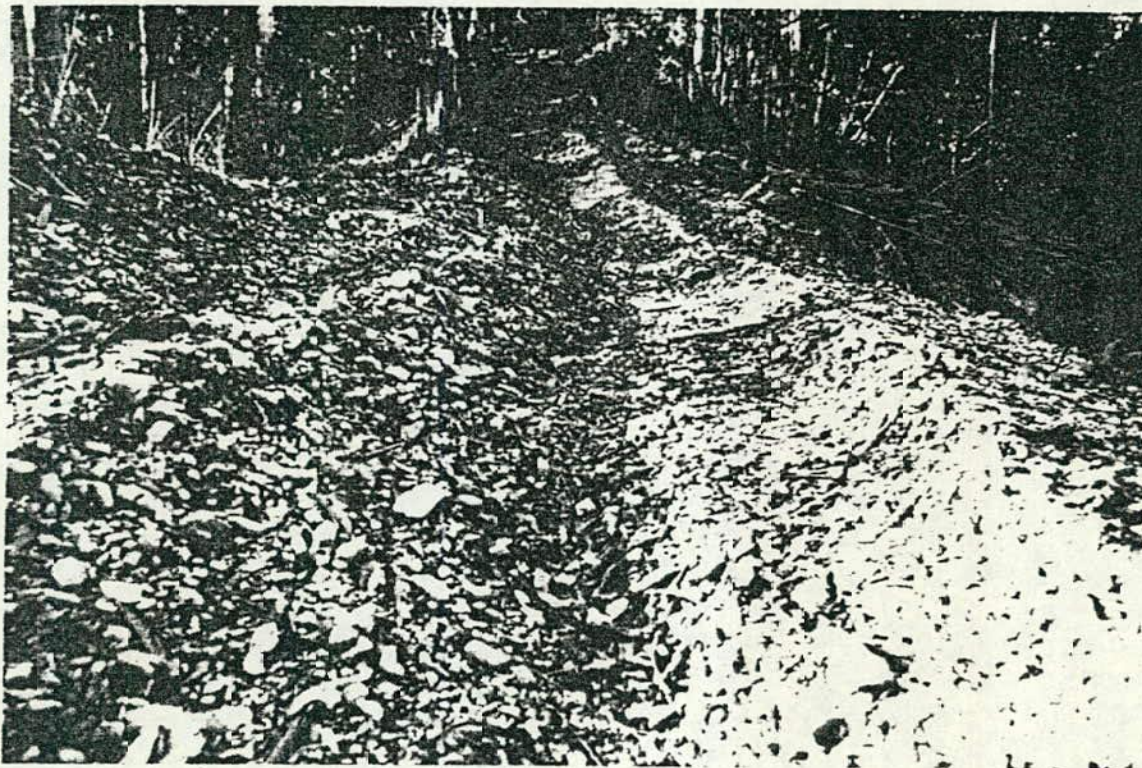
RIDGE SNIG TRACK WITH DEEP LOG SCOUR.

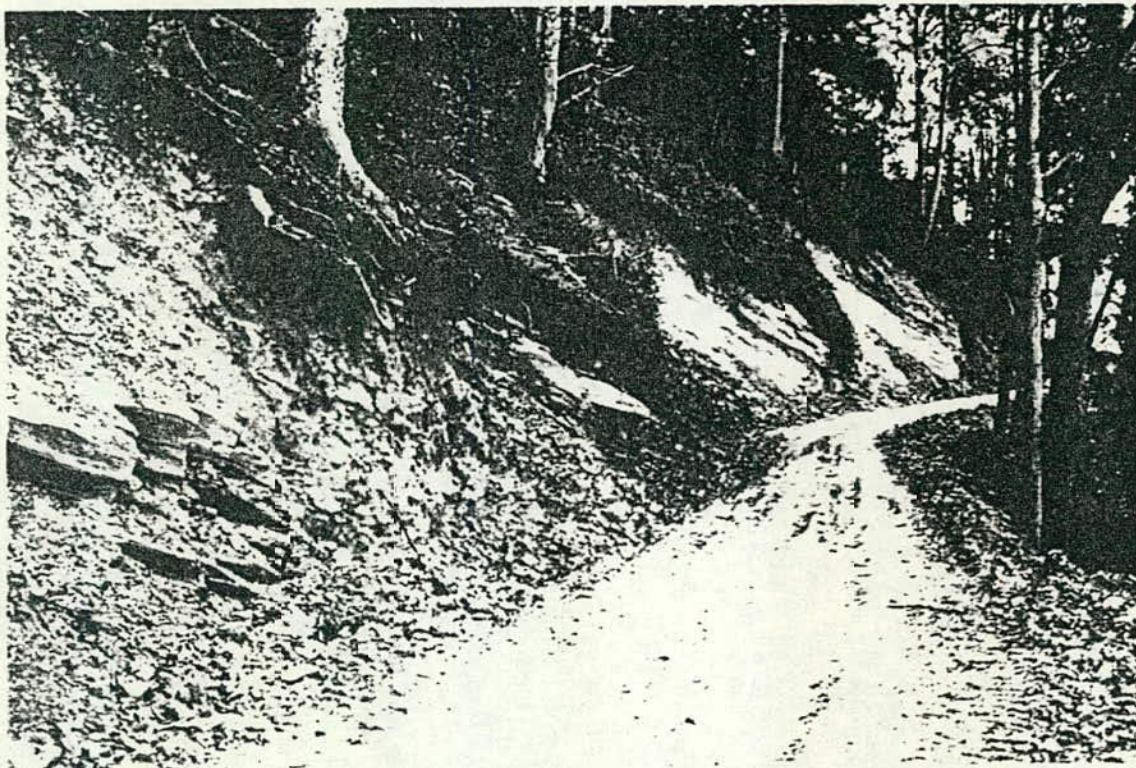
CATBIRD ROAD WITH SLIPS

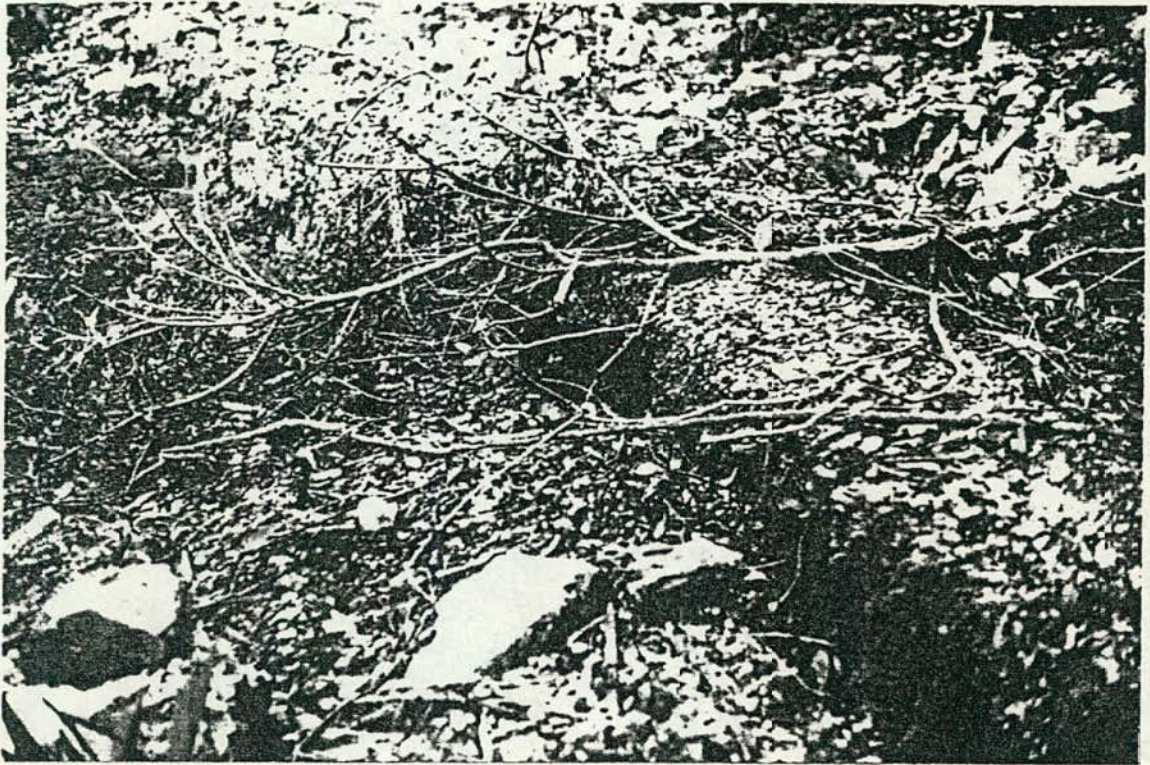
SLUMPS OF SNIG TRACK PAVEMENT.
